# Branch Street School

City of Methuen  
ADA Transition Plan

November 2024

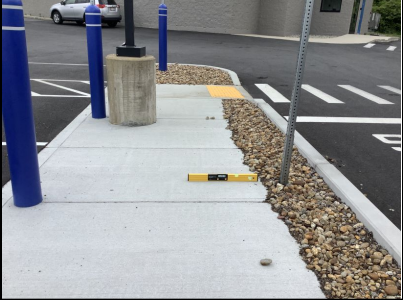
ID	Location	Floor	Room	Element	Type	Photo	Issues	Current Measure	Recommendations	Quantity	Price	Cost Estimation
Approach and Entrance												
Exterior Access Route												
1	Accessible Spaces in Front of West Entrance	Ext.	-	Exterior Access Route	Walkway

Cross slope > 1:50 (2.00%)	2.9%	Reduce cross slope to be no steeper than 1:50 (2.00%).	1	-	-
2	Playground	Ext.	-	Exterior Access Route	Play Area

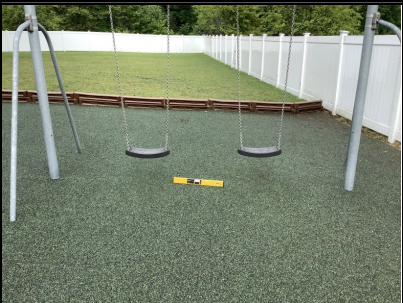
Cross slope > 1:50 (2.00%)	6.3%	Ensure that the clear floor space at the play component is no greater than 1:50 (2.00%).	1	-	-
3	Playground	Ext.	-	Exterior Access Route	Play Area

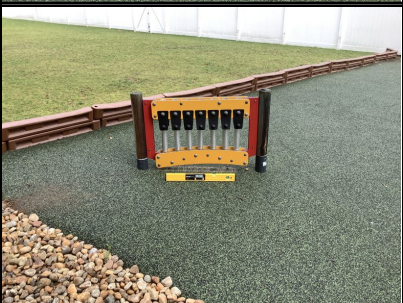
Cross slope > 1:50 (2.00%)	3.6%	Ensure that the clear floor space at the play component is no greater than 1:50 (2.00%).	1	-	-
4	Exterior Route From Crosswalk to Main Entrance	Ext.	-	Exterior Access Route	Walkway

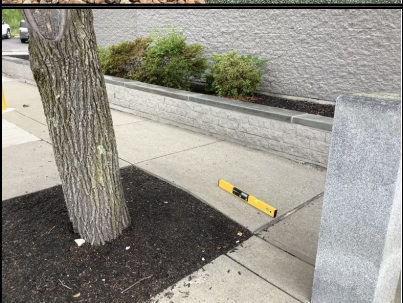
Running slope > 1:20 (5.00%)	8.5%	Reduce running slope to be no steeper than 1:20 (5.00%).	1	-	-

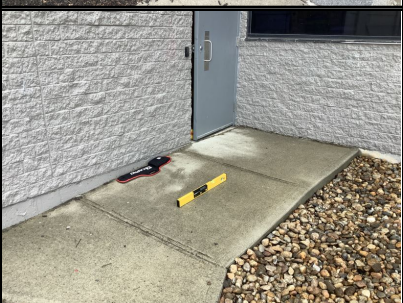
5	Playground Entrance	Ext.	-	Exterior Access Route	Walkway

Running slope > 1:20 (5.00%)	10.4%	Reduce running slope to be no steeper than 1:20 (5.00%) or provide a ramp with a slope that is no greater than 1:12 (8.33%). During renovation, ensure that there is a level landing (2.00% max.) that extends from the rear wall to a point 24" min. on the latch side of the door.	1	-	-

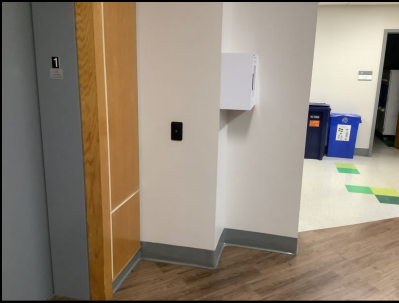
Obstructed by protruding objects	8.5"	Provide a cane-detectable barrier underneath the defibrillator. Barriers must have leading edges no higher than 27" so that they are within cane sweep. Barriers can include fixed planters, benches, and guardrails.	1	398	\$398
Doors, Doorways, & Gates												
12	Administration Office Corridor	1	-	Doors, Doorways, & Gates	Circulation

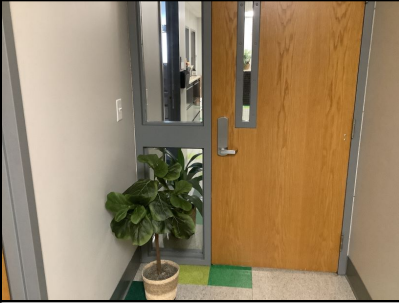
Maneuvering clearance(s) not provided		Relocate the plant.	1	Labor	Labor
13	Single Testing Room	1	119	Doors, Doorways, & Gates	Office

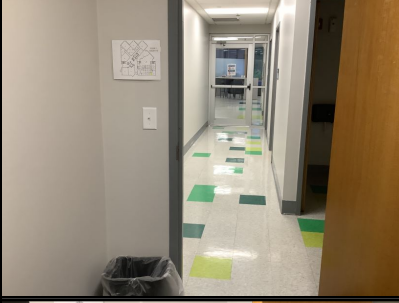
Maneuvering clearance(s) not provided	-	Relocate the trash can to provide 18" of pull side maneuvering clearance.	1	Labor	Labor
14	Enrollment Specialist	1	122	Doors, Doorways, & Gates	Meeting Room

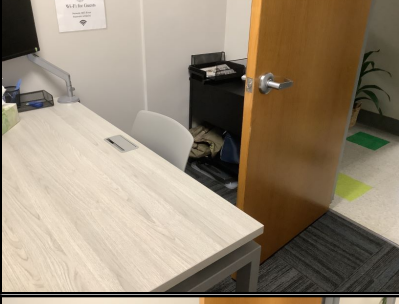
Maneuvering clearance(s) not provided	50.5"	Ensure that staff can assist wheelchair users and others who need help with opening the door, or provide access to an enrollment specialist in Room 123.	1	Labor	Labor

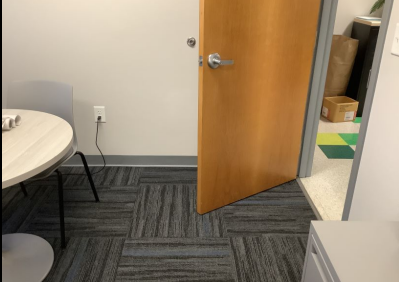
15	Family Resource Center Coordinator	1	124	Doors, Doorways, & Gates	Office

Maneuvering clearance(s) not provided	-	Remove the cabinet to provide 18" of pull side clearance at the latch side of the door.	1	Labor	Labor

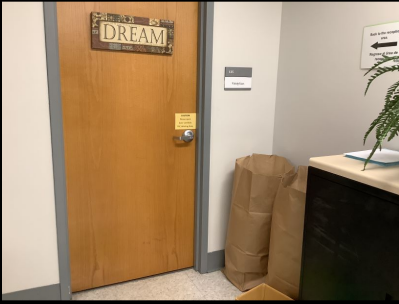
Maneuvering clearance(s) not provided	-	Relocate the bags and table to provide 12" of push side maneuvering clearance and 48" min. between the table and the wall on the latch side of the door.	1	Labor	Labor
17	All-Gender Single-User Toilet Room in School Corridor	1	135	Doors, Doorways, & Gates	Toilet Room

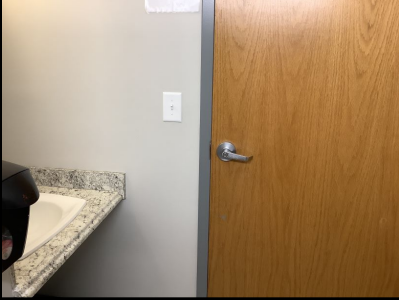
Maneuvering clearance(s) not provided	16"	Provide an automatic door opener.	1	6000	\$6000
											6000	
18	Playground Entrance	Ext.	-	Doors, Doorways, & Gates	Circulation

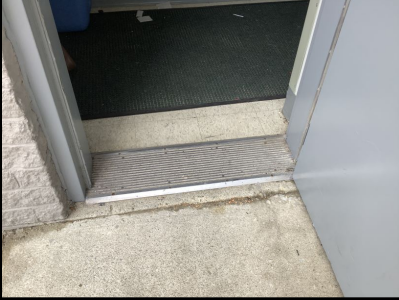
Threshold not maintained in operable working condition		Repair the cracks in front of the threshold.	1	-	-
19	Administratio n Office Corridor	1	-	Doors, Doorways, & Gates	Circulation

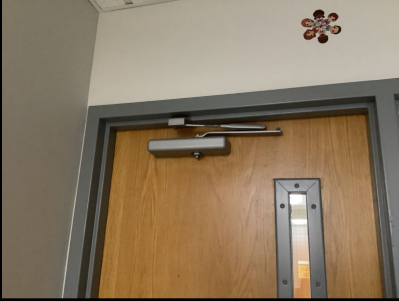
Door requires > 5 lbs. of force to open	13 lbs	Adjust closers so doors do not require more than 5 pounds of force to open.  Applies to all doors in this condition.	1	Labor	Labor

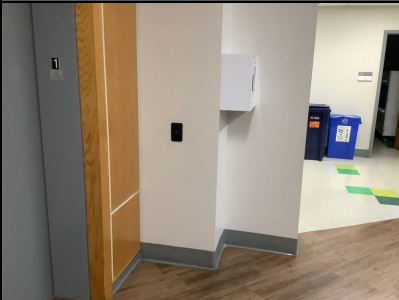
Tactile stars not provided at main entry level	-	Provide a tactile star on both sides of jambs at main floor. At other floors, provide appropriate number.	2	96	\$192
											192

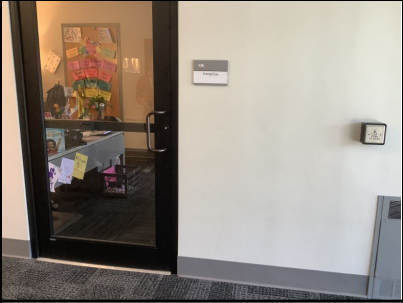
Raised characters not provided on sign		Provide text with raised characters duplicated in braille on the sign.  Applies to all designation signs in this condition.	1	250	\$250
											250	
22	Single-User Toilet Room in Administration Office Corridor	1	130	Signage	Designation

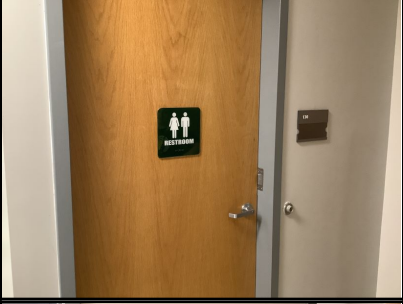
Raised characters not provided on sign Braille not provided on sign Location of tactile sign not compliant	- - -	Provide text with raised characters duplicated in braille on the sign.  Locate sign alongside the door on the latch side.	1	250	\$250
											250	
23	Enrollment Specialist	1	121, 122, 123	Signage	Designation

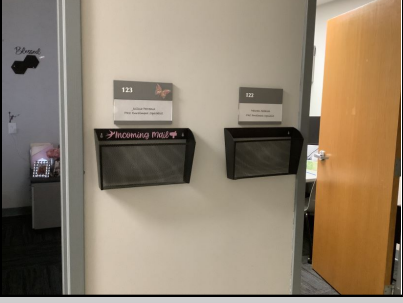
Signage lacks 18" by 18" clear floor space		Relocate storage bins provide a clear floor space of 18" min. by 18" min.	3	500	\$1500

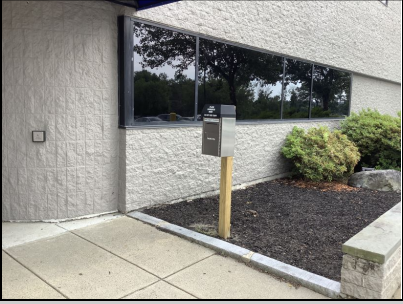
Reach < 15" or > 48"(forward/side approach)	51"	Relocate the intercom control so that controls are between 15"- 48" above the finished floor.	1	800	\$800
											800	
Dining or Work Surfaces												
25	Reception Office	1	125	Dining or Work Surfaces	Work Surface

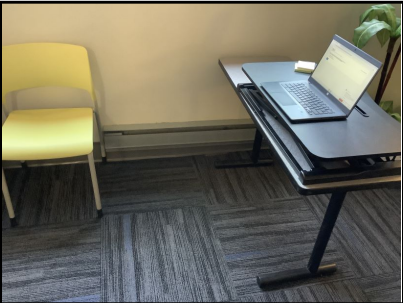
Not on a accessible route	-	Ensure work surfaces are located on an accessible route that allows for a 30" by 48" forward approach. Relocate the chair.	1	Labor	Labor

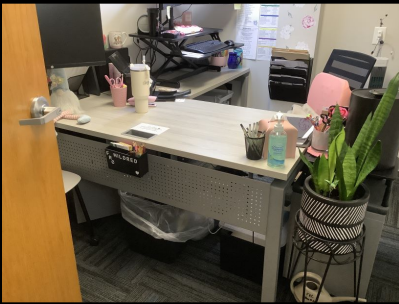
Knee or toe clearance not provided Maneuvering clearance(s) not provided	16.5" 52"	This Enrollment Specialist office lacks maneuvering clearance at the door and does not allow wheelchair users a forward approach to the work surface. Provide access to an enrollment specialist in Room 123 or 122 for people who need it.	1	Labor	Labor
27	Reception Office	1	125	Dining or Work Surfaces	Work Surface

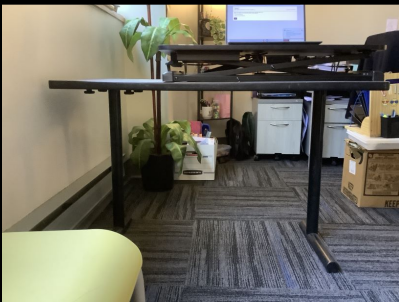
Top of work surface < 28" or > 34"	-	Relocate the additional height adjustable surface on top of this work surface to ensure the height of this work surface does not exceed 34".	1	Labor	Labor
28	Single Testing Room	1	119	Dining or Work Surfaces	Work Surface

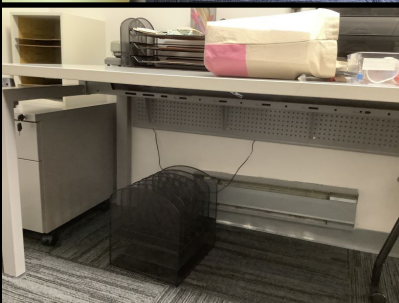
Knee clearance less than 19" deep	15.5"	Provide at least one work surface with knee clearance that is 19" deep min.  Applies to all Enrollment Specialist Rooms 122 and 123.	4	700	\$2800

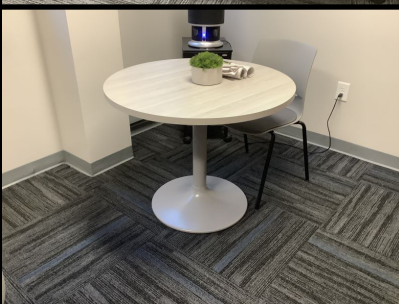
Knee clearance less than 19" deep	8"	Provide at least one work surface with knee clearance that is 19" deep min.	1	700	\$700
											700	
Toilet & Bathing Rooms												
Overall Access												
30	All-Gender Single-User Toilet Room in Administration Office Corridor	1	130	Overall Access	Toilet Room

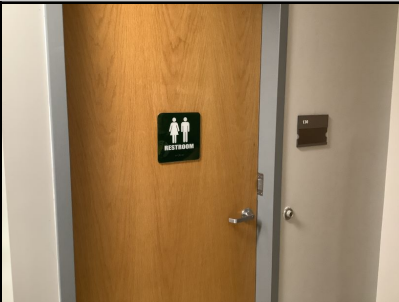
Sign to accessible toilet not provided	-	Provide a directional sign to toilet room (133).	1	250	\$250
											250

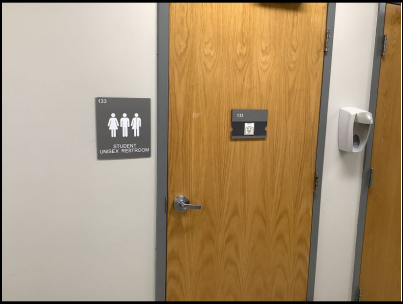
International Symbol of Acc. not provided	-	Provide a sign with the International Symbol of Accessibility (ISA).	1	250	\$250
Lavatory												
32	All-Gender Single-User Toilet Room in School Corridor	1	135	Lavatory	N/A

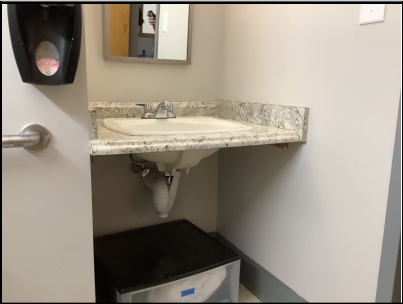
Toe or knee clearances not provided Mirror above lavatory w/reflective surface > 40"	- 42.25"	Relocate items from under the lavatory. Lower mirror so that the bottom surface is at 40" max. above the finished floor.	1	500	\$500
33	All-Gender Single-User Toilet Room in School Corridor	1	133	Lavatory	N/A

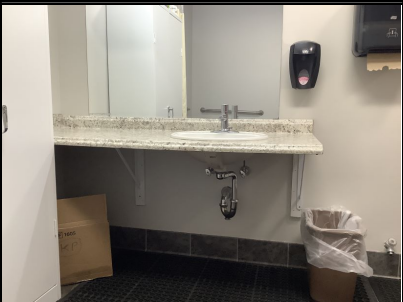
Plumbing underneath is exposed	-	Insulate or otherwise configure pipes to prevent contact for at least one lavatory.	1	150	\$150
Single-User Toilet												
34	Single-User Toilet Room in School Corridor	1	133	Single-User Toilet	N/A

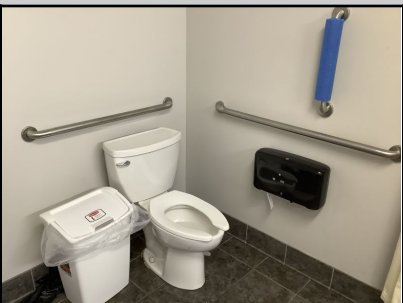
Centerline < or > 18" (MAAB) Side or rear grab bar < 33" or > 36" high Rear grab bar < 42" long (MAAB) Clearance at toilet < 60" clear width	20.75" 37" 37.75" -	Relocate toilet so that the centerline is 18" from the side wall. Mount grab bars 33"- 36" above the finished floor. Provide a rear wall grab bar that is 42" long min. and extends from the toilet 12" min. on one side and 24" min. on the other side (open side). Relocate trash can to provide 60" clear width next to the toilet.	1	3676 800 750 Labor	\$5226

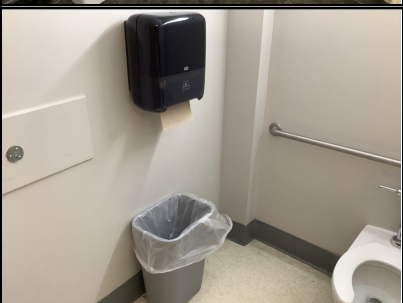
35	All-Gender Single-User Toilet Room in School Corridor	1	135	Single-User Toilet	N/A

Clearance at toilet < 60" clear width	-	Relocate the paper towel dispenser and trash bin out of the clear floor space required at the toilet.	1	500	\$500

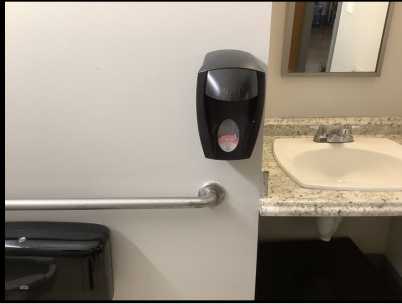
Item mounted over grab bar (MAAB)	-	Relocate soap dispenser so that it is not mounted over the grab bar.	1	500	\$500
500												
Dispensers												
37	Single-User Toilet Room in School Corridor	1	133	Dispensers	Paper Towel Dispenser

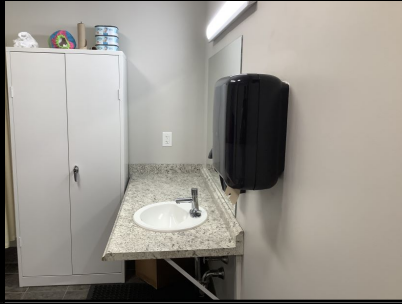
Dispenser acts as a protruding object	8.5"	Provide a cane-detectable barrier underneath the paper towel dispenser. Barriers must have leading edges no higher than 27" so that they are within cane sweep. Barriers can include fixed planters, benches, and guardrails.	1	398	\$398
398												
38	Single-User Toilet Room in School Corridor	1	133	Dispensers	Soap Dispenser

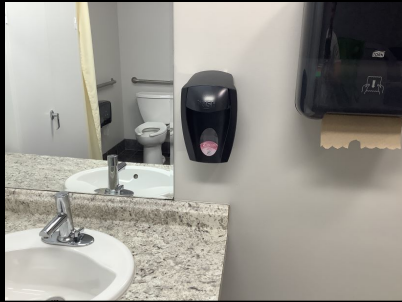
Forward reach if obstruction > 20"- 25" deep is > 44" high	48"	Relocate the soap dispenser so that the controls are 44" above the finished floor.	1	500	\$500

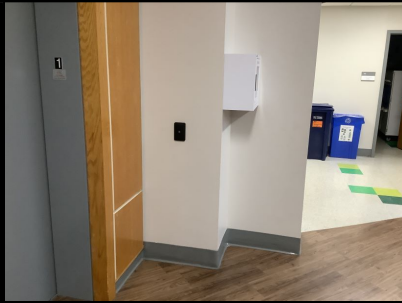
Recommend providing blade signs over all defibrillators in the building.	1	-	-
40	Single-User Toilet Room in Administration Office Corridor	1	130

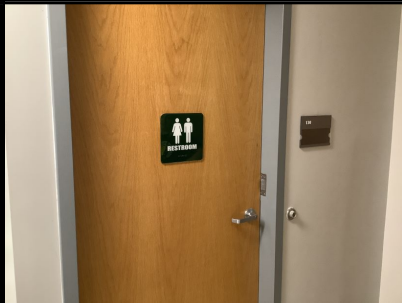
If one or two foreign languages are spoken by students, recommend providing additional signage in the appropriate languages spoken by these students.	1	-	-

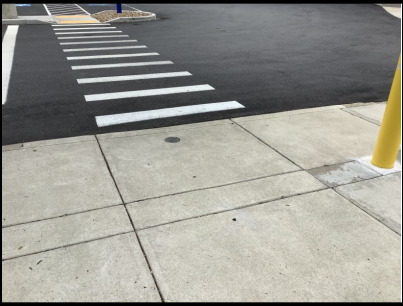
Recommend providing a detectable warning at each end of the crosswalk.	1	-	-
42	Accessible Spaces in Front of West Entrance	Ext.	-

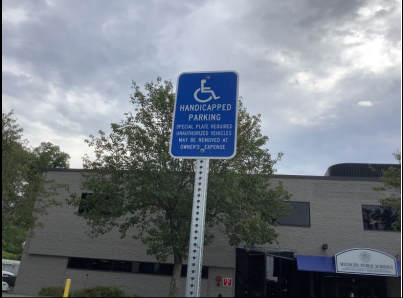
Recommend using the term "Accessible Parking" rather than "Handicapped Parking".	1	-	-
