# Tenney Grammar School

## City of Methuen ADA Transition Plan

November 2024

Institute for Human Centered Design

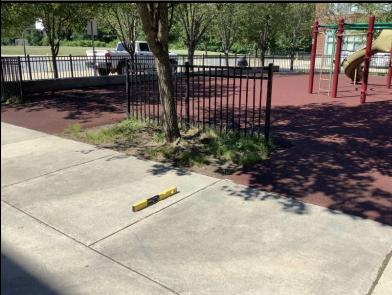
ID	Location	Floor	Room	Element	Type	Photo	Issues	Current Measure	Recommendations	Quantity	Price	Cost Estimation
<b>Approach and Entrance</b>												
<b>Exterior Access Route</b>												
1	Playground In Between Lower and Upper Schools	Ext.		Exterior Access Route	Walkway

Cross slope > 1:50 (2.00%)	2.6%	Reduce cross slope to be no steeper than 1:50 (2.00%).	1	-	-
2	Basketball Courts	Ext.		Exterior Access Route	Walkway

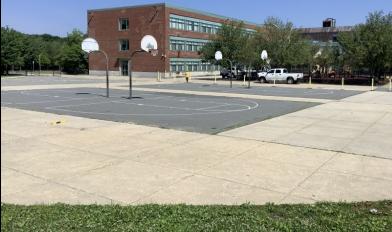
Cross slope > 1:50 (2.00%)	2.6%	Reduce cross slope to be no steeper than 1:50 (2.00%).	1	-	-
3	Playground South of Lower School	Ext.		Exterior Access Route	Walkway

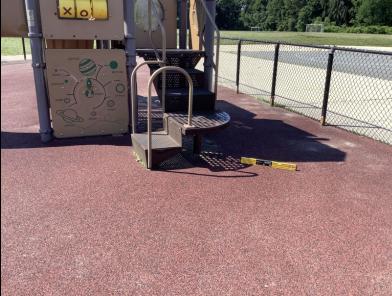
Cross slope > 1:50 (2.00%)	6.7%	Reduce the slope of the clear floor space next to the transfer platform to 1:50 (2.00%).	1	-	-
4	Walkway Next to East Side of Lower School	Ext.		Exterior Access Route	Walkway

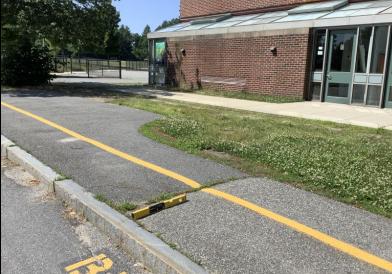
Cross slope > 1:50 (2.00%) Route not maintained in operable working condition	4.9% -	Reduce cross slope to be no steeper than 1:50 (2.00%). Ensure the accessible route is maintained in operable working condition.	1	-	-

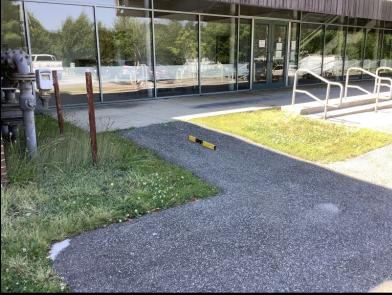
5	Exterior Route From Accessible Parking to North Entrance (Doors 2 + 1)	Ext.		Exterior Access Route	Walkway

Running slope > 1:20 (5.00%)	8.4%	Reduce running slope to be no steeper than 1:20 (5.00%) or provide handrails that are compliant with an ADA/521 CMR ramp.	1	-	-

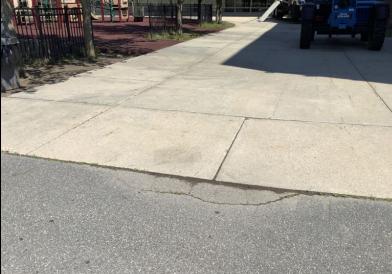
ID	Location	Floor	Room	Element	Type	Photo	Issues	Current Measure	Recommendations	Quantity	Price	Cost Estimation
6	Playground in Between Lower and Upper Schools; Next to Lower School	Ext.		Exterior Access Route	Walkway

Level changes > 1/4"	0.5"	Alter change in level to be 1/4" high max.	1	-	-
7	Curb Ramp Next to Accessible Parking in East Lot	Ext.		Exterior Access Route	Sidewalk

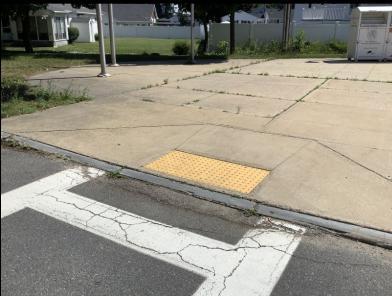
Level changes > 1/4"	0.5"	Alter change in level to be 1/4" high max.	1	-	-
8	Accessible Parking in East Lot	Ext.		Exterior Access Route	Sidewalk

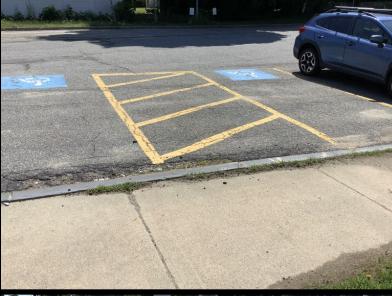
Level changes > 1/4"	0.5"	Alter change in level to be 1/4" high max.	1	-	-
9	Route Next to Basketball Court on South Side of School	Ext.		Exterior Access Route	Walkway

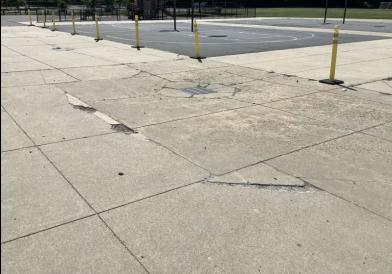
Route not maintained in operable working condition	-	Ensure the accessible route is maintained in operable working condition.	1	-	-
10	South Doors Outside Cafeteria	Ext.		Exterior Access Route	Walkway

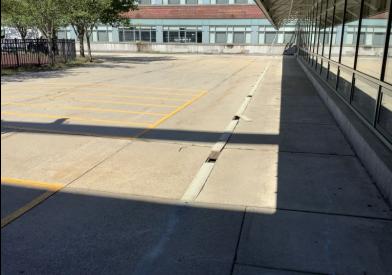
Route not maintained in operable working condition	-	Ensure the drains are maintained and covered.	1	-	-

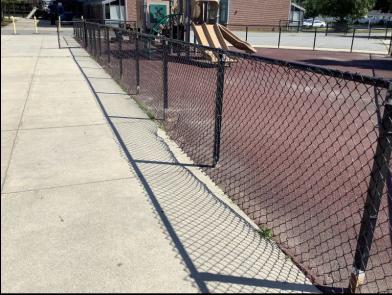
ID	Location	Floor	Room	Element	Type	Photo	Issues	Current Measure	Recommendations	Quantity	Price	Cost Estimation
11	Playground South of Lower School	Ext.		Exterior Access Route	Walkway

Route not maintained in operable working condition		Ensure the fence along the accessible route is maintained in operable working condition. On the day of surveying, The IHCD team observed that the fence was curled out past the fence post, and sharp edges of the fence projected into the circulation path.	1	-	-
12	Walkway Next to South/East Corner of Lower School	Ext.		Exterior Access Route	Walkway

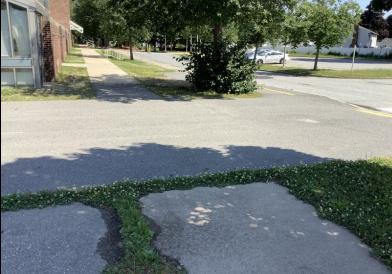
Route not maintained in operable working condition	-	Ensure the accessible route is maintained in operable working condition.	1	-	-
13	Sidewalk in Front of North Entrance	Ext.		Exterior Access Route	Sidewalk

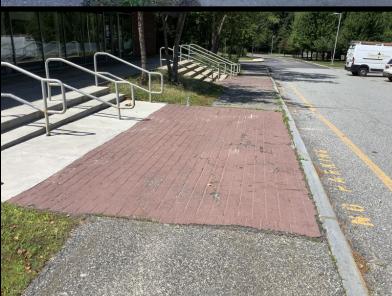
Route not maintained in operable working condition	-	Ensure the accessible route is maintained in operable working condition. The brick route in front of the stairs is very bumpy.	1	-	-

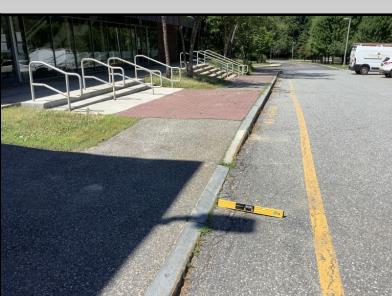
<b>Curb Ramp</b>												
14	Curb Ramp From Accessible Parking at North Parking Lot	Ext.		Curb Ramp	Blended Transition

Counter slope > 1:20 (5.00%)	10.3%	Reduce the counter slope of the adjoining gutter and road surface adjacent to the curb ramp so that it is no steeper than 1:20 (5.00%).	1	-	-
15	Curb Ramp Outside Lower School East Entrance	Ext.		Curb Ramp	N/A

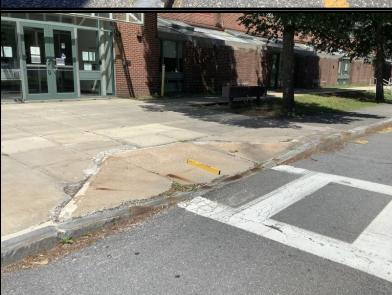
Running slope is > 1:12 (8.33%) Surface not stable, firm and slip-resistant	10.1% -	Reduce running slope to be no steeper than 1:12 (8.33%). Repair surface.	1	-	-

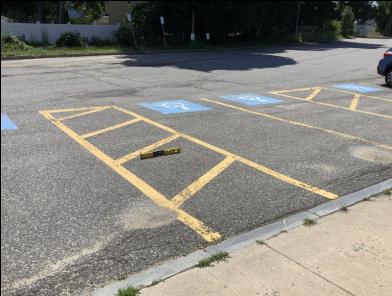
ID	Location	Floor	Room	Element	Type	Photo	Issues	Current Measure	Recommendations	Quantity	Price	Cost Estimation
<b>Off-Street Parking Lot or Garage</b>												
16	Accessible Parking in East Lot	Ext.		Off-Street Parking Lot or Garage	Visitor

Running or cross slope at space > 1:50 (2.00%)	3%	Reduce running or cross slope to be no steeper than 1:50 (2.00%).	1	-	-
17	Accessible Parking in East Lot	Ext.		Off-Street Parking Lot or Garage	Visitor

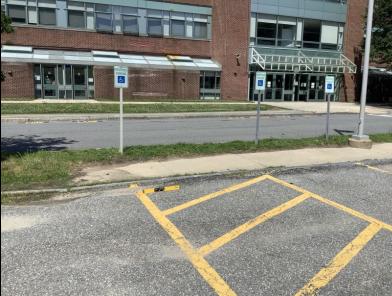
Running or cross slope at space > 1:50 (2.00%)	4.1%	Reduce running or cross slope to be no steeper than 1:50 (2.00%).	1	-	-
18	Accessible Parking in North Lot	Ext.		Off-Street Parking Lot or Garage	Visitor

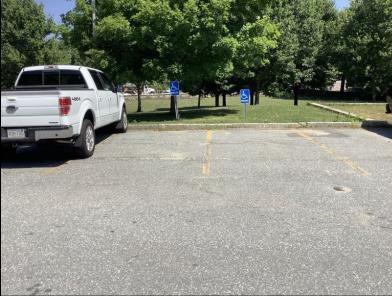
Access aisle not provided Sign bottom < 60" above finished grade	- 22"	Provide a marked access aisle that is at least 60" wide either between the two accessible car parking spaces or provide one on each side of the two spaces. Locate both signs with the bottom of the sign 60" above the ground.	2	- Labor	- Labor

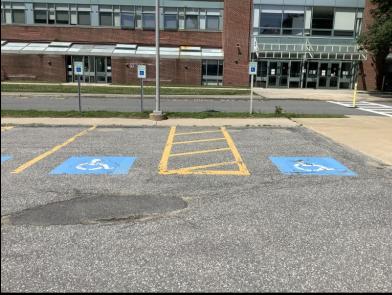
19	Accessible Parking in East Lot	Ext.		Off-Street Parking Lot or Garage	Visitor

Access aisle < 60" wide at car space	57"	Provide a marked access aisle that is at least 60" wide.	1	-	-
20	Accessible Parking on West Lot	Ext.		Off-Street Parking Lot or Garage	Visitor

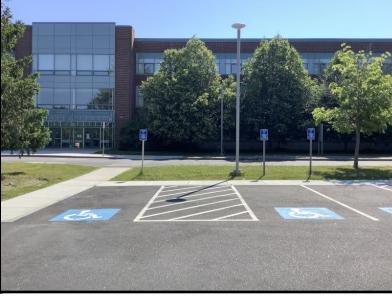
Sign does not have the designation "Van Accessible"	-	Add the designation "Van Accessible" to the sign located at the van accessible space.	1	500	\$500
											500

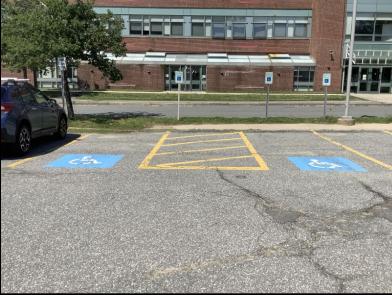
ID	Location	Floor	Room	Element	Type	Photo	Issues	Current Measure	Recommendations	Quantity	Price	Cost Estimation
21	Accessible Parking in East Lot	Ext.		Off-Street Parking Lot or Garage	Visitor

Sign does not have the designation "Van Accessible"	-	Add the designation "Van Accessible" to the sign located at the van accessible space.	1	500	\$500
500												
<b>Access to Goods and Services</b>												
<b>Means of Egress</b>												
22	Door 7 Egress	1		Means of Egress	N/A

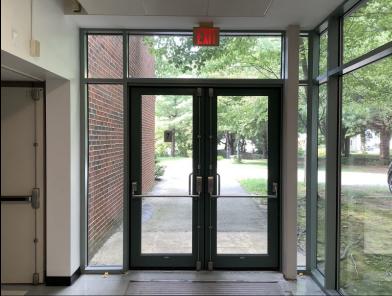
Tactile exit sign not provided Illuminated ISA symbol not provided (MAAB)	- -	Ensure that a tactile exit sign with raised characters and braille is provided at the exit door. Mount the sign between 48"- 60" above the finished floor located to the right of the right-hand door on the nearest adjacent wall. When the illuminated exit sign is repaired or replaced, provide an illuminated sign with the International Symbol of Accessibility (ISA).	1	250	\$250

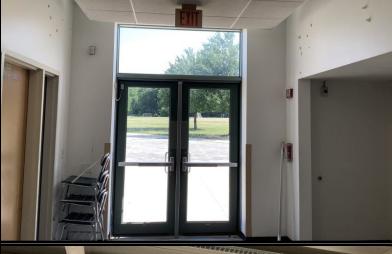
Tactile exit sign not provided Illuminated ISA symbol not provided (MAAB)	- -	Ensure that a tactile exit sign with raised characters and braille is provided at the exit door. Mount the sign between 48"- 60" above the finished floor located on the nearest adjacent wall to the right side of the double doors. When the illuminated exit sign is repaired or replaced, provide an illuminated sign with the International Symbol of Accessibility (ISA).	1	250	250
250												
24	Lower School Cafeteria	1		Means of Egress	N/A

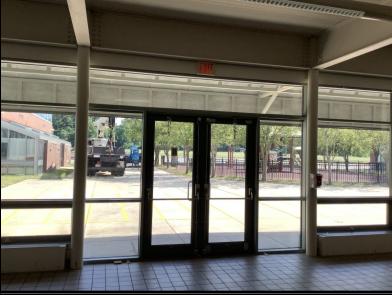
Tactile exit sign not provided Illuminated ISA symbol not provided (MAAB)	- -	Ensure that a tactile exit sign with raised characters and braille is provided at the exit door. Mount the sign between 48"- 60" above the finished floor located on the right side of the double door. When the illuminated exit sign is repaired or replaced, provide an illuminated sign with the International Symbol of Accessibility (ISA). Applies to all direct egress doors in this condition.	1	250	\$250

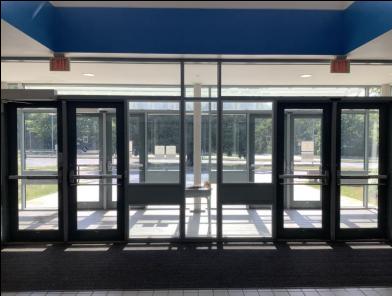
Tactile exit sign not provided Illuminated ISA symbol not provided (MAAB)		Ensure that a tactile exit sign with raised characters and braille is provided on the right side of the right most double door. When the illuminated exit sign is repaired or replaced, provide an illuminated sign with the International Symbol of Accessibility (ISA).	2	250	\$500
500

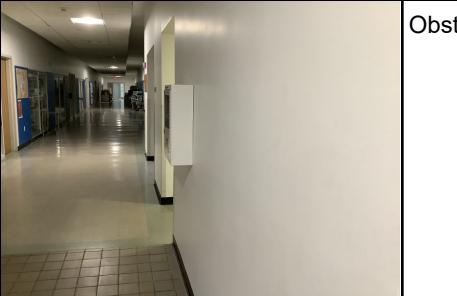
ID	Location	Floor	Room	Element	Type	Photo	Issues	Current Measure	Recommendations	Quantity	Price	Cost Estimation
<b>Interior Access Route</b>												
26	Defibrillator in Upper Corridor Level 1	1		Interior Access Route	N/A

Obstructed by protruding objects	6"	Provide a cane-detectable barrier underneath the defibrillator. Barriers must have leading edges no higher than 27" so that they are within cane sweep. Barriers can include fixed planters, benches, and guardrails.	1	398	\$398
											398	
27	Lower School Cafeteria	1		Interior Access Route	N/A

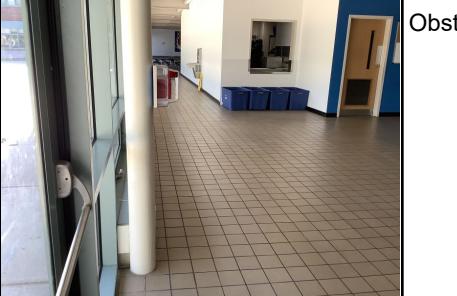
Obstructed by protruding objects	7"	Provide a cane-detectable barrier underneath the fire alarm pull. Barriers must have leading edges no higher than 27" so that they are within cane sweep. Barriers can include fixed planters, benches, and guardrails.	1	398	\$398
											398	
<b>Doors, Doorways, &amp; Gates</b>												
28	Between South Playground and Lower School	Ext.		Doors, Doorways, & Gates	Exterior Gate

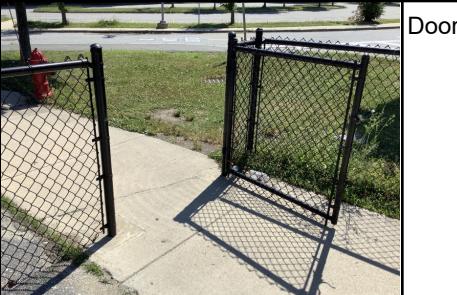
Door not maintained in operable working condition.	-	Maintain the gate. It touches on the surface and requires 9 lbs. of force.	1	-	-

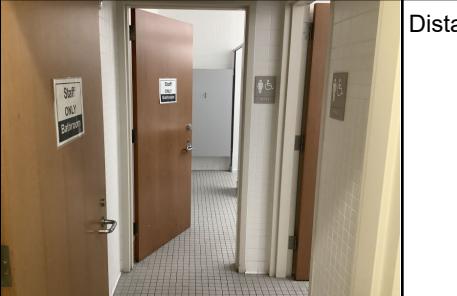
29	Staff Multi-User Toilet Room Upper Corridor by the Boys' and Girls' Rooms	1		Doors, Doorways, & Gates	Toilet Room

Distance between doors in series < 48"	41"	Ensure the first door, on the left of the photo, that leads into these multi-user toilet rooms is always left open during hours of operation for public events.	1	Labor	Labor
30	West Entrance Door 24	Ext.		Doors, Doorways, & Gates	Circulation

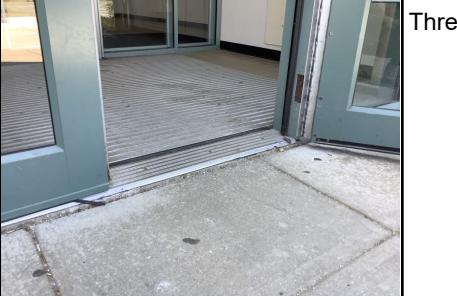
Threshold > 1/2" high	1"	Alter the threshold to be 1/2" high max.	1	1000	\$1000
											1000	
<b>Toilet &amp; Bathing Rooms</b>

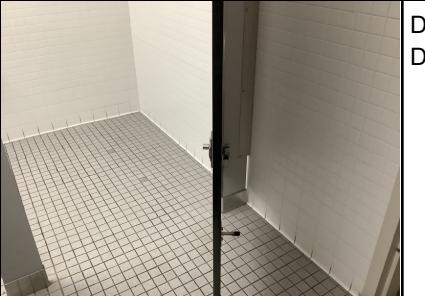
ID	Location	Floor	Room	Element	Type	Photo	Issues	Current Measure	Recommendations	Quantity	Price	Cost Estimation
<b>Toilet Compartment</b>												
31	West Staff Multi-User Toilet Room by the Boys' and Girls' Rooms	1		Toilet Compartment	Accessible Compartment

Door has malfunctioning self-closing hinge Door pull not provided	- -	Repair hinge. Provide a door pull on each side of the door between 34" to 48" above the finished floor that does not require tight grasping, pinching or twisting of the wrist.	1	Labor 140  <b>140</b>	\$140
32	West Staff Multi-User Toilet Room by the Boys' and Girls' Rooms	1		Toilet Compartment	Accessible Compartment

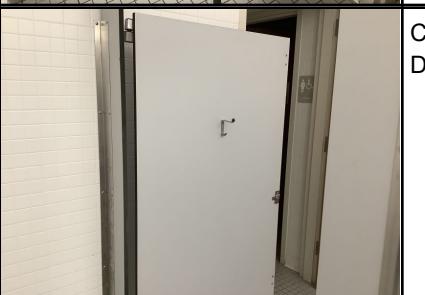
Coat hook > 48" (2010 ADA) Door pull not provided	54" -	Locate the coat hook no higher than 48" above the finished floor. Provide a door pull on each side of the door between 34" to 48" above the finished floor that does not require tight grasping, pinching or twisting of the wrist.	1	75 140  <b>215</b>	\$215

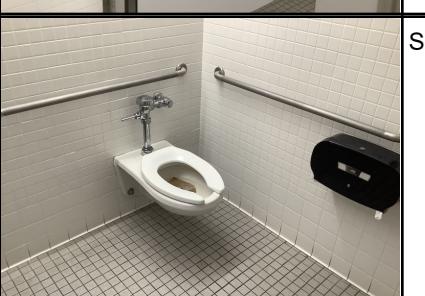
33	Both Staff Multi-User Toilet Rooms by the Boys' and Girls' Rooms	1		Toilet Compartment	Accessible Compartment

Side grab bar < 54" from back wall	48.75"	Provide a side wall grab bar that is 42" long min. located 12" max. from the rear wall.	2	800  <b>1600</b>	\$1600
<b>Dispensers</b>												
34	East Staff Multi-User Toilet Room by the Boys' and Girls' Rooms	1		Dispensers	Tampon Dispenser

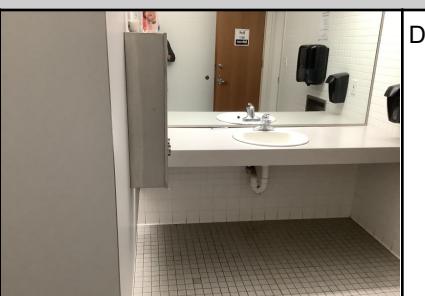
Dispenser acts as a protruding object	6"	Provide a cane-detectable barrier underneath the tampon dispenser. Barriers must have leading edges no higher than 27" so that they are within cane sweep. Barriers can include fixed planters, benches, and guardrails.	1	398  <b>398</b>	\$398
<b>Additional Access</b>

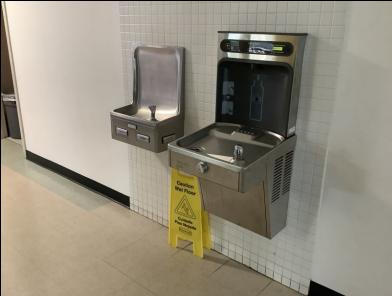
ID	Location	Floor	Room	Element	Type	Photo	Issues	Current Measure	Recommendations	Quantity	Price	Cost Estimation
<b>Drinking Fountains</b>												
35	Drinking Fountain Lower Corridor	1		Drinking Fountains	Hi-Lo

Spout < 38" or > 43" (standing users) Standing height fountain does not have cane protection	36.5" -	Relocate drinking fountain for standing users so that the spout is between 38"- 43" above the finished floor or ground. Provide a cane-detectable barrier skirt under the high unit.	1	2028 890	\$2918  <b>2918</b>
36	Upper Corridor Level 1	1		Drinking Fountains	Hi-Lo

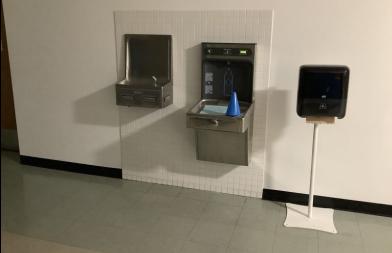
Standing height fountain does not have cane protection	-	Provide a cane-detectable barrier skirt under the high unit.	1	890	\$890  <b>890</b>
<b>Play and Sport Areas</b>												
<b>Field</b>												
37	North Soccer Field			Field	Soccer

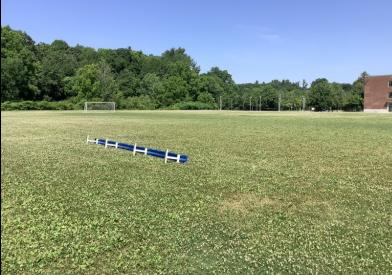
Accessible spaces not provided at team seating	-	Provide a 36" x 48" clear floor space at team seating.  Applies to soccer field farthest from school.	2	-	-

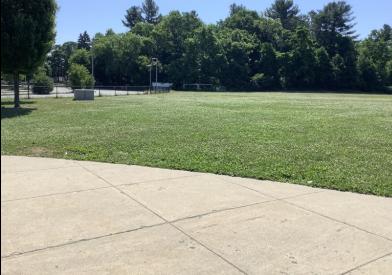
38	North / East Corner of North Soccer Field Next to Basketball Courts and Playground			Field	Soccer

Field not connected to an accessible route	-	Provide an accessible route to the boundary of sport activity.  This is the most level part of the field near an accessible route. Would recommend starting an accessible route to the north and south soccer fields from this point.	2	-	-
<b>Best Practice</b>

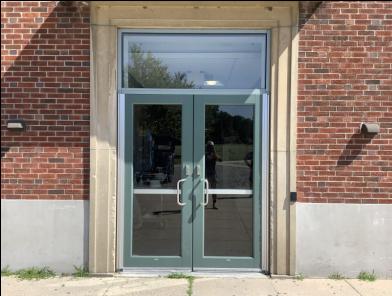
ID	Location	Floor	Room	Element	Type	Photo	Issues	Current Measure	Recommendations	Quantity	Price	Cost Estimation
39	South Egress on Upper School

Provide a sign that indicates this door is an exit only.  Applies to all doors that are egress only.	1	-	-
40	Playground In Between Lower and Upper Schools

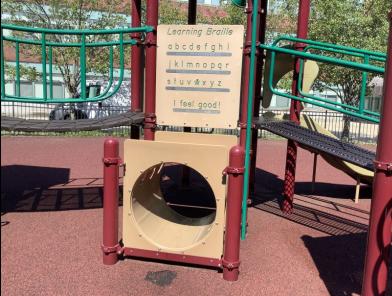
Recommend locating the "Learning Braille" board between 15" and 48" above the finished playground surface so that everyone can touch it.	1	-	-
41	Designation Sign Outside Lower School East Entrance

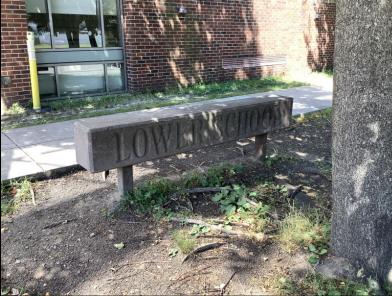
When replacing the sign, provide a sign where the letters have a greater contrast with the background.  Applies to the Upper School sign on the west side of the school.	2	-	-
42	Stairs Between Exterior Walkways on East Side of Lower School

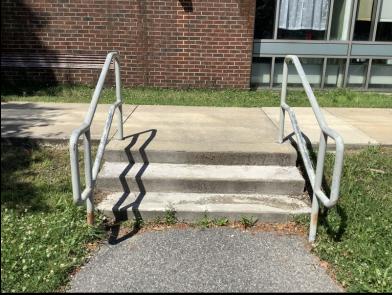
Recommend providing a solid and continuous stripe applied to the horizontal leading edge of each stair tread so that each tread is readily apparent when viewed in descent at each stair exterior stair.  Applies to all exterior stairs in this condition.	1	-	-

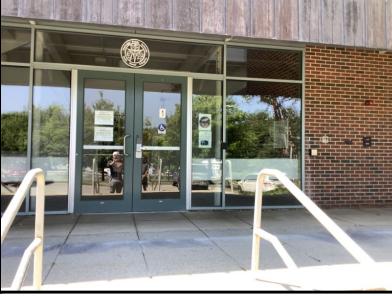
43	North Entrance Door 1				202

Recommend providing signage directing users to the West Upper School accessible entrance. During voting, this entrance is only able to be opened by people with a keycard for the school and it is kept locked to the public.	1	-	-

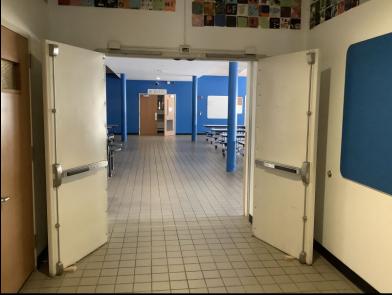
ID	Location	Floor	Room	Element	Type	Photo	Issues	Current Measure	Recommendations	Quantity	Price	Cost Estimation
44	Upper School Cafeteria	1			324

Locate an additional compliant designation sign with raised characters and braille to the right of the right-hand door, outside of the full door swing when the door is left open.	1	-	-	
45	Defibrillator in Upper Corridor Level 1	1

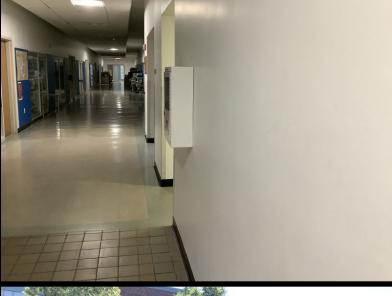
Recommend providing blade signage over all defibrillators in the school.	1	-	-	
46	Accessible Parking on West Lot	Ext.

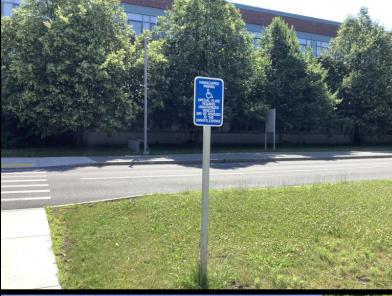
Recommend using the term "Accessible Parking" rather than "Handicapped Parking".	1	-	-	
47	Curb Ramp From Accessible Parking at North Parking Lot	Ext.

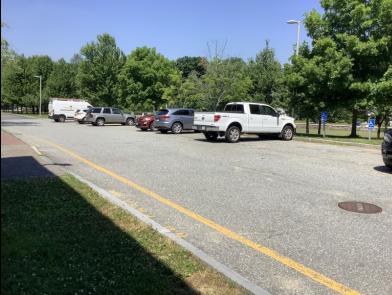
Recommend providing a ladder style crosswalk between the access aisle of the accessible parking spaces and the curb ramp.	1	-	-	
48	Curb Ramp Outside Lower School East Entrance	Ext.

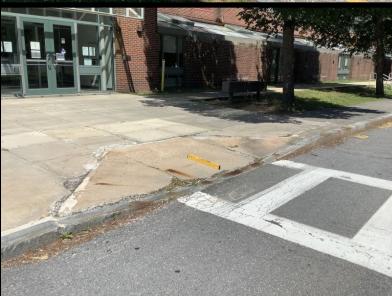
Recommend providing detectable warnings on all curb ramps around the school.	1	-	-
