Raymond J. Martin Riverside Park

City of Methuen ADA Transition Plan

November 2024

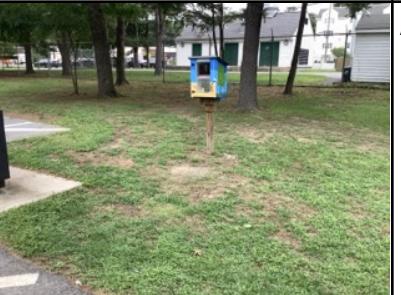
ID	Location	Floor	Room	Element	Type	Photo	Issues	Current Measure	Recommendations	Quantity	Price	Cost Estimation
Approach and Entrance												
Exterior Access Route												
1	Book Share Stand Near Playground	Ext.		Exterior Access Route	Exterior

Accessible route not provided	-	Ensure an accessible route is provided to the book share stand or relocate the book share stand to an accessible route.	1	-	-
Off-Street Parking Lot or Garage												
2	Parking by Dock	Ext.		Off-Street Parking Lot or Garage	Visitor

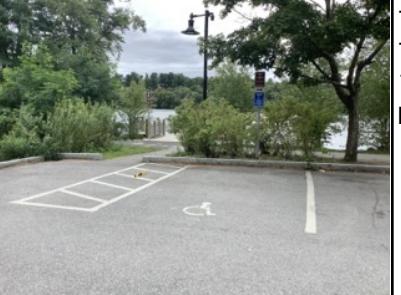
Total # of parking Total # of designated car accessible parking spaces Total # of designated van accessible spaces Running or cross slope at space > 1:50 (2.00%) Sign does not have the designation "Van Accessible"	36 - 1 3% -	Provide one car accessible parking space 96" wide min. with a marked access aisle 60" wide min. and with a sign with the International Symbol of Accessibility (ISA) Reduce running or cross slope to be no steeper than 1:50 (2.00%) in all directions at the van accessible parking space. Add the designation "Van Accessible" to the sign located at the van accessible space. Cost is for signage.	2	500 1000	\$1000

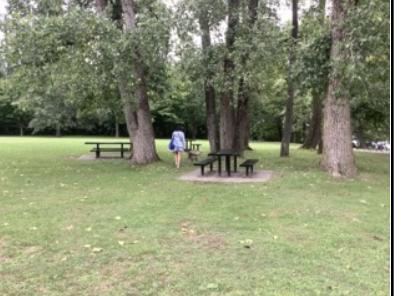
Access to Goods and Services												
Picnic Tables												
3		Ext.		Picnic Tables

Picnic table not on an accessible route	-	Ensure that at least one of the accessible picnic tables in this area is connected to an accessible route.	3	-	-
Exterior Benches												
4	Benches Near Gazebo	Ext.		Exterior Benches	N/A

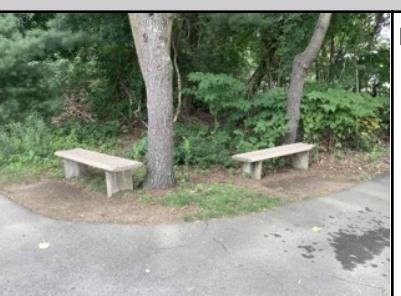
No accessible route to one bench in area		Relocate one bench to an accessible route or provide an accessible route to one bench in this area.	1	-	-

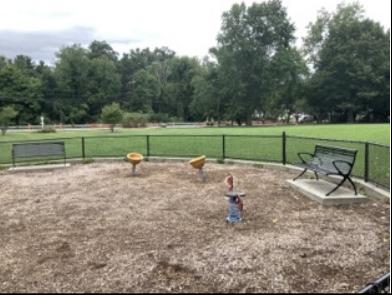
ID	Location	Floor	Room	Element	Type	Photo	Issues	Current Measure	Recommendations	Quantity	Price	Cost Estimation
5		Ext.		Exterior Benches	N/A

No accessible route to one bench in area	-	Provide an accessible route to at least one bench in the playground area.	1	-	-
Play and Sport Areas												
Play Areas												
6	Playground	Ext.		Play Areas	N/A

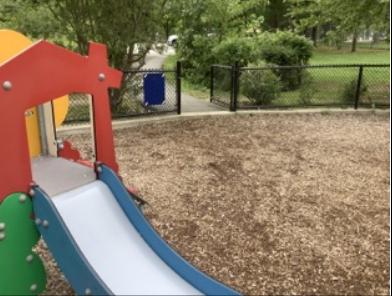
Accessibility issues include lack of an accessible route to the playground and lack of an impact-attenuating surface to and around the play components within the playground.

Accessible route not provided to playground Accessible route not provided to play components	3" -	Install an accessible route to and around the playground. (There is an excessive change in level at the playground entry.) Provide a compliant impact-attenuating surface to and around the play components within the playground.	1	-	-
Best Practice												
Exterior Stairs												
7	Gazebo	Ext.		Exterior Stairs	N/A

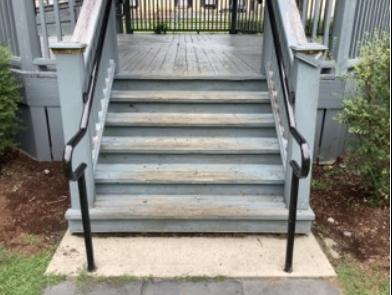
Recommend providing a contrasting color on the first 2" of each stair nosing.	1	-	-
