Methuen Fire Department

City of Methuen ADA Transition Plan

August 2024

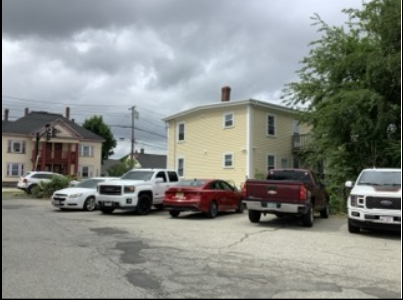
ID	Location	Floor	Room	Element	Type	Photo	Issues	Current Measure	Recommendations	Quantity	Price	Cost Estimation
Approach and Entrance												
Off-Street Parking Lot or Garage												
1	Parking Lot	Ext.		Off-Street Parking Lot or Garage	Visitor

Total # of parking Van space < 132" or <96" wide Access aisle not provided Access aisle < 96" wide at van space Sign with the International Symbol of Acc. not provided Sign does not have the designation "Van Accessible"	20 - - - -	Provide a van accessible space that is at least 96" wide with a marked access aisle that is at least 96" wide. Provide a sign with the International Symbol of Accessibility (ISA) with the bottom of the sign 60" min. above the ground and the top 96" max. above the ground. Add the designation "Van Accessible" to the sign located at the van accessible space. (Cost estimate is for the sign.)	1	500	\$500
											500

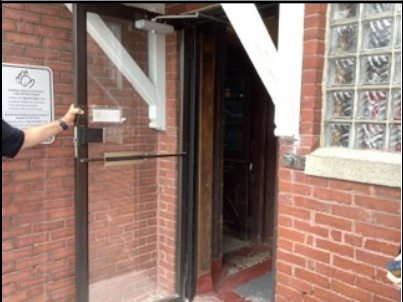
Entrance												
2	Main Entrance	Ext.		Entrance	Main Entrance

Clear width at door is < 32" Maneuvering clearance is not provided Vertical clearance < 80" above ground	31" - -	Install offset hinges to ensure that the door has a clear width of 32 inches. The support for the roof obstructs the maneuvering clearance at the door and acts as a protruding object in the circulation path. (Cost estimate is for cane-detectable barriers on each side of door (consider providing fixed planters), an automatic door opener and providing a door with offset hinges.)	1	2902 796 6000	\$9698
											9698	
Access to Goods and Services												
Means of Egress												
3	Main Entrance	1		Means of Egress	N/A

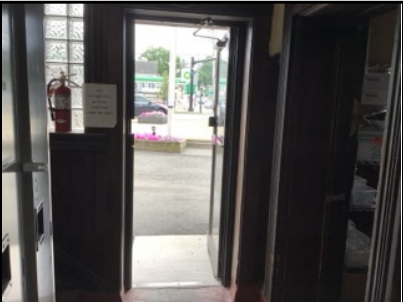
Tactile exit sign not provided	-	Ensure that a tactile exit sign with raised characters and braille is provided at the exit door. Mount the sign between 48"- 60" above the finished floor located on the latch side of the door. If and when an illuminated sign is provided at the exit door, it should contain an International Symbol of Accessibility (ISA).	1	250	\$250

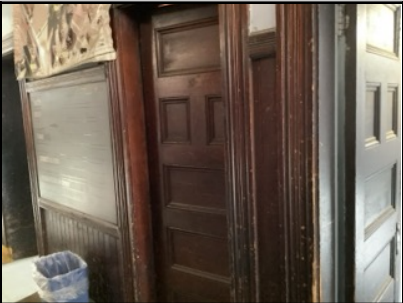
250	
Signage												
4	Single-User Toilet Room (Bay)	1		Signage	Designation

Signage is not provided	-	Locate compliant signage with raised characters and braille alongside the door on the latch side.	1	250	\$250
											250	
Toilet & Bathing Rooms

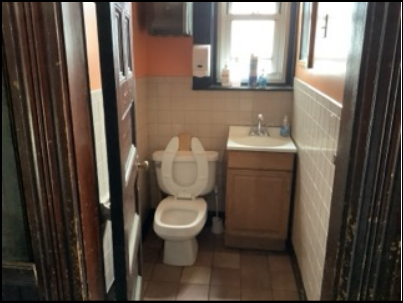
ID	Location	Floor	Room	Element	Type	Photo	Issues	Current Measure	Recommendations	Quantity	Price	Cost Estimation
Overall Access												
5	Single-User Toilet Room (Bay)	1		Overall Access	Toilet Room

Accessible plumbing fixtures or stalls not provided Audible and visible alarm not provided Clear width at door < 32" Threshold not beveled Hardware not compliant	- - 29" - -	Provide an accessible single-user toilet room. Widen the door so that there is 32" min. clear width. Bevel the threshold. Provide hardware that can be operable with one hand and not require tight grasping, pinching, or twisting of the wrist. When fire system is updated, ensure that a visible and audible fire alarm is installed. (Cost estimate is typical for an accessible toilet room.)	1	31985	\$31985
											31985
