Comprehensive Grammar School

City of Methuen ADA Transition Plan

October 2024

Institute for Human Centered Design

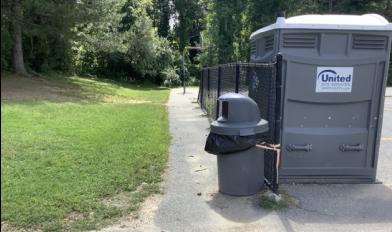
Exterior route < 36" wide Surface is not stable, firm, and slip-resistant	29"	Relocate the trash barrel to ensure that a clear width of 36" min. is maintained at the accessible route. Remove dust and loose gravel on the surface.	1	Labor -	Labor -
2	Route to Howe Street Playgrounds	Ext.		Exterior Access Route	Walkway

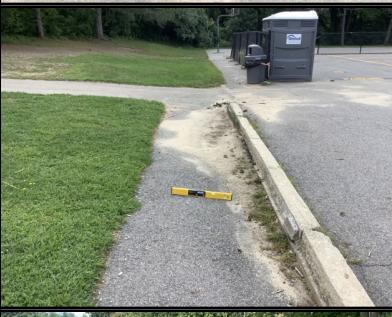
Cross slope > 1:50 (2.00%) Surface is not stable, firm, and slip-resistant	9.5%	Reduce cross slope to be no steeper than 1:50 (2.00%). Remove sand and loose gravel on the surface.	1	-	-
3	Route From Kensington Avenue Parking to Fields - By Baseball Field	Ext.		Exterior Access Route	Walkway

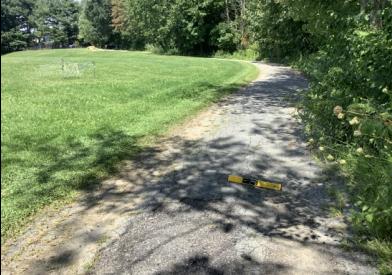
Cross slope > 1:50 (2.00%) Surface is not stable, firm, and slip-resistant Route not maintained in operable working condition	15.2%	Reduce cross slope to be no steeper than 1:50 (2.00%). Remove leaves and loose gravel on surface. Repair the cracks in the asphalt to ensure the accessible route is maintained in operable working condition.	1	-	-

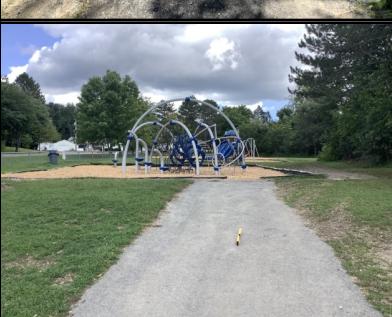
4	Route to Howe Street Playgrounds	Ext.		Exterior Access Route	Walkway

Running slope > 1:20 (5.00%)	12.8%	Reduce running slope to be no steeper than 1:20 (5.00%).	1	-	-
5	Bridge Entrance From Basketball Court - Leading to Visitor Parking Lot	Ext.		Exterior Access Route	Walkway

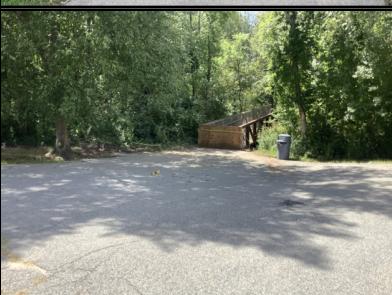
Running slope > 1:20 (5.00%)	8.9%	Reduce running slope to be no steeper than 1:20 (5.00%).	1	-	-

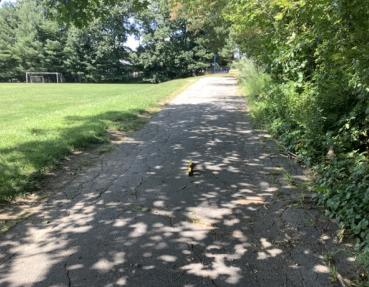
Running slope > 1:20 (5.00%)	7.6%	Reduce running slope to be no steeper than 1:20 (5.00%).	1	-	-
7	Bridge Entrance From School Parking Lot - Leading to Basketball Court	Ext.		Exterior Access Route	Walkway

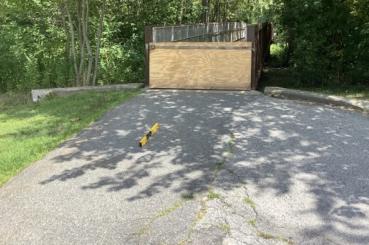
Running slope > 1:20 (5.00%) Route not maintained in operable working condition	15.9%	Reduce running slope to be no steeper than 1:20 (5.00%). Repair cracks in the asphalt where grass is growing to ensure the accessible route is maintained in operable working condition.	1	-	-
8	Route From Kensington Avenue Parking to Fields	Ext.		Exterior Access Route	Walkway

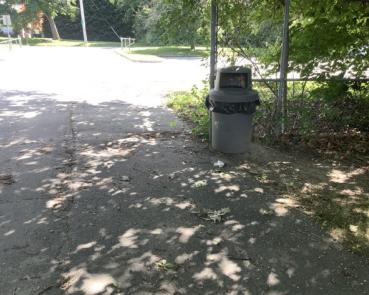
Surface is not stable, firm, and slip-resistant	-	Remove leaves and loose gravel on surface.	1	-	-
9	Route from Kensington Avenue Parking to Fields - By Parking	Ext.		Exterior Access Route	Sidewalk

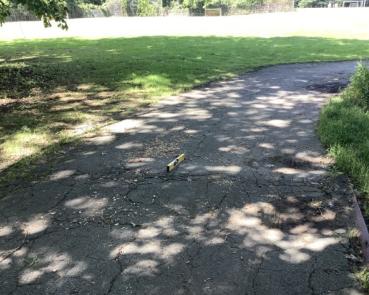
Running slope > 1:20 (5.00%) Route not maintained in operable working condition	15.3%	Reduce running slope to be no steeper than 1:20 (5.00%). Repair the cracks in the asphalt to ensure the accessible route is maintained in operable working condition.	1	-	-

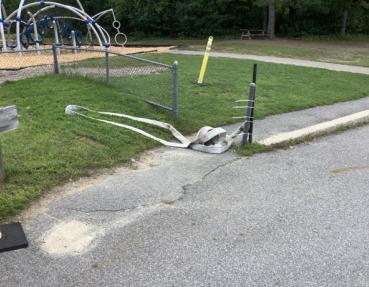
10	Route to Howe Street Playgrounds	Ext.		Exterior Access Route	Exterior

Route not maintained in operable working condition Accessible route not provided		Repair the cracks in the asphalt to ensure the accessible route is maintained in operable working condition. Relocate the hose so it does not obstruct the accessible route.	1	- Labor	- Labor

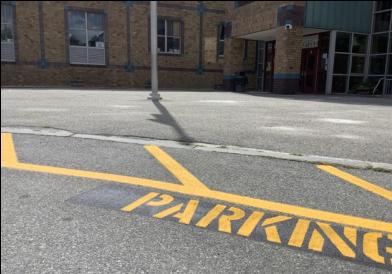
Not maintained in operable working condition.		Repair cracks in the asphalt, ensure the transition in the curb ramp is maintained in operable working condition.	1	-	-
12	Parking by Howe Street Playgrounds	Ext.		Curb Ramp	N/A

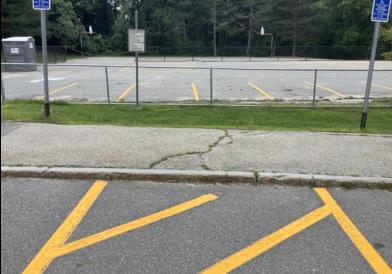
Curb ramp not provided	-	Provide a curb ramp at intersection of the access aisle and the sidewalk.	1	-	-
13	Parking Lot off Kensington Avenue to Fields	Ext.		Curb Ramp	Blended Transition

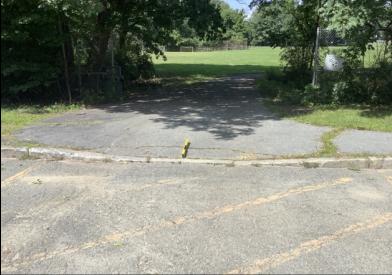
Running slope is > 1:12 (8.33%) Not maintained in operable working condition.	13.6%	Reduce running slope at curb ramp to be no steeper than 1:12 (8.33%). Repair the cracks in the asphalt to ensure the curb ramp is maintained in operable working condition.	1	-	-
14	Curb Ramp by East Playground and Bridge Entrance	Ext.		Curb Ramp	Blended Transition

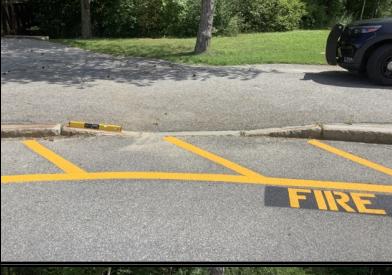
Curb ramp flares > 1:10 (10%)	14.1%	Reduce slope at curb ramp flares to be no steeper than 1:10 (10%).	1	-	-

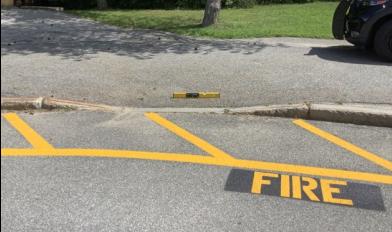
15	Curb Ramp by East Playground and Bridge Entrance	Ext.		Curb Ramp	Blended Transition

Cross slope > 1:50 (2.00%) (MAAB)	4.6%	Reduce cross slope at curb ramp to be no steeper than 1:50 (2.00%).	1	-	-

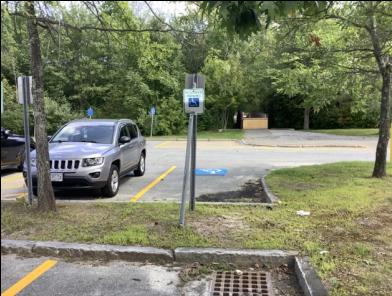
Parking designation sign not maintained in operable working condition.		Ensure the parking designation sign is not bent, or provide a new sign.	1	500	\$500
											500	
17	Parking by Howe Street Playgrounds	Ext.		Off-Street Parking Lot or Garage	Visitor

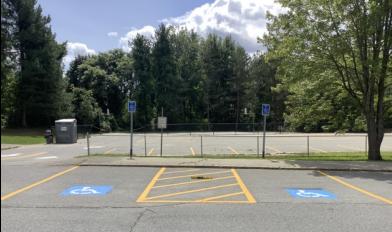
Total # of designated car accessible parking spaces Running or cross slope at space > 1:50 (2.00%) Sign does not have the designation "Van Accessible"	2 4.2% -	Provide one additional car accessible space. Reduce running or cross slope to be no steeper than 1:50 (2.00%). Add the designation "Van Accessible" to the sign located at the van accessible space, which can be either of the two spaces seen in this image.	1	500 - 500	\$1000

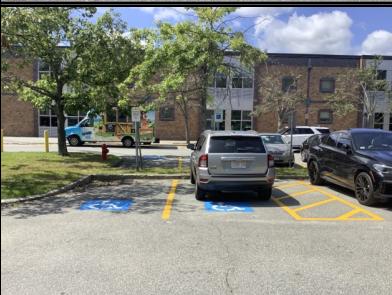
Access aisle not provided	-	At the space on the left in this photo, provide a marked access aisle that is at least 60" wide for a car accessible parking space and at least 96" wide for a van accessible parking space.	1	-	-
19	Accessible Parking in Visitor Parking Lot on East Side of School	Ext.		Off-Street Parking Lot or Garage	Visitor

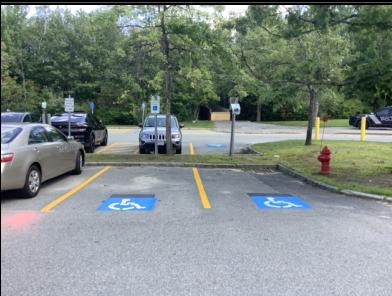
Access aisle not provided		Provide one marked access aisle that is at least 60" wide between the two car accessible parking spaces.	2	-	-
20	Parking Lot off Kensington Avenue to Fields	Ext.		Off-Street Parking Lot or Garage	Visitor

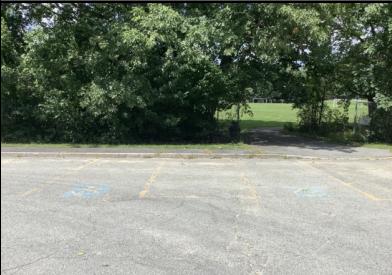
Sign with the International Symbol of Acc. not provided Striping at access aisle is noncompliant (MAAB)	- -	Provide a sign with the International Symbol of Accessibility (ISA) with the bottom of the sign 60" min. above the ground and the top 96" max. above the ground. Ensure that access aisles are clearly marked with diagonal stripes. Cost is for the sign.	2	500 - 1000	\$1000

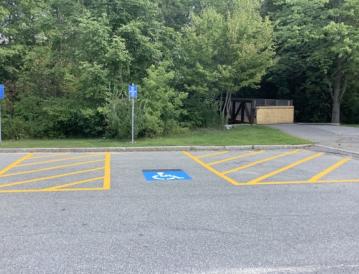
Sign does not have the designation "Van Accessible"	-	Add the designation "Van Accessible" to the sign located at the van accessible space. Cost is for the sign.	1	500	\$500
22	Parking Lot off Kensington Avenue to Fields	Ext.		Off-Street Parking Lot or Garage	Visitor

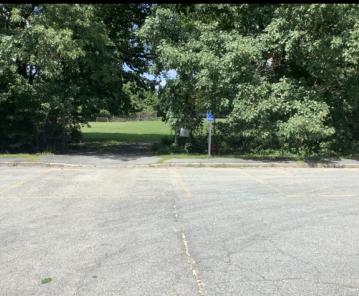
Sign does not have the designation "Van Accessible" Striping at access aisle is noncompliant (MAAB)		Add the designation "Van Accessible" to the sign located at the van accessible space. Ensure that access aisles are clearly marked with diagonal stripes. Cost is for the sign.	1	500	\$500
Exterior Ramp												
23	Ramp to Playground on East Side of School	Ext.		Exterior Ramp	N/A

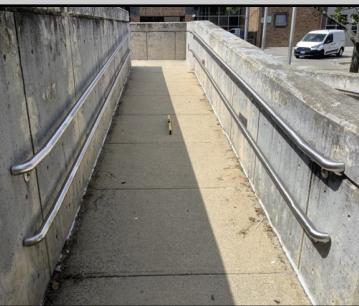
Running slope > 1:12 (8.33%)	10%	Reduce running slope to be no steeper than 1:12 (8.33%). Further study may be needed to determine whether it is technically feasible to bring this ramp into full compliance with the ADA and 521 CMR, the regulations of the Massachusetts Architectural Access Board.	1	-	-

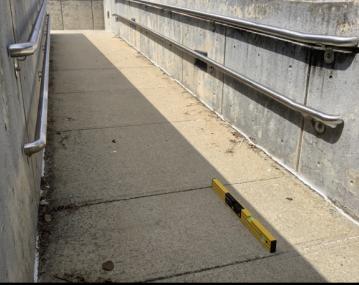
24	Ramp to Playground on East Side of School	Ext.		Exterior Ramp	N/A

Landing has a slope > 1:50 in either direction	4.2%	Alter so that the slope in all directions is no greater than 1:50 (2.00%)./Rebuild the ramp to ensure that the slope of the landing does not exceed 1:50 (2.00%). Further study may be needed to determine whether it is technically feasible to bring this ramp into full compliance with the ADA and 521 CMR, the regulations of the Massachusetts Architectural Access Board.	1	-	-
25	Ramp to Playground on East Side of School	Ext.		Exterior Ramp	N/A

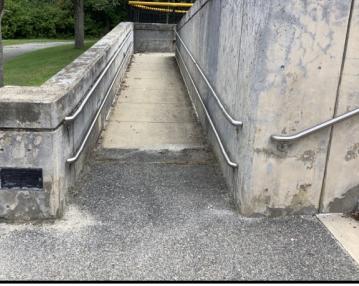
Surface is not stable, firm, and slip-resistant Not maintained in operable working condition	- -	At the bottom landing of the ramp, remove any loose gravel and vegetation.	1	-	-

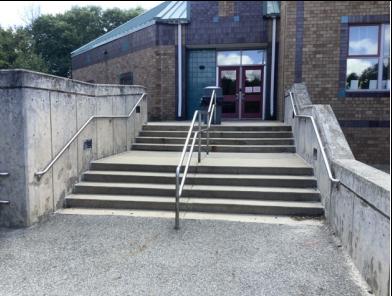
Handrail height < 34" or > 38"	41"	Alter so the handrails are 34"- 38" high above the finished floor or ground.	1	-	-
27	Stairs to Playground on East Side of School	Ext.		Exterior Stair	N/A

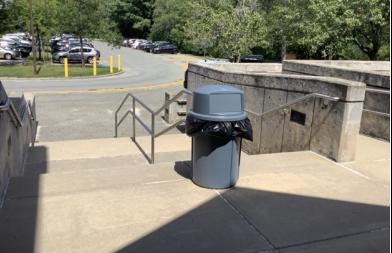
Handrails do not extend 12" from stair at top	-	Relocate the trash barrel so that the top extension of the centrally located handrail is not obstructed.	1	Labor	Labor
Access to Goods and Services												
Operable Parts / Reach Range												
28	Howe Street Playground	Ext.		Operable Parts / Reach Range	Trash/Recycling

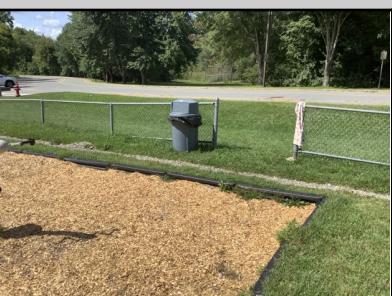
Element not on an accessible route		Ensure the trash barrel is located on an accessible route or provide an accessible route to the trash barrel.	1	Labor	Labor
Picnic Tables

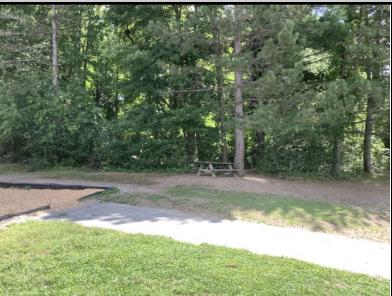
29	Picnic Table Next to Howe Street Playgrounds	Ext.		Picnic Tables	N/A

At least 5% accessible spaces not provided Picnic table not on an accessible route		Ensure that at least 5% (minimum one) of picnic tables are accessible. Ensure that the picnic table is connected to an accessible route.	1	1400 1400	\$1400
Toilet & Bathing Rooms

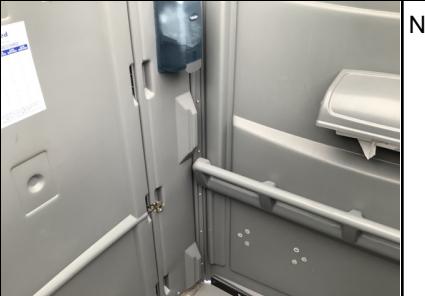
Noncompliant toilet paper dispenser	-	When a new accessible portable toilet is provided, ensure the soap dispenser is located no higher than 48" above the finished floor.	1	-	-
31	Portable Toilet by Howe Street Playgrounds	Ext.		Portable Toilet	N/A

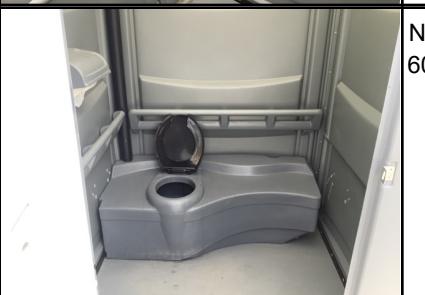
Noncompliant toilet paper dispenser 60" by 72" clear space not provided	- 58.25"	Provide an accessible portable toilet that has 60" wide and 72" deep at the toilet. When a new accessible portable toilet is provided, ensure the toilet paper dispenser is located 24" min. high, located under the grab bar, and between 7" and 9" from the front of the toilet.	1	4600	\$4600
Play and Sport Areas												
Play Areas												
32	Howe Street Playgrounds	Ext.		Play Areas	N/A

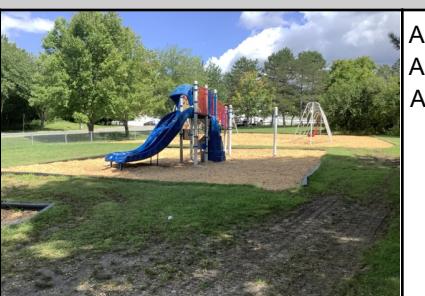
Accessible route not provided to playground Accessible route not provided around playground Accessible route not provided to play components		Install an accessible route to and around the playground. Provide an accessible route around the play area. Provide a compliant impact-attenuating surface to and around the play components. Applies to the two playgrounds located closest to Howe Street.	2	-	-

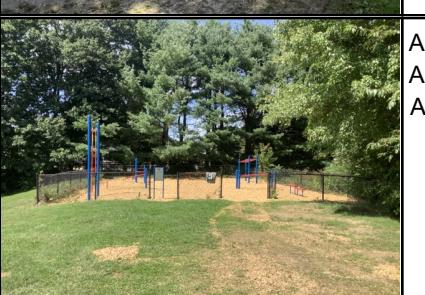
33	Playground Next to Soccer Field	Ext.		Play Areas	N/A

Accessible route not provided to playground Accessible route not provided around playground Accessible route not provided to play components	- - -	Install an accessible route to and around the playground. Provide an accessible route around the play area. Provide a compliant impact-attenuating surface to and around the play components.	1	-	-
34	Howe Street Playgrounds	Ext.		Play Areas	N/A

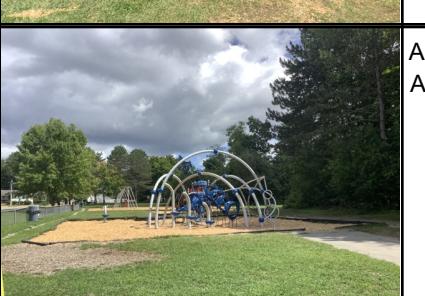
Accessible route not provided around playground Accessible route not provided to play components		Provide an accessible route around the play area. Provide a compliant impact-attenuating surface to and around the play components.	3	-	-

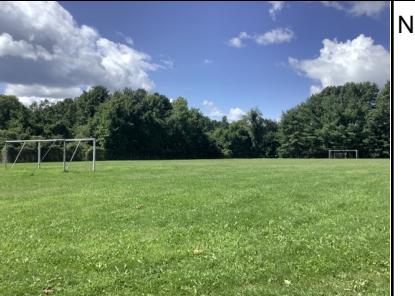
No accessible route to all areas of sport activity	-	Install an accessible route between all areas of sport activity.	1	Labor	Labor
36	Soccer Fields	Ext.		Field	Soccer

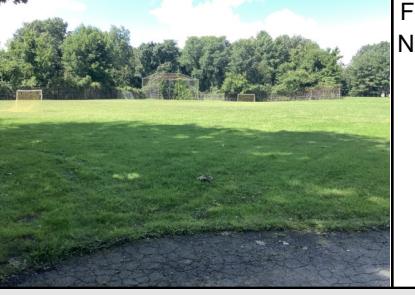
Field not connected to an accessible route No accessible route to all areas of sport activity	- -	Provide an accessible route to the boundary of sport activity at the soccer field. Install an accessible route between all areas of sport activity.	3	Labor	Labor
Best Practice												
37	Playground on East Side of School	Ext.

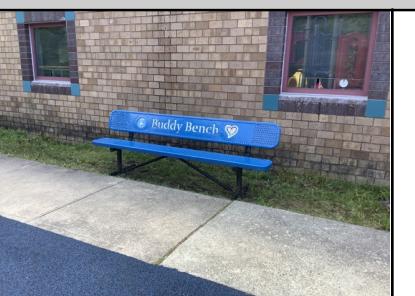
Recommend providing a 36" min. by 48" min. stable, firm and slip-resistant surface adjacent to at least one bench in each area where benches are provided positioned to allow a person in a wheeled mobility device and a person sitting on the bench to have their shoulders aligned. Since this applies to at least one bench in each area where benches are provided, it will apply to the new benches by the east side playground.	1	-	-

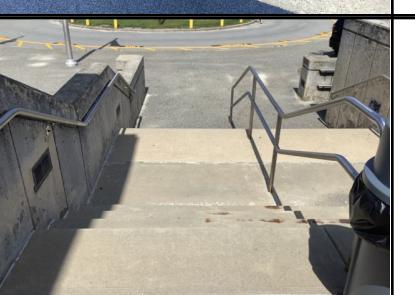
38	Stairs to Playground on East Side of School	Ext.

Recommend providing a solid and continuous stripe applied to the horizontal leading edge of each exterior stair tread so that each tread is readily apparent when viewed in descent at this exterior stair. Recommendation applies to all interior and exterior stairs that lack visual contrast on the stair nosings.	1	-	-
