# Marsh Grammar School

## City of Methuen ADA Transition Plan

October 2024

Institute for Human Centered Design

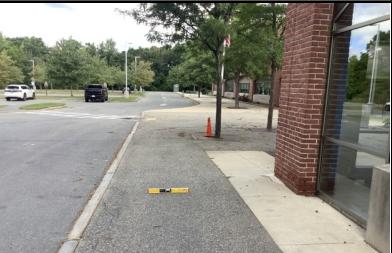
ID	Location	Floor	Room	Element	Type	Photo	Issues	Current Measure	Recommendations	Quantity	Price	Cost Estimation
Approach and Entrance												
Exterior Access Route												
1	Sidewalk on West Side of Building	Ext.		Exterior Access Route	Sidewalk

Cross slope > 1:50 (2.00%)	3.3%	Reduce cross slope to be no steeper than 1:50 (2.00%).	1	-	-
2	Sidewalk on West Side of Building by Lower School Entrance	Ext.		Exterior Access Route	Sidewalk

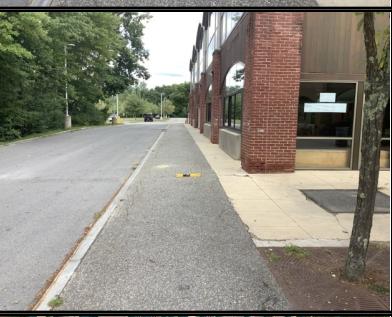
Cross slope > 1:50 (2.00%)	4.2%	Reduce cross slope to be no steeper than 1:50 (2.00%).	1	-	-
3	South Accessible Playground	Ext.		Exterior Access Route	Walkway

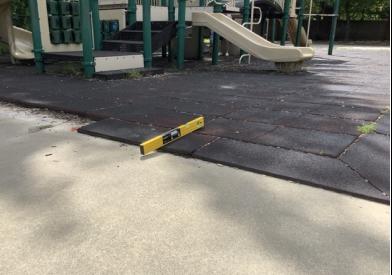
Running slope > 1:20 (5.00%) Level changes > 1/4"	10.2% 1"	Reduce running slope to be no steeper than 1:20 (5.00%). Alter change in level to be 1/4" high max.	1	-	-
4	North Basketball Courts	Ext.		Exterior Access Route	Walkway

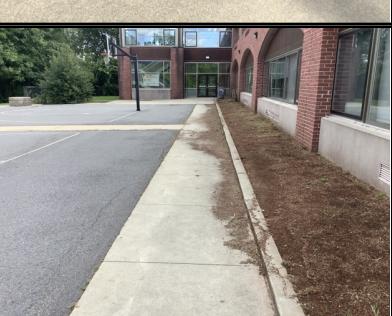
Surface is not stable, firm, and slip-resistant	-	Remove all dirt and loose gravel from surface. Ensure that surfaces are monitored and maintained.	1	-	-

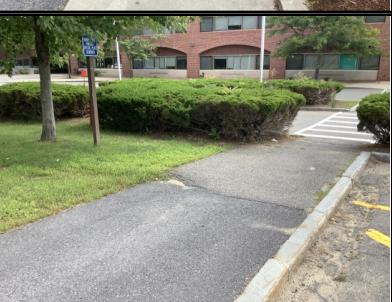
5	Walkway To Crosswalk From South Parking Lot to Lower School Entrance	Ext.		Exterior Access Route	Sidewalk

Route not maintained in operable working condition	-	Repair the surface opening to ensure the accessible route is maintained in operable working condition.	1	-	-

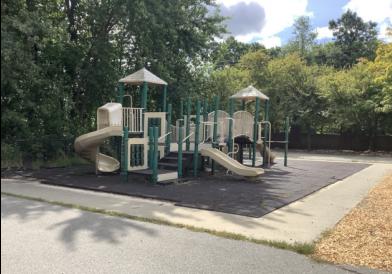
ID	Location	Floor	Room	Element	Type	Photo	Issues	Current Measure	Recommendations	Quantity	Price	Cost Estimation
6	South Accessible Playground	Ext.		Exterior Access Route	Walkway

Route not maintained in operable working condition	-	Ensure the accessible route is maintained in operable working condition. Remove the grass that is growing in the pavement.	1	-	-
7	West Main Entrance at North Parking Lot	Ext.		Exterior Access Route	Walkway

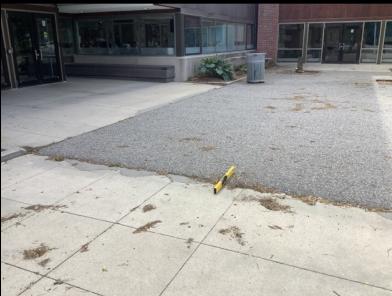
Running slope > 1:20 (5.00%) Route not maintained in operable working condition	6.1%	Reduce running slope to be no steeper than 1:20 (5.00%). Ensure the accessible route is maintained in operable working condition.	1	-	-
<b>Curb Ramp</b>												
8	Crosswalk From South Parking Lot to Lower School Entrance	Ext.		Curb Ramp	Crosswalk

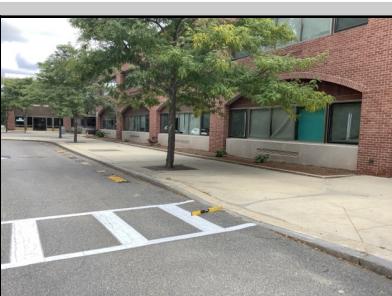
Counter slope > 1:20 max.	10.2%	Ensure that the counter slope is no greater than 1:20 (5%) max.	1	-	-
9	South Parking Lot	Ext.		Curb Ramp	Blended Transition

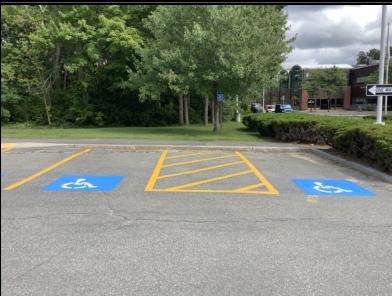
Curb ramp not provided	-	Provide a curb ramp at the access aisle.	1	-	-

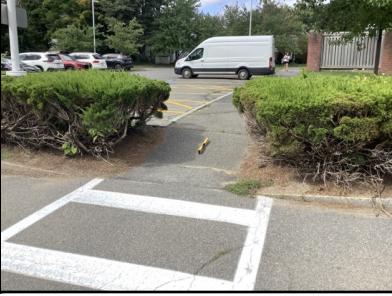
10	Crosswalk From South Parking Lot to Lower School Entrance	Ext.		Curb Ramp	3

Running slope is > 1:12 (8.33%)	12.7%	Reduce running slope to be no steeper than 1:12 (8.33%).	1	-	-

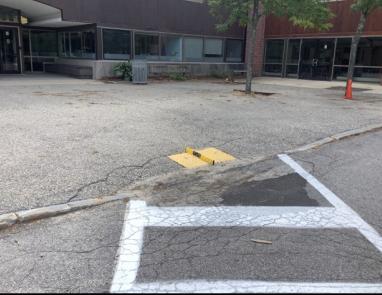
ID	Location	Floor	Room	Element	Type	Photo	Issues	Current Measure	Recommendations	Quantity	Price	Cost Estimation
11	West Main Entrance at North Parking Lot	Ext.		Curb Ramp	N/A

Running slope is > 1:12 (8.33%) Surface not stable, firm and slip-resistant	13.6% -	Reduce running slope to be no steeper than 1:12 (8.33%). Remove all dust and loose gravel from the curb ramp.	1	-	-
12	Crosswalk From North Parking Lot to West Main Entrance	Ext.		Curb Ramp	Blended Transition

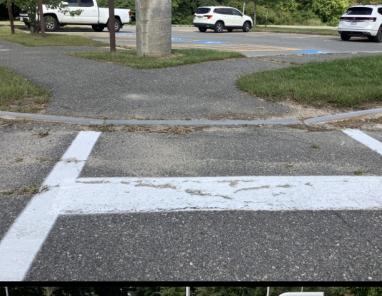
Transition from curb ramp to street not flush	1"	Ensure transition from curb ramp to street is flush or free of changes in level.	1	-	-
13	Crosswalk From South Parking Lot to Lower School Entrance	Ext.		Curb Ramp	Blended Transition

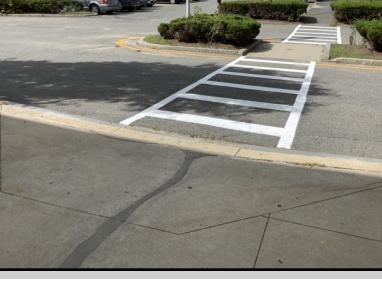
Transition from curb ramp to street not flush	1"	Ensure transition from curb ramp to street is flush or free of changes in level.	1	-	-
<b>Off-Street Parking Lot or Garage</b>												
14	North Parking Lot	Ext.		Off-Street Parking Lot or Garage	Visitor

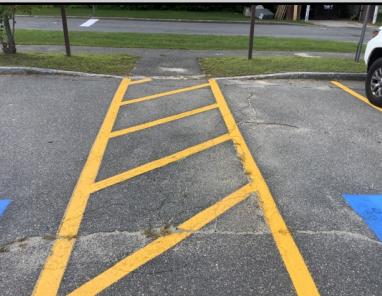
Access aisle not maintained in operable working condition.	-	Repair the cracks in the asphalt at both access aisles in the north parking lot.	1	-	-

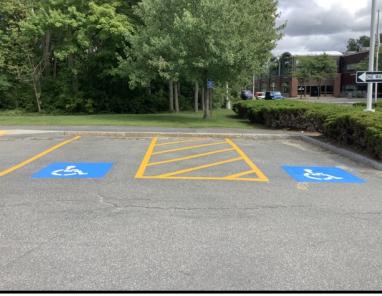
15	South Parking Lot - 2 Accessible Spaces Near School	Ext.		Off-Street Parking Lot or Garage	Visitor

Sign with the International Symbol of Acc. not provided Sign does not have the designation "Van Accessible"	- -	Provide a sign with the International Symbol of Accessibility (ISA) with the bottom of the sign 60" min. above the ground and the top 96" max. above the ground. Add the designation "Van Accessible" to the sign located at the van accessible space.	3	500  1500	\$1500

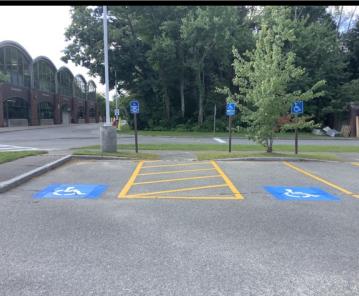
ID	Location	Floor	Room	Element	Type	Photo	Issues	Current Measure	Recommendations	Quantity	Price	Cost Estimation
16	North Parking Lot	Ext.		Off-Street Parking Lot or Garage	Visitor

Sign does not have the designation "Van Accessible"	-	Add the designation "Van Accessible" to the sign located at the van accessible space.	1	500	\$500
											500	
17	South Parking Lot - 2 Accessible Spaces Further From School	Ext.		Off-Street Parking Lot or Garage	Visitor

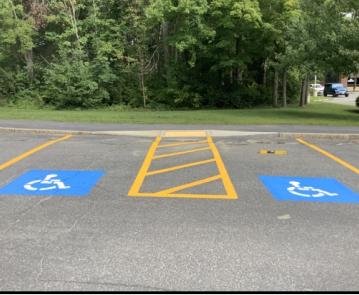
Running or cross slope at space > 1:50 (2.00%) Sign with the International Symbol of Acc. not provided Surface not stable, firm, and slip-resistant	3.6% - -	Reduce running or cross slope to be no steeper than 1:50 (2.00%). Provide two signs with the International Symbol of Accessibility (ISA) with the bottom of the sign 60" min. above the ground and the top 96" max. above the ground. Repair the surface of the access aisle in front of the curb ramp. (Cost estimate is for two signs with the ISA.)	2	500	\$1000

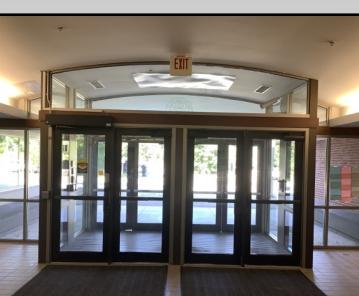
Tactile exit sign not provided Illuminated ISA symbol not provided (MAAB)	-	Ensure that a tactile exit sign with raised characters and braille is provided at the exit door. Mount the sign between 48"- 60" above the finished floor located on the right side of the right-handed door. When the illuminated exit sign is repaired or replaced, provide an illuminated sign with the International Symbol of Accessibility (ISA).	1	250	\$250
											250	
<b>Interior Access Route</b>												
19	Drinking Fountains by South Cafeteria	1		Interior Access Route	N/A

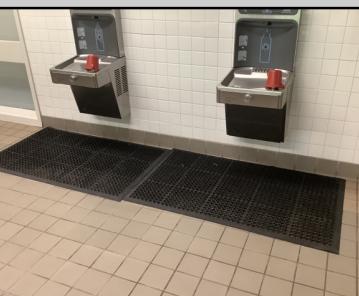
Surface not stable, firm, and slip-resistant	-	Secure both mats.	2	Labor	Labor

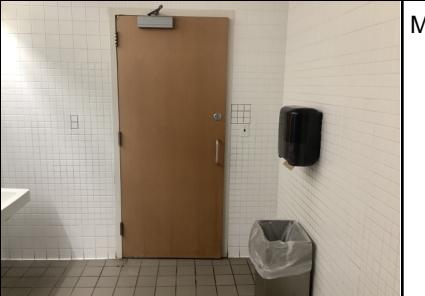
ID	Location	Floor	Room	Element	Type	Photo	Issues	Current Measure	Recommendations	Quantity	Price	Cost Estimation
<b>Doors, Doorways, &amp; Gates</b>												
20	Girls' Multi-User Toilet Room by Gymnasium	1		Doors, Doorways, & Gates	Toilet Room

Maneuvering clearance(s) not provided	5"	Relocate the trash barrel and the paper towel dispenser 60" min. from the wall on the latch side of the door.	1	500	\$500
<b>Signage</b>												
21	Gymnasium Entrance by Boys' and Girls' Multi-User Toilet Rooms	1		Signage	Designation

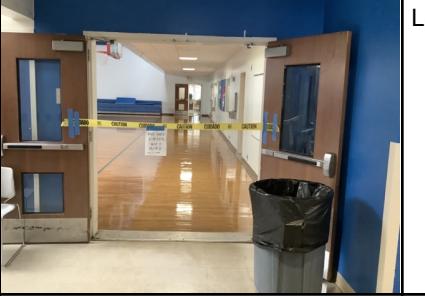
Location of tactile sign not compliant	-	Locate the sign to the right of the right-hand door.	1	Labor	Labor
22	Boys' and Girls' Multi-User Toilet Rooms by Gymnasium	1		Signage	Designation

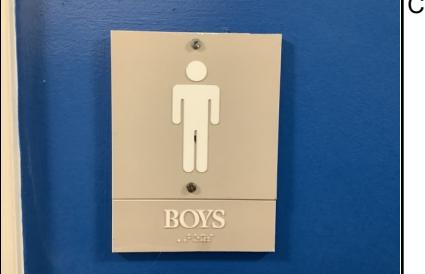
Character style not compliant	-	Provide a sign with compliant characters. Characters should be sans serif.  Applies to all designation signage in this condition.	2	250	\$500
<b>Picnic Tables</b>

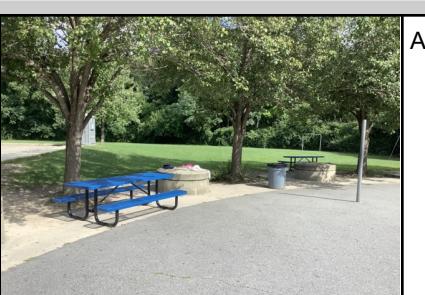
23	By North Basketball Courts	Ext.		Picnic Tables	N/A

At least 5% accessible spaces not provided	13" deep	Ensure that at least 5% (minimum one) of picnic tables are accessible.	1	1400	\$1400
24	South Playground	Ext.		Picnic Tables	N/A

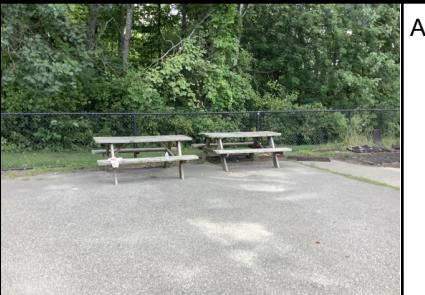
At least 5% accessible spaces not provided	-	Ensure that at least 5% (minimum one) of picnic tables are accessible.	1	1400	\$1400

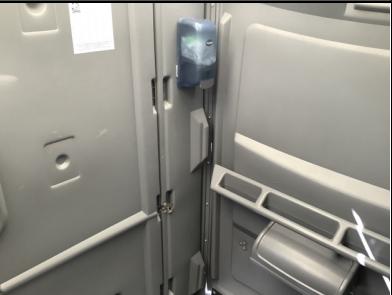
Side reach is > 54"	52"	When a new portable toilet is provided, ensure the soap dispenser is located no higher than 48" above the finished floor.	1	Labor	Labor
<b>Portable Toilet</b>												
26	Portable Toilet by North Parking Lot	Ext.		Portable Toilet	N/A

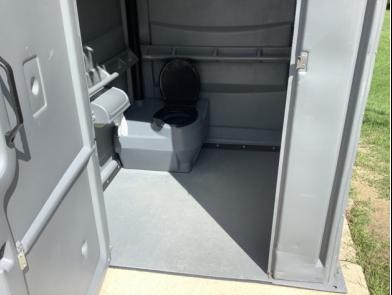
60" by 72" clear space not provided	60"	Provide an accessible portable toilet that has 60" wide and 72" deep at the toilet.	1	4600	\$4600
<b>Toilet Rooms for Children</b>												
<b>Toilet Compartment (Children)</b>												
27	Boys' and Girls' Multi-User Toilet Rooms by Gymnasium	1		Toilet Compartment (Children)	Accessible Compartment

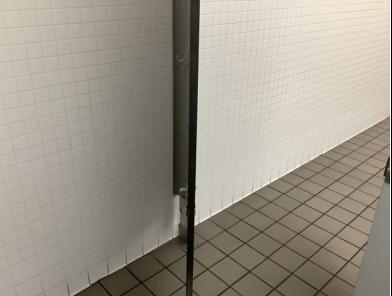
Door with malfunctioning self-closing hinge Door pull not provided Coat hook higher than 36"	- - 47"	Repair self-closing hinge. Provide a door pull on each side of the door between 34" to 48" above the finished floor that does not require tight grasping, pinching or twisting of the wrist. Lower hook so that it is no higher than 36" high for children.	2	Labor 140 75	\$430

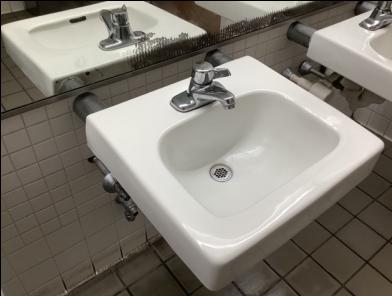
Faucet not compliant	14 lbs	Ensure the the faucet does not require greater than 5 pounds of force to operate.	1	Labor	Labor
<b>Additional Access</b>												
<b>Drinking Fountains</b>												
30	Drinking Fountains by Gymnasium	1		Drinking Fountains	Hi-Lo

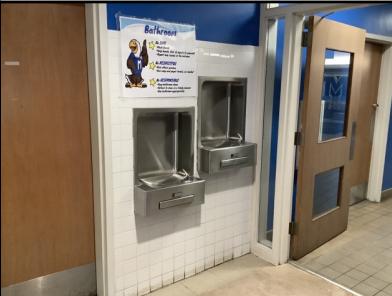
Spout < 38" or > 43" (standing users) Knee or toe clearance not provided	45" -	Relocate drinking fountain for standing users so that the spout is between 38"- 43" above the finished floor or ground. At the lower drinking fountain, provide knee and toe clearance, 27" min. high at drinking fountain for seated users. Knee and toe space must be between 17" min. and 25" max. deep.	1	2028 4028	\$6056 <b>6056</b>
<b>Play and Sport Areas</b>

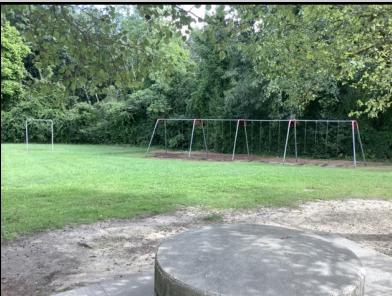
<b>Play Areas</b>												
31	North Swing Set	Ext.		Play Areas	N/A

Accessible route not provided to playground Accessible route not provided around playground Accessible route not provided to play components	- - -	Install an accessible route to and around the playground. Provide an accessible route around the play area. Provide a compliant impact-attenuating surface to and around the play components.	1	-	-
32	South Playground	Ext.		Play Areas	N/A

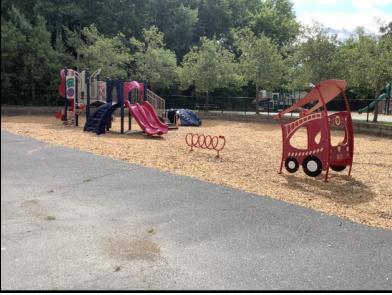
Accessible route not provided around playground Accessible route not provided to play components	- -	Provide an accessible route around the play area. Provide a compliant impact-attenuating surface to and around the play components.	1	-	-

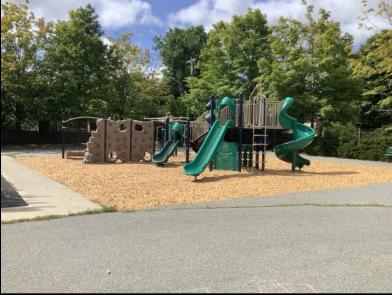
ID	Location	Floor	Room	Element	Type	Photo	Issues	Current Measure	Recommendations	Quantity	Price	Cost Estimation
33	South Playground	Ext.		Play Areas	N/A

Accessible route not provided around playground Accessible route not provided to play components	- -	Provide an accessible route around the play area. Provide a compliant impact-attenuating surface to and around the play components.	1	-	-
<b>Best Practice</b>												
34	Gymnasium	1

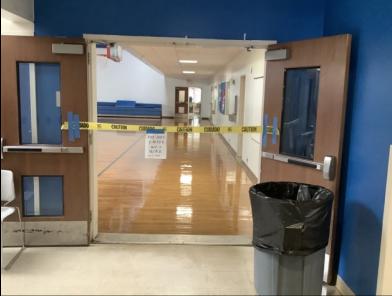
Recommend providing an additional designation sign for the gymnasium outside of the door swing of the right handed door that users can see when the door is propped open.	1	-	-
35	North Parking Lot	Ext.

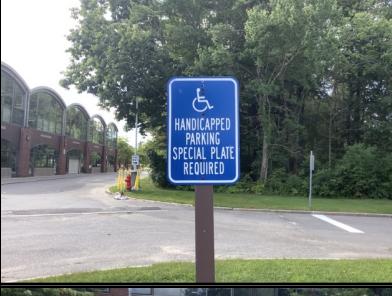
Recommend using the term "Accessible Parking" rather than "Handicapped Parking" on all parking designation signage.	1	-	-
36	Crosswalk From North Parking Lot to West Main Entrance	Ext.

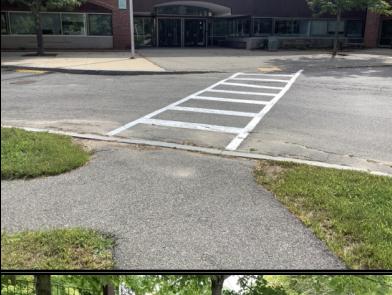
Recommend providing detectable warnings on each curb ramp on the site.	1	-	-

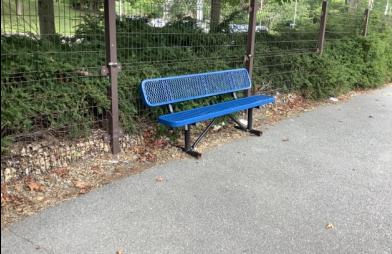
37	South Playground	Ext.

Recommend providing a 36" min. by 48" min. stable, firm and slip-resistant surface adjacent to at least one bench in each area where benches are provided positioned to allow a person in a wheeled mobility device and a person sitting on the bench to have their shoulders aligned.	1	-	-

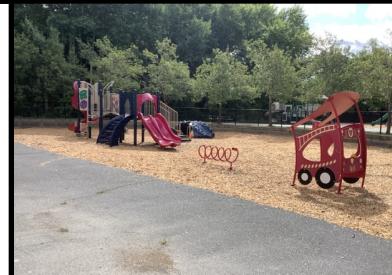
ID	Location	Floor	Room	Element	Type	Photo	Issues	Current Measure	Recommendations	Quantity	Price	Cost Estimation
38	South Playground	Ext.

Recommend providing adaptive play and sport equipment.	1	-	-
