Searles Tenney Nevins Historic District

DESIGN GUIDELINES HANDBOOK

Methuen Historic District Commission

Methuen, Massachusetts

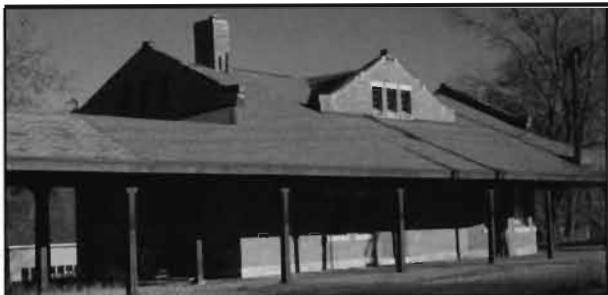
Built with funds provided by Edward F. Searles, the Railroad Depot on Union Street (1907) has an iconic form and modest architectural detailing.

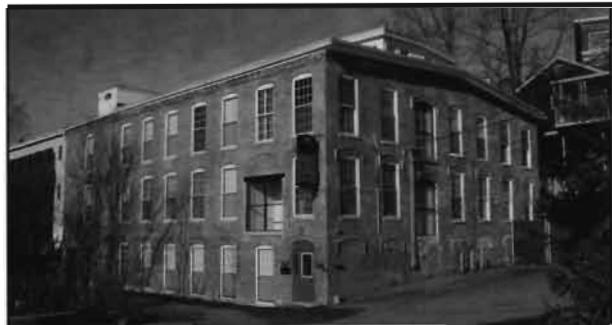
Built in 1826, this Methuen Company Mills building (45 Osgood St.) has a distinctive monitor roof, and is one of the best examples of its type in the state.

Most houses of this period in the District were constructed of wood; the Tenney Gatehouse (ca. 1830, significantly remodeled 1883; 37 Pleasant St.) is an unusual example in stone. The Methuen Co. Mill at 45 Osgood Street (1826) illustrates an industrial application of the style, with brick construction and a roof monitor to provide valuable interior illumination.

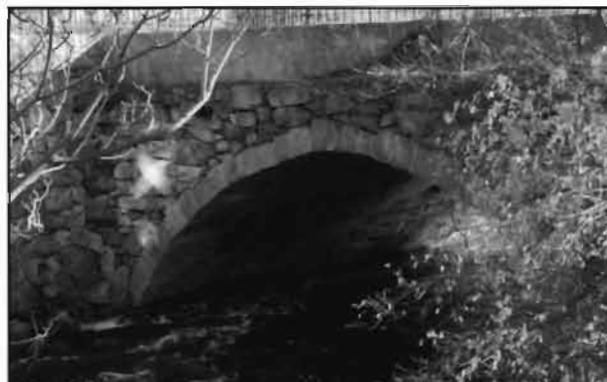
This simple bridge at Osgood Street (ca. 1830) is an unusual example of Methuen's early industrial period.

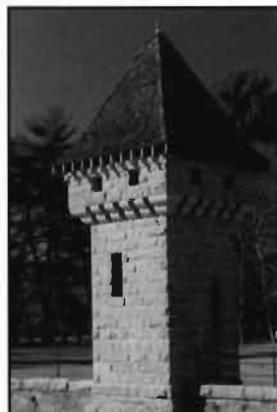
Stone retaining walls and four medieval-style towers at the crossing of Broadway and the Spicket River were built in 1912 by Edward F. Searles, accentuating his Memorial Music Hall next door.

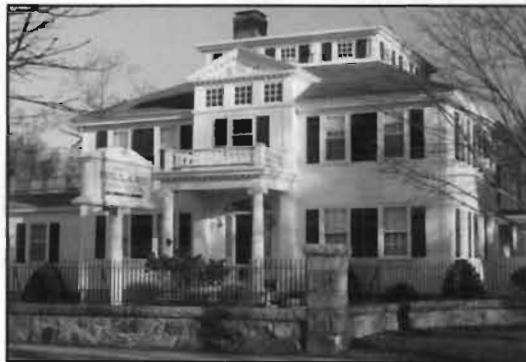
The George Waldo House at 233 Lawrence Street (1825) is a high-style example of the Federal period, with a hip roof and monitor, elaborate cornice trim and balustrades, and a lavish entrance composition.

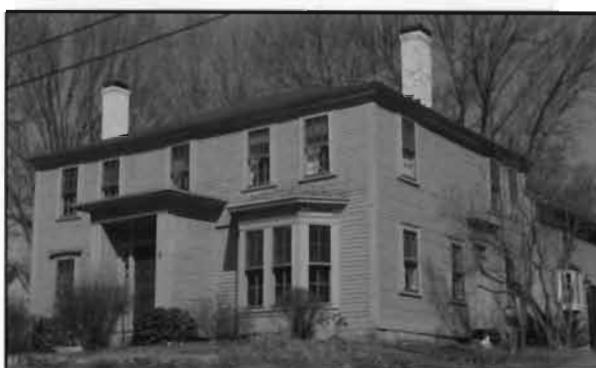
The Carleton/Johnson House at 8 Ditson Place (1811; originally located on Broadway), is a relatively simple example of the Federal style. Its square shape, low hip roof, and slender end chimneys are characteristic of the period.

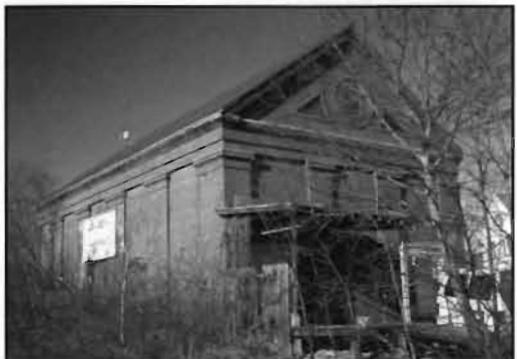
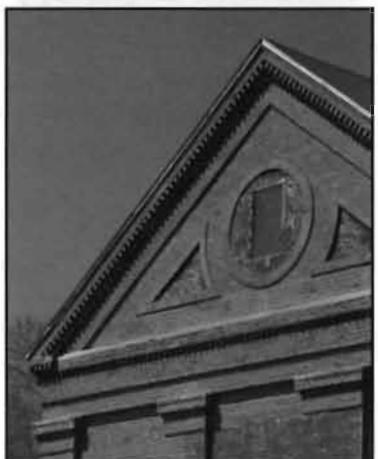
(above and left)
The brick Methuen Company Storehouse (1854; 62 Osgood St.) is a very well-detailed example of the Greek Revival style, with a pedimented façade supported by broad pilasters, which march around the side walls as well.

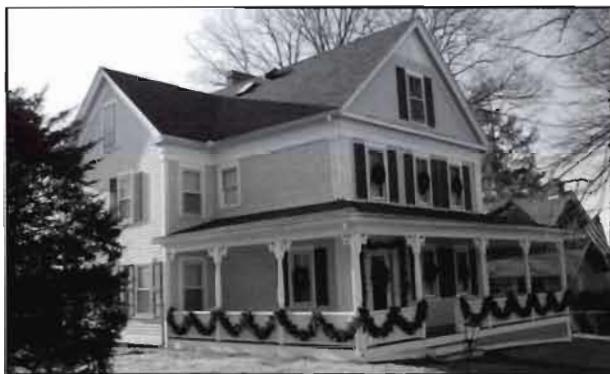
The Gutterson/Peirce House (ca. 1845; 13 Pleasant St.) is a substantial Greek Revival house, with an L-shaped plan, fully pedimented gable end, and boldly articulated trim. The wrap-around porch might be original, but with Victorian updates.

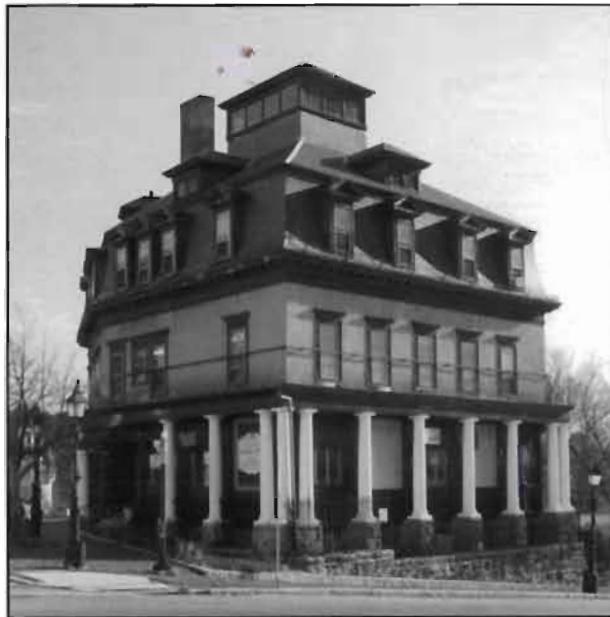
The mansard roof on the Page Building (1879; 271 Broadway) caps a stately Second Empire style building with a wrap-around porch; tall, decoratively-trimmed windows; and a large central monitor.

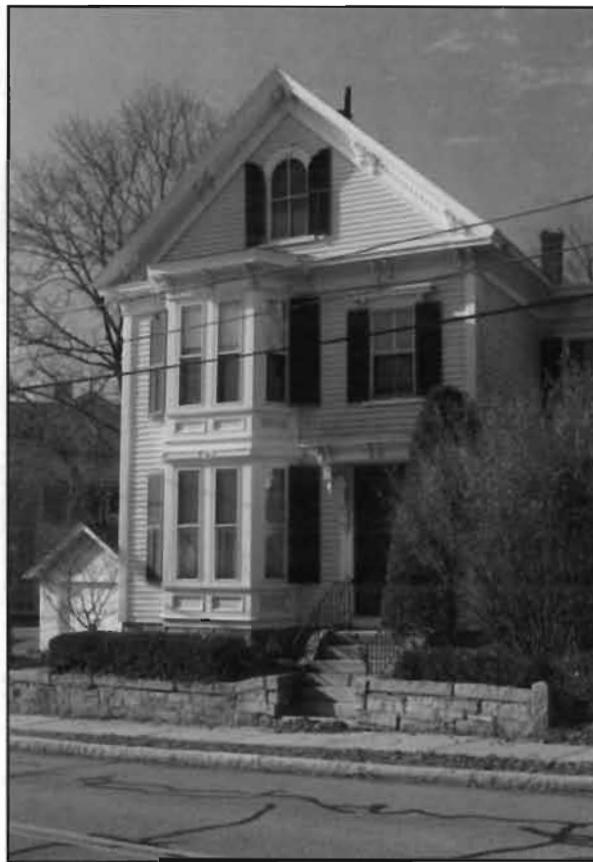
Typical of the Italianate style, the Elbridge Clark House (ca. 1875; 10 Park St.) displays an L-shape structure with its gable end facing the street, bracketed eaves and door hood, and a round-arched window in the gable.

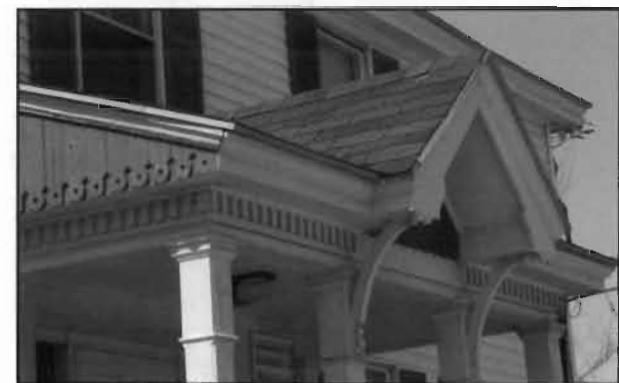
The front entrance and gable ends of the Federal-period Benjamin Osgood House (ca. 1819/1881; 248 Broadway) were updated with lively Stick Style details.

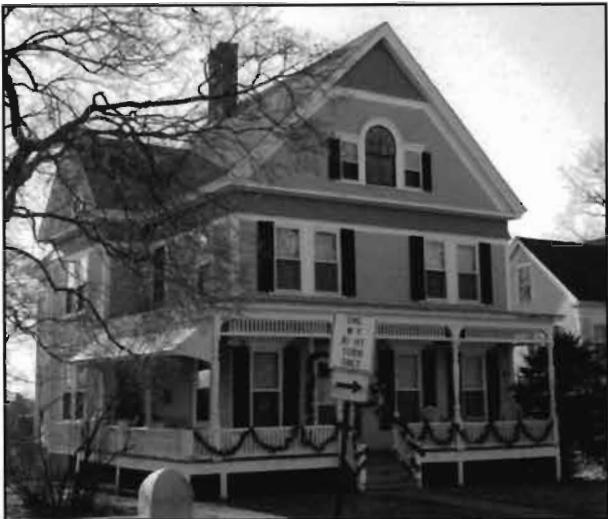
The Peirce House (1889; 15 Pleasant St.) is a fine example of the Queen Anne style, exuberantly detailed with bands of contrasting wall materials, a wrap-around porch, and a Palladian window in the gable end.

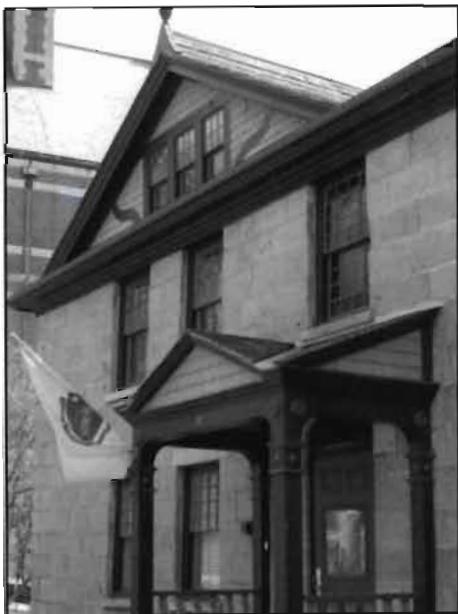
At the Tenney Gatehouse (37 Pleasant St.), a simple five bay, center entrance, Federal-period house was transformed by Queen Anne style window sash, porches, decorative siding and tower.

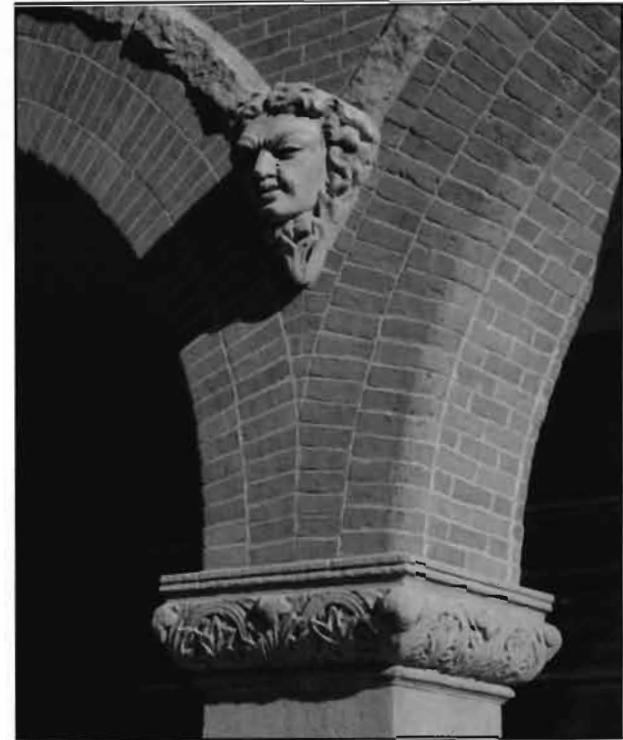
Detailing of the Library's arcade contrasts highly sculptural limestone and terra cotta ornament with the smooth, rich red brick of the wall surfaces.

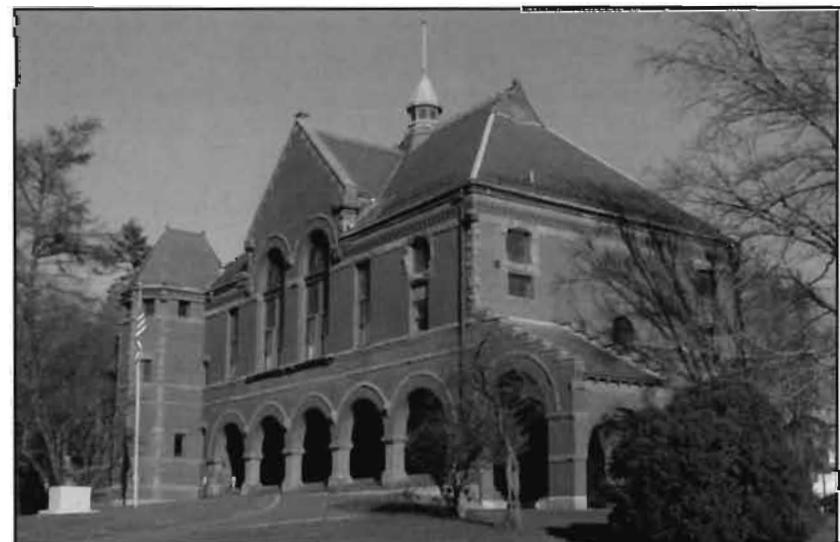
The Nevins Memorial Library (1883; 305 Broadway) is an excellent local example of the Richardsonian variant of the Romanesque style. It is distinguished by large, simple building forms, a ground floor arcade, massive roof, and terra cotta ornament.

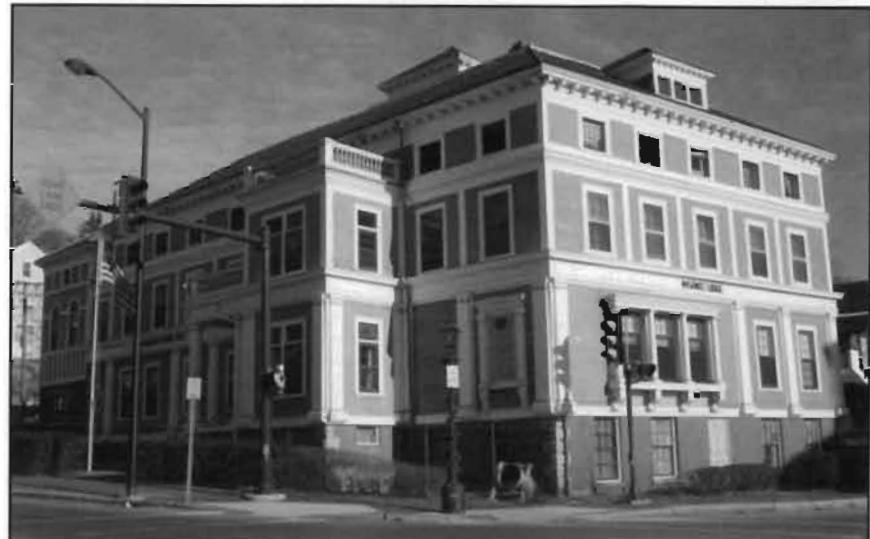
(above right) Originally constructed as a hotel, the Masonic Lodge building (1851/1906; 275 Broadway) was significantly remodeled by Edward F. Searles. The Colonial influence is evident in its blocky form, hip roof, small-paned windows, and classical ornament.

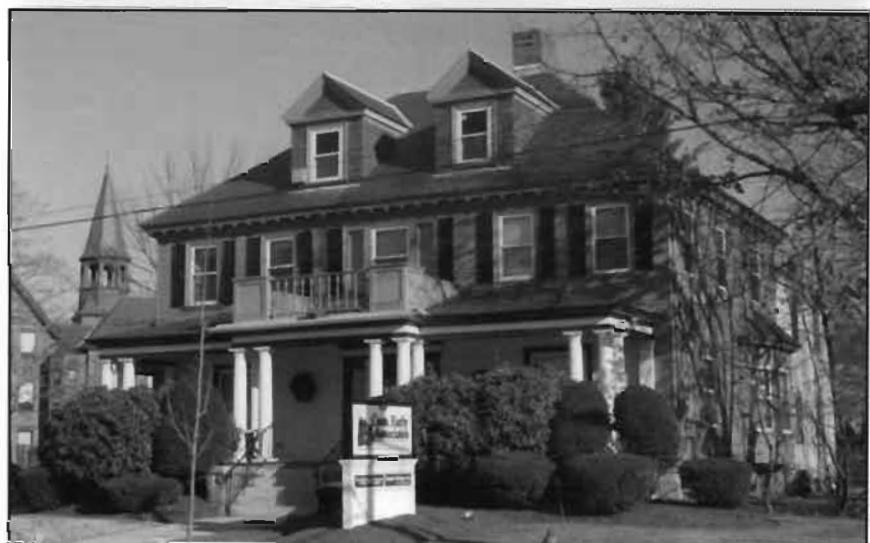
(below right) The Dr. Richard Lawlor House (1909; 251 Broadway) exemplifies the residential use of the Colonial Revival style in its hip roof, traditional 5-bay façade, and full-length porch. It was built at a time when suburban houses still predominated on Broadway.

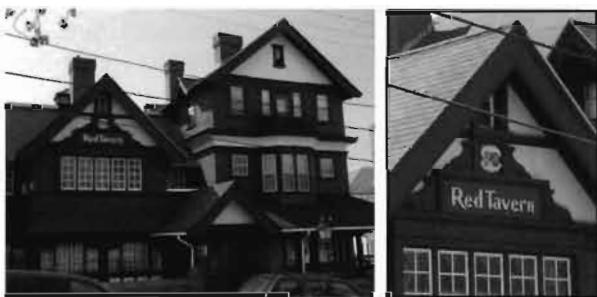
The Red Tavern (1900; 5 Pleasant St.) was designed as a guest house for Edward F. Searles, but was soon converted to an inn. Its multiple gables, irregular massing, and half-timbering are characteristic of wood buildings in the Jacobethan style.

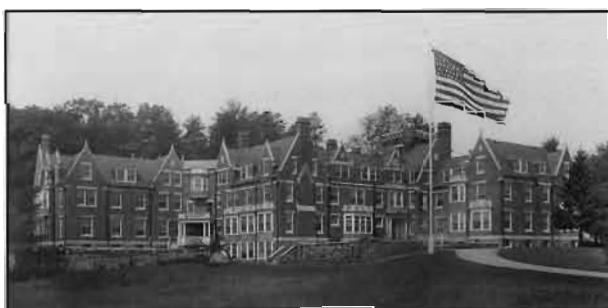
The Nevins Home for the Aged (1906; 100 Broadway) is a zig-zagging brick assembly of tall gabled structures ornamented with a wealth of bay windows, entry porches, towers, crenellation, finials, balustrades, and limestone trim.

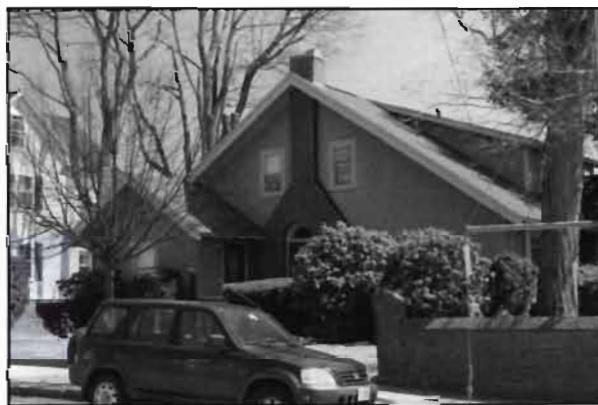
The bungalow-style Rolf C. Norris House (1924; 9 Pleasant St.) is characterized by multiple gable roofs with deep overhanging eaves, stucco siding, an arched doorway, and irregular clinker brick.

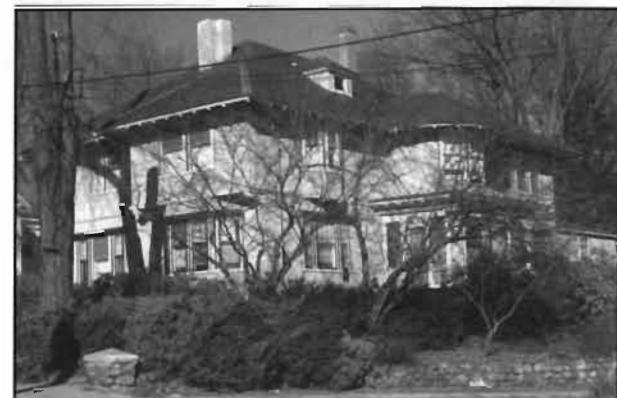
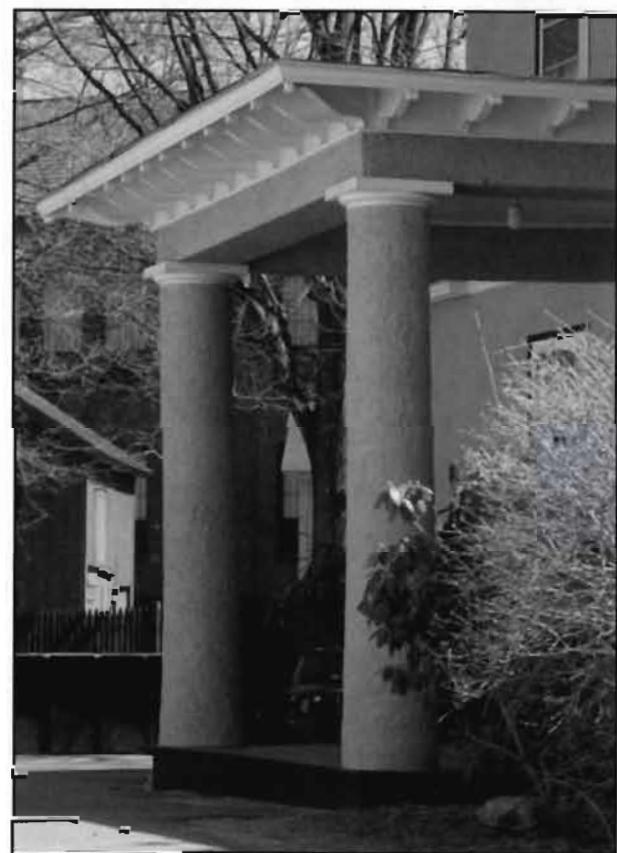
(above top and bottom) The Lewis E. Barnes House (1906; 259 Broadway) is a fine example of the Craftsman style, featuring a high hip roof with deep overhanging eaves, stucco siding, and classical details.

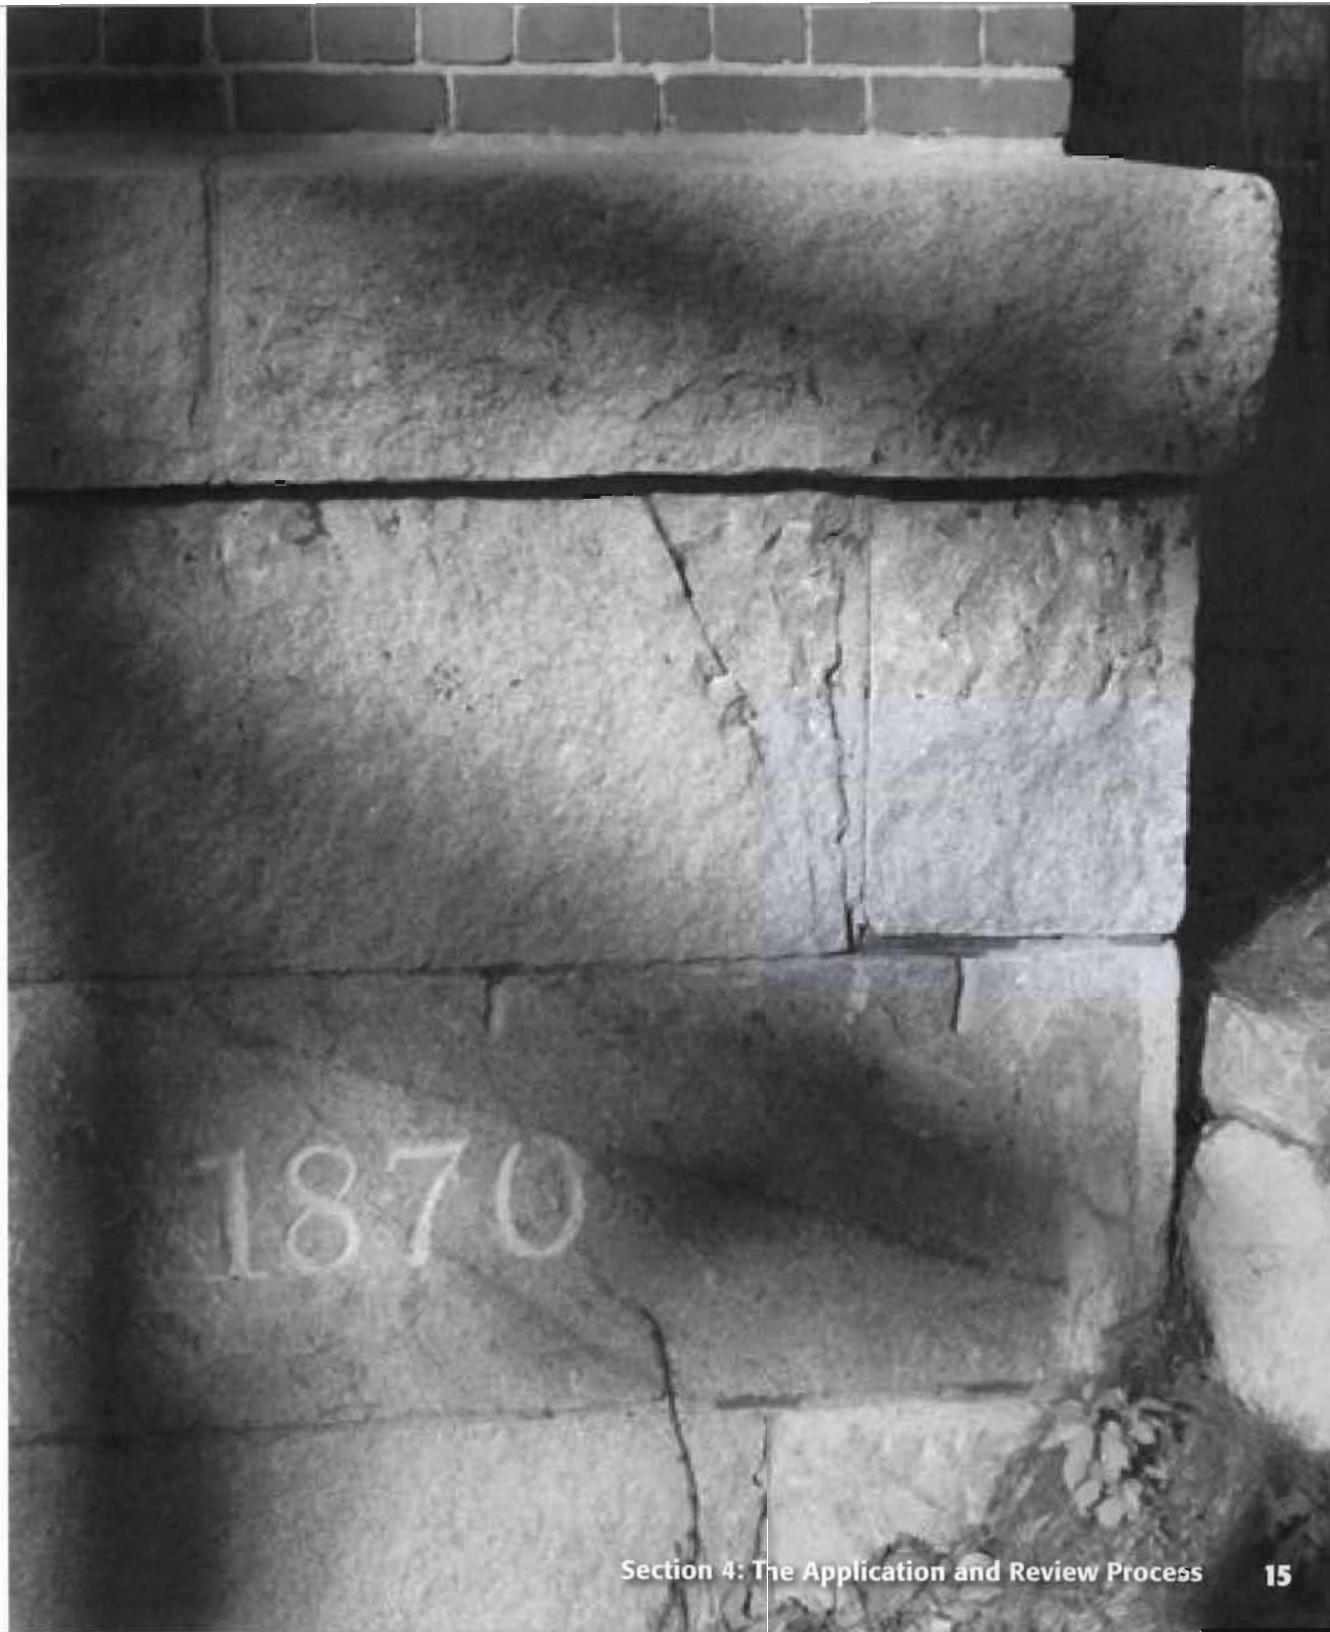
(right) Methuen Company Mills foundation detail.

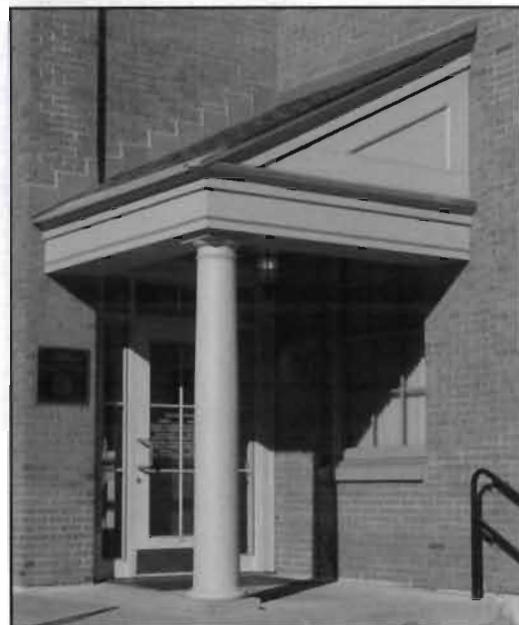
This entrance to the recent Methuen Cooperative Bank building (1964; 243 Broadway) reinforces important historic design patterns in the District with its attention to detail and its relationship to the street.

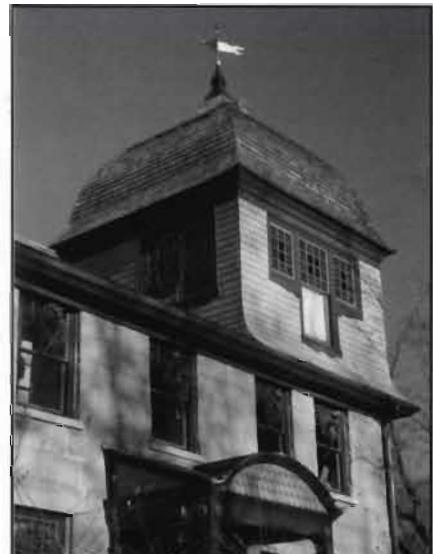
(below left) The Tenney Gatehouse (ca. 1830/1883; 37 Pleasant St.) represents a major late 19th century remodeling of an early 19th century house, using compatible materials and proportions.

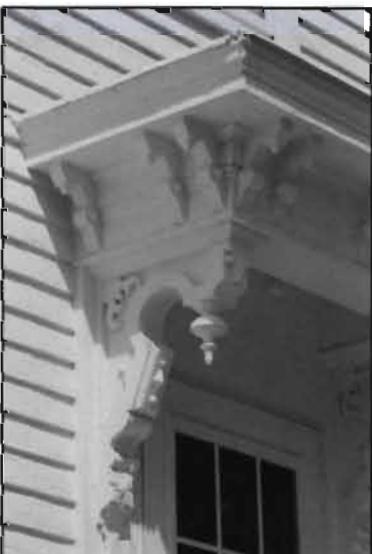
(below right) Historic door hoods, such as this beautifully carved example on the Baptist Church Parsonage, (1877; 32 Park St.) are vulnerable to removal but are essential to the character of Victorian buildings.

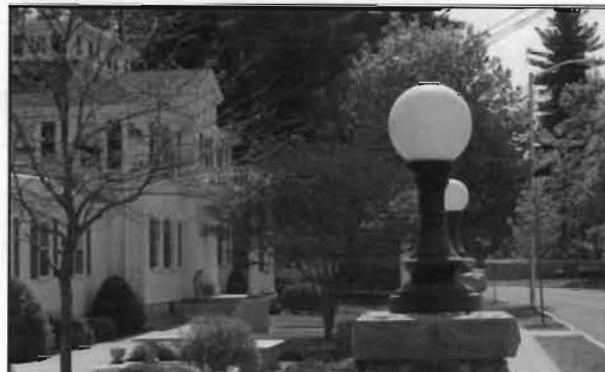
The George Waldo House (1825; 233 Lawrence St.) is enhanced by a layering of site elements—street trees, sidewalk, stone wall, an elaborate front porch, and projecting entrance bay—that creates a rich interface between the building and its environment.

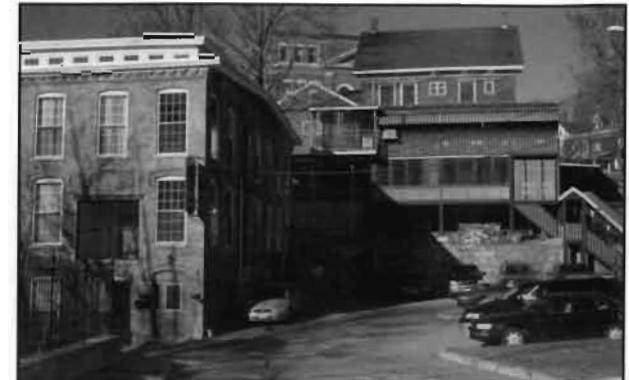
The fronts of the commercial buildings on Hampshire Street are dramatically different from their back view on Osgood Street. The steep grade change and the adjacent mill buildings down below give a whole new perspective.

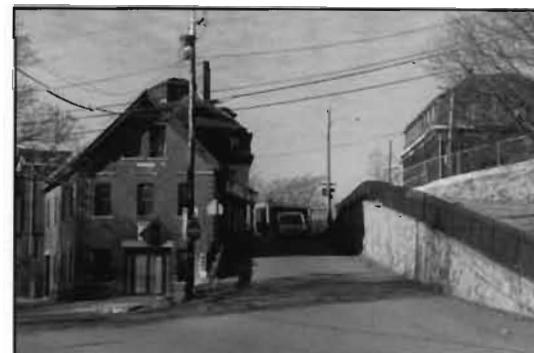
Changes in elevation and an irregular web of streets at the intersection of Osgood, Lawrence, and Charles streets are integrated by terracing of the land, granite retaining walls, and well-designed buildings that take advantage of highly visible building sites.

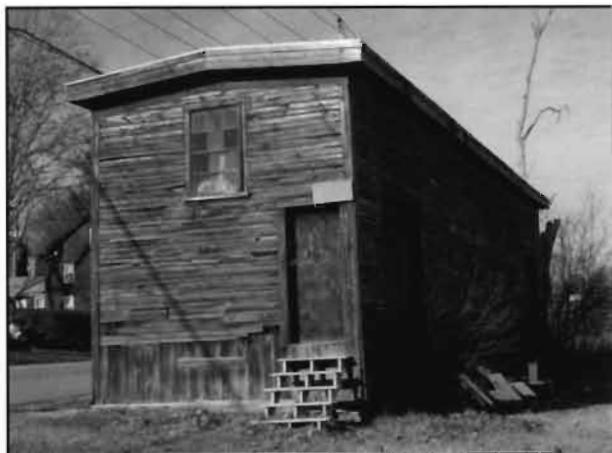
This utilitarian late 19th century warehouse on Union Street is as simple as possible—one highly efficient rectangular shape and no ornament to spare.

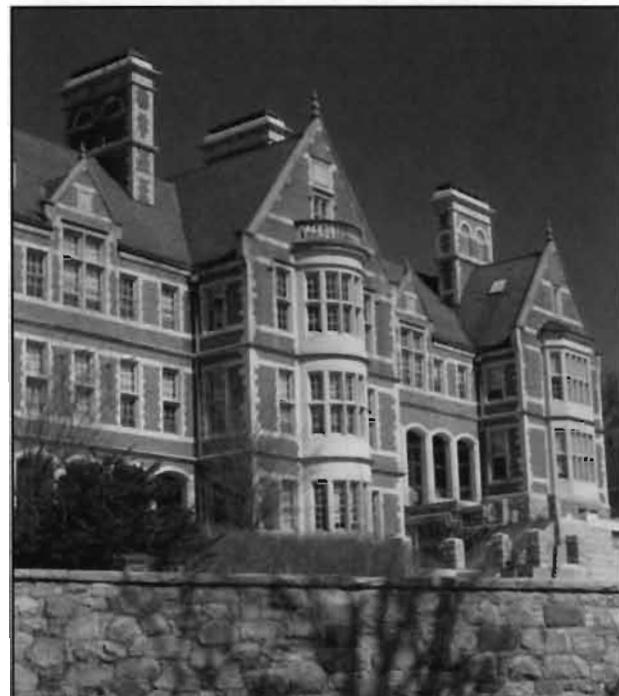
The highly articulated volume of the Searles Building (1904; 41 Pleasant St.) consists of three gabled, connected wings elaborated with a variety of wall and roof projections and lavish trimwork.

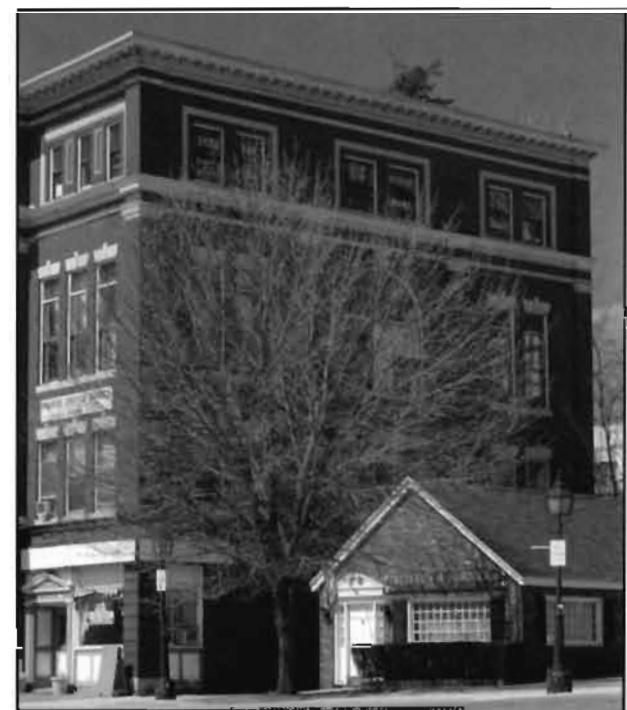
The contrast between the ample, four-story mass of the Odd Fellows Building and its small one-story neighbor on Hampshire Street is incongruous.

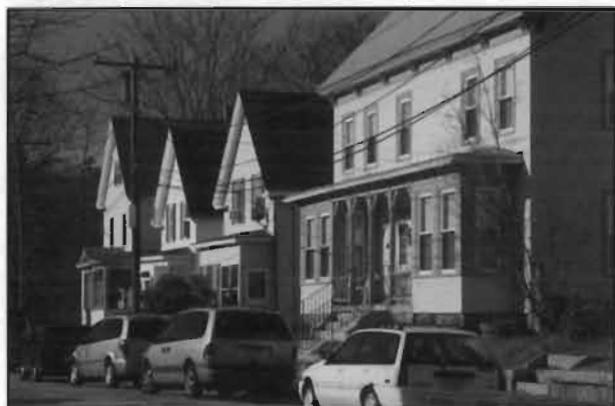
Lining Gleason Street is a row of houses built at roughly the same time (ca. 1884–1906), with similar setbacks and spacing. A consistent, 2½ story building form with similar proportions, arrangement of entrances and bay windows, and gable roofs marches down the street.

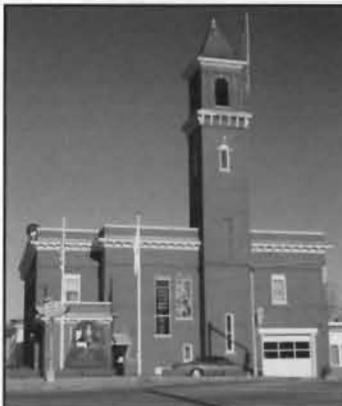
Central Fire Station (1899; 24 Lowell St.) balances its general horizontal orientation with a vertical tower of approximately equal dimension.

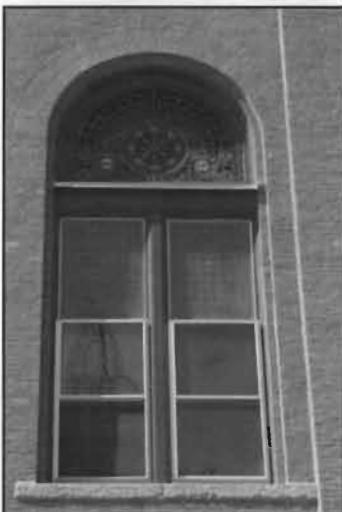
This window at the Nevins Memorial Library (1883; 305 Broadway) demonstrates the typical vertical proportions of windows and other architectural elements in historic buildings.

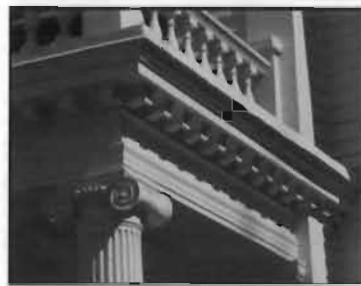
The beautifully composed porch of the George Waldo House (1825; 233 Lawrence Street) features fluted Ionic columns, modillion brackets at molded cornices, and a roof balustrade.

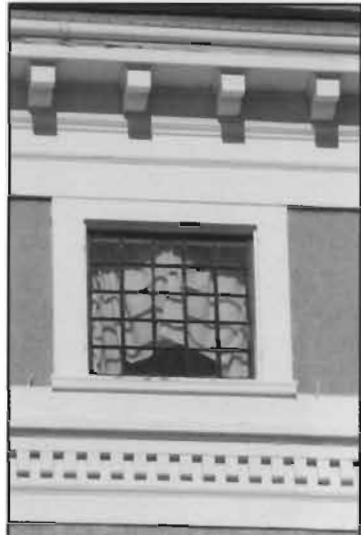
This detail of the Masonic Lodge (1851/1906; 275 Broadway) exemplifies the combination of materials, textures, and ornament found throughout this richly articulated building.

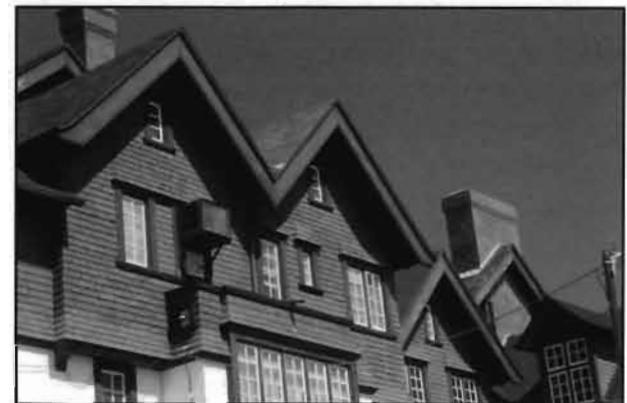
The Red Tavern (1900; 5 Pleasant St.) is distinguished by its multiple intersecting and overlapping gables, punctuated by decorative chimneys. The building is easily visible from all four sides.

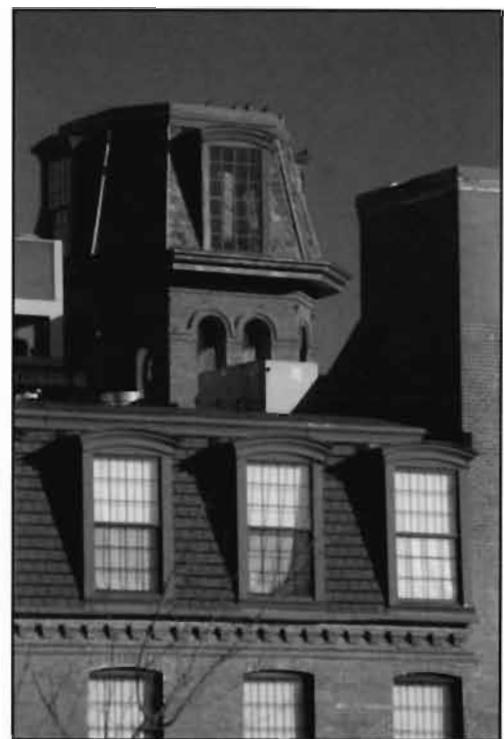
The Methuen Co. Mills complex on Osgood Street (1826–1882) has a remarkably elaborate roof edge, with decorative cornices, mansard roofs, dormers, and smokestacks.

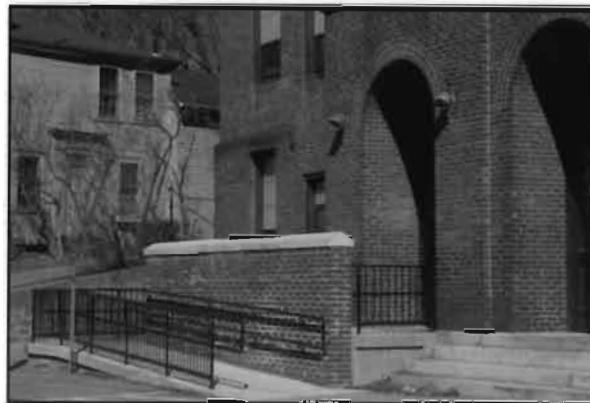
Universal access to the Central School (1904/24; 10 Ditson Pl.) is neatly provided at one of its major entrances. A brick wall conceals the upper ramp, repeating the materials and planar forms of the building and minimizing the more cluttered effect of lengthy railings.

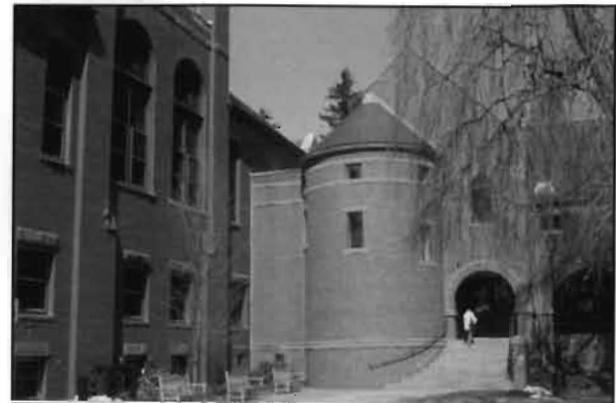
(above) A large addition on the Nevins Memorial Library (1883; 305 Broadway) is sited at the back of the property and uses the scale, shapes, window patterns, and ornament of the original building in a contemporary way.

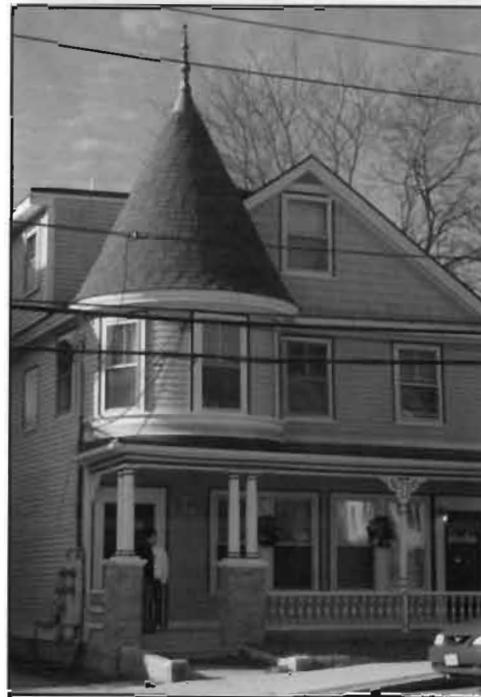
(below) A lively Queen Anne tower and porch were added to a simple Greek Revival-style house (ca. 1840; 266 Broadway). Although dramatic in visual impact, the proportions, materials, and detailing of the additions complement the original design.

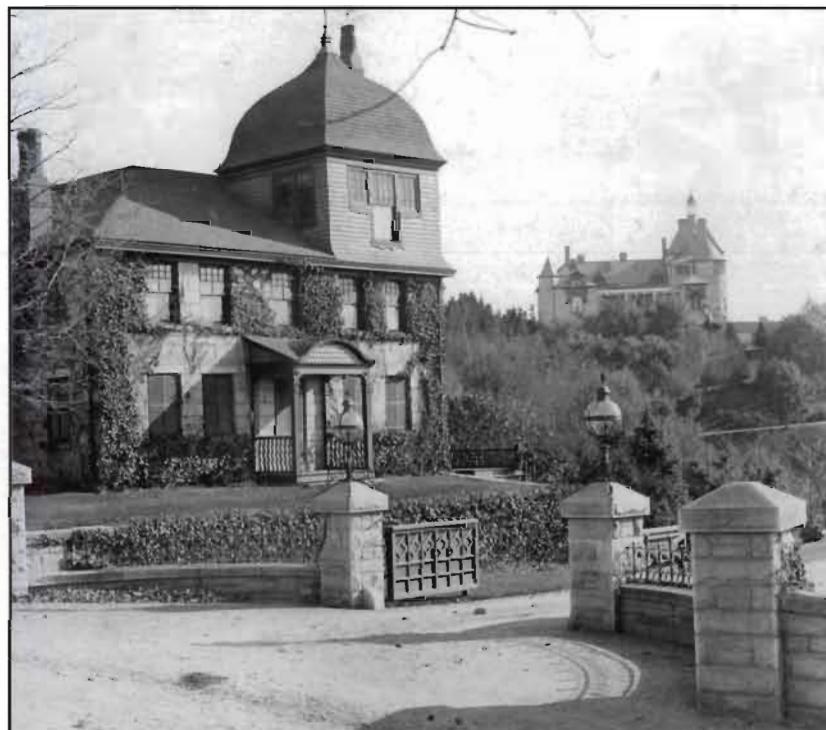
Destruction by fire of the main house at the Tenney estate (Greycourt, 1890; 37 Pleasant St.) meant the loss of not only an individually significant building, but also an integral part of the estate complex and a prominent element in Methuen's skyline.

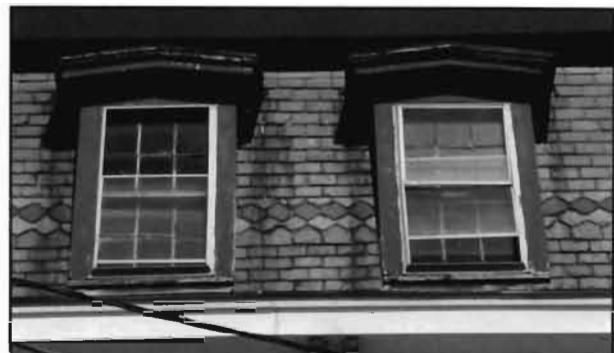
The dormers and slate roof of the Tenney Shoe Factory (1868; 2 Charles St.) are among the few original design features remaining on this historic building. Their decorative detailing highlights this very visible property.

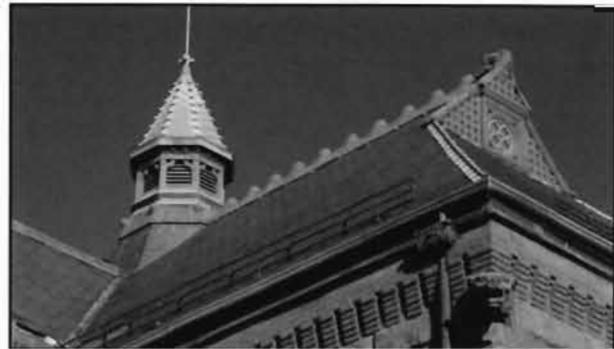
A delicately detailed cupola and terra cotta cresting on the Nevins Memorial Library (1883; 305 Broadway) crown the voluminous building below.

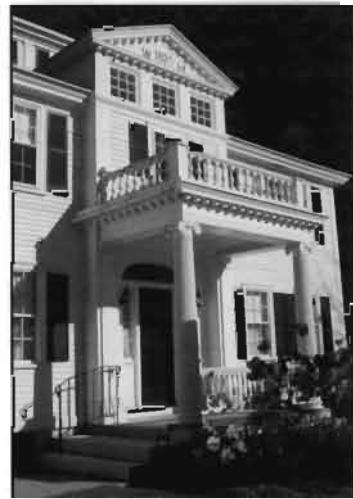
The George Waldo House (1825; 233 Lawrence St.) has one of the most elaborate entrances in the Historic District, layering a porch with Ionic columns, bracketed cornice, and carved balustrade onto a three-story projecting bay surmounted by a bracketed pediment.

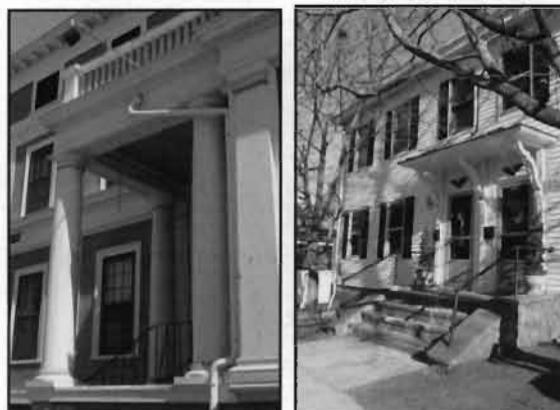
(left) Tucked into a corner of an elaborate commercial building, this entrance to the Masonic Lodge (1851/1901; 275 Broadway) features a porch with sturdy Doric columns supporting a carved entablature and balustrade.

(right) This otherwise plain Victorian duplex (ca. 1870s; 10-12 Lowell St.) is embellished with a decoratively bracketed hood that spans the paired doorways.

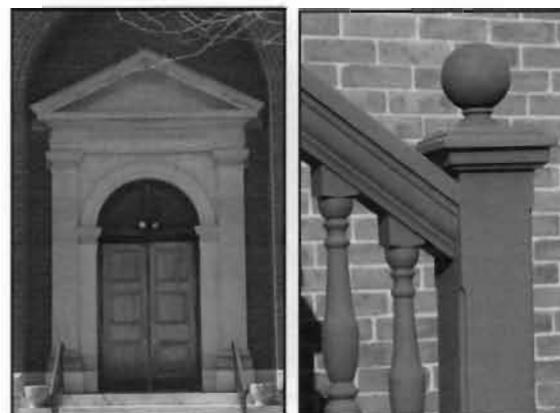
(left) Memorial Music Hall (1899-1909; 192 Broadway) is entered through a high-style classical doorway above a formal stone stairway.

(right) The beautifully carved railing at a back stairway of the Red Tavern (1900; 5 Pleasant St.) brings the building solidly to the ground, and dramatically manipulates light and shadow.

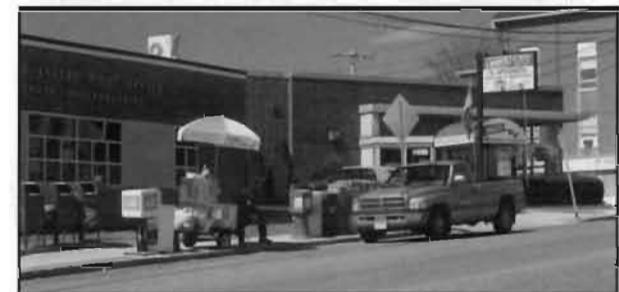
These two mid-20th century commercial buildings (272 and 276 Broadway) break the cohesive patterns of the Historic District in their low height and utilitarian designs. The building on the right is also set at an angle to the sidewalk, rather than parallel to it, further disrupting the street edge.

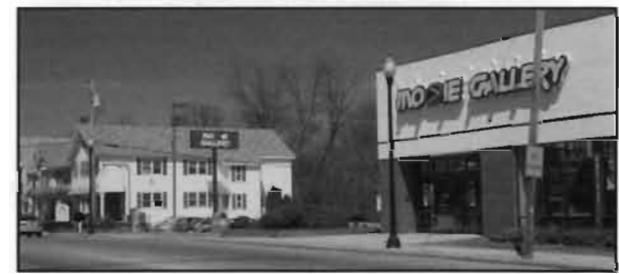
The box-like commercial building at 193 Broadway (late 20th century) relies on oversize graphics for visual distinction. Its massing, façade composition, materials, and adjacent parking lot detract from the rhythm and historic articulation of the streetscape.

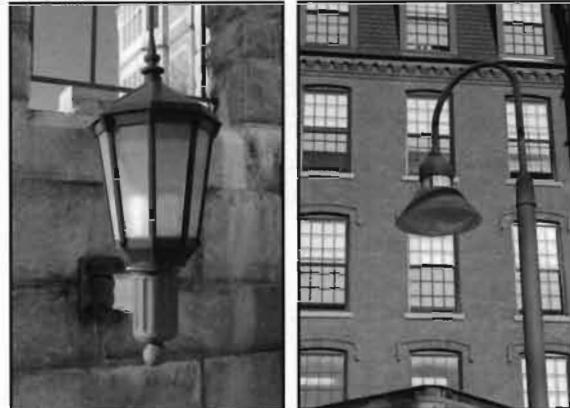
(left) The scale and style of this period light fixture complement the large forms and high-style design of the Searles Building and its granite retaining walls.

(right) This new light pole at the Methuen Co. Mills complex on Osgood Street is clearly modern in style, but its simple forms and minimalist detailing provide an attractive contrast to the historic buildings.

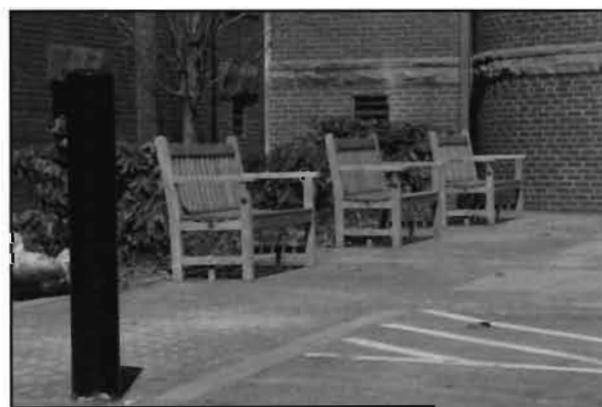
New seating, bollards, light poles, trash cans, and bicycle racks at the rear entrance to the Nevins Memorial Library (1883; 305 Broadway) are constructed of natural wood and black metal.

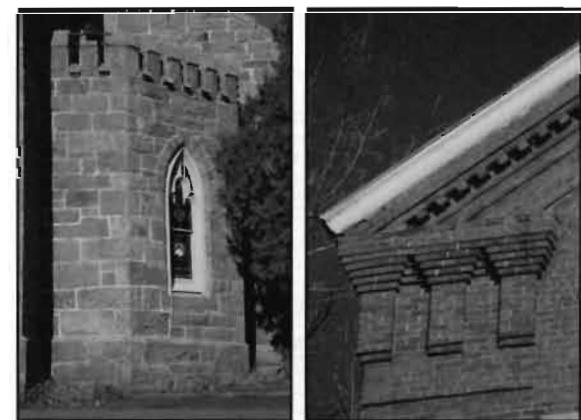
(left) The fine stonework at the First Church Congregational (1855; 30 Pleasant St.) includes roughly-coursed granite ashlar (squared blocks), voissoirs (wedge-shaped stones over the arched windows), and crenellation at the roof edge.

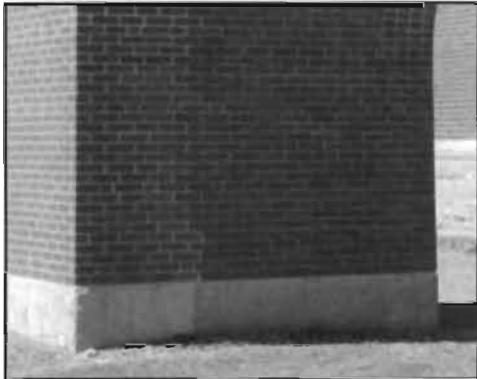
Selective repointing with a brighter color mortar makes the repair work highly conspicuous. Such a patch not only detracts from the quality of the original brickwork, but also can spoil the overall design effect. (Memorial Music Hall, 192 Broadway)

Match the existing joint width and the existing profile of the joint (e.g., convex, concave, sloped). Do not smear mortar on the surface of adjacent brick or stone. New mortar must match adjacent historic mortar in composition, color, and texture, to avoid a patchwork look on historic facades. Physical damage can also result from an improper mortar recipe. Until the late 19th century, most mortars were lime-based and relatively soft; stronger modern mortars contain cement and can pull old bricks apart. (See the National Park Service's "Preservation Brief #2, Repointing Mortar Joints in Historic Brick Buildings.")

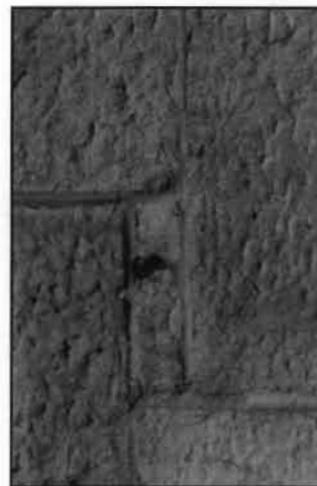
At the base of the Old Town Hall (1853; 290 Broadway), the granite foundation exhibits an almost modern, abstract composition of masonry sizes and textures, framed by crisp, historic mortar joints.

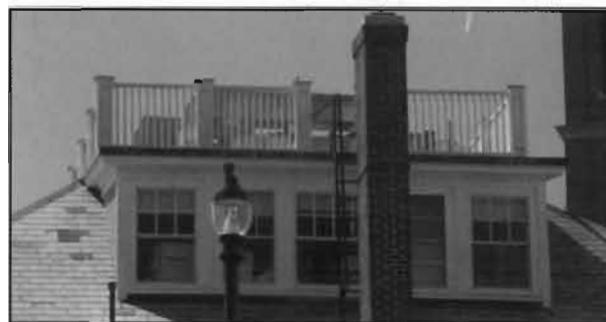
Mechanical equipment added to the rooftop of the old St. Monica Rectory (1922; 231 Broadway) is concealed with a railing that blends with the Colonial Revival style of the building, greatly minimizing its visibility.

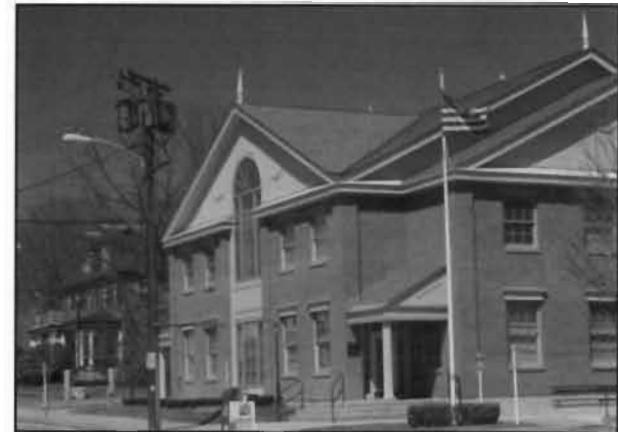
The recent Methuen Cooperative Bank (1964; 243 Broadway) exemplifies a clearly modern but traditionally-styled new building. In the location of its front entrances near the street and in its massing, height, and materials, the design of this building is consistent with others in the District. The building reinforces the historic street edge and encourages pedestrian activity.

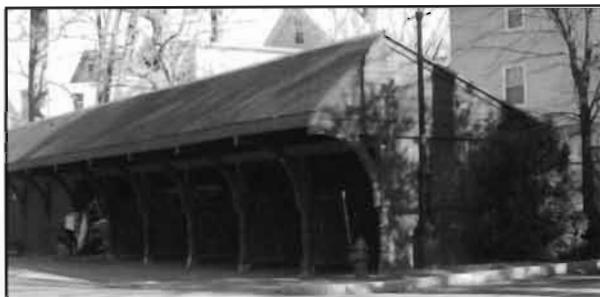
The very well-preserved carriage house at the Nevins Memorial Library (1883; 305 Broadway) is appropriately set at the back of the property and recalls earlier methods of transportation.

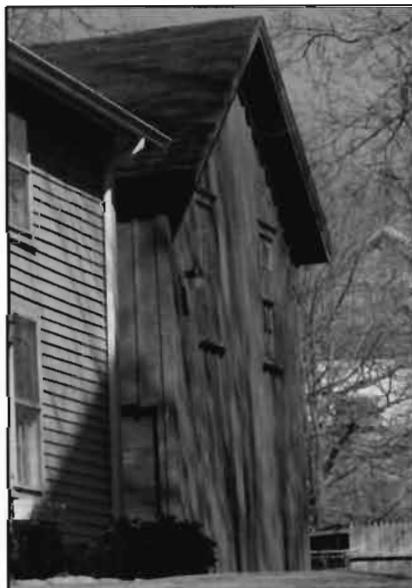
This utilitarian barn is attached to the back of the Federal-period Carleton/Johnson House (1811; 8 Ditson Pl.).

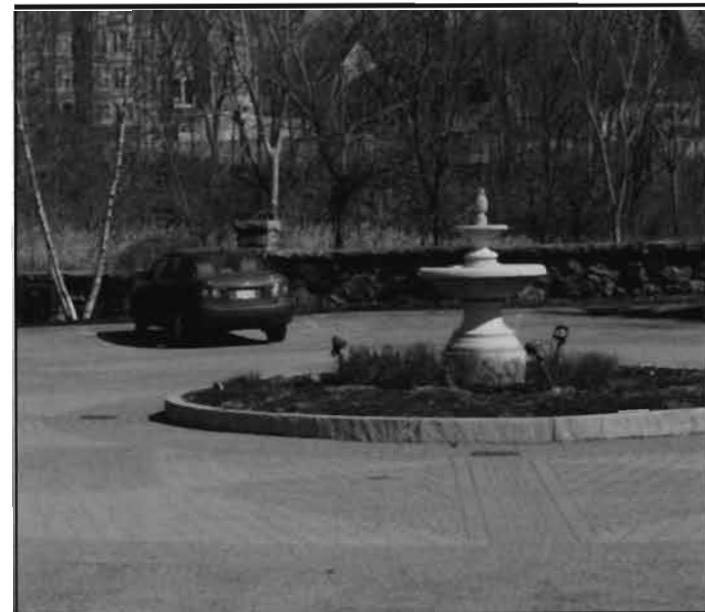
This well-designed parking lot adjacent to the George Waldo House (1825; 233 Lawrence St.) features stone walls, historically appropriate lighting, and a landscaped island that give appropriate scale, texture, and detail to what is usually an intrusive element in the historic landscape.

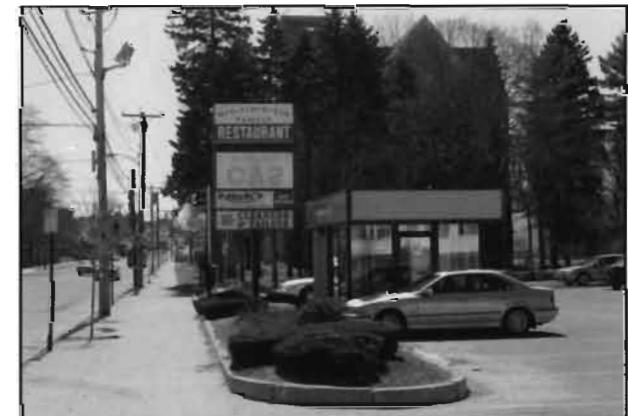
At this strip shopping plaza on Broadway, a large parking lot is set right at the street edge, with no effective mitigation for the obtrusive expanse of pavement.

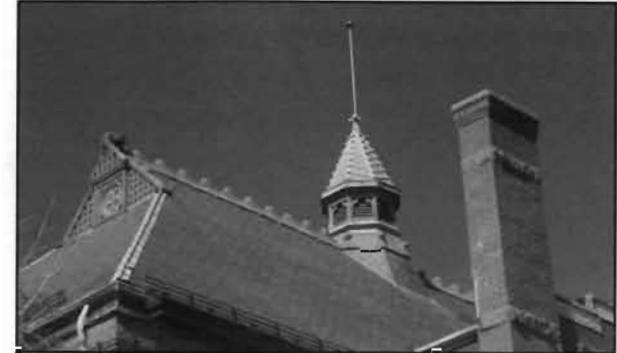
Nevins Memorial Library (1883; 305 Broadway) has a richly elaborated roofline, with a corbelled brick cornice, copper gutters and flashing, decorative chimneys, slate roof tiles, terra cotta cresting at the top ridge, and a copper-clad cupola.
