Searles Tenney Nevins Historic District

DESIGN GUIDELINES HANDBOOK

Methuen Historic District Commission

Methuen, Massachusetts

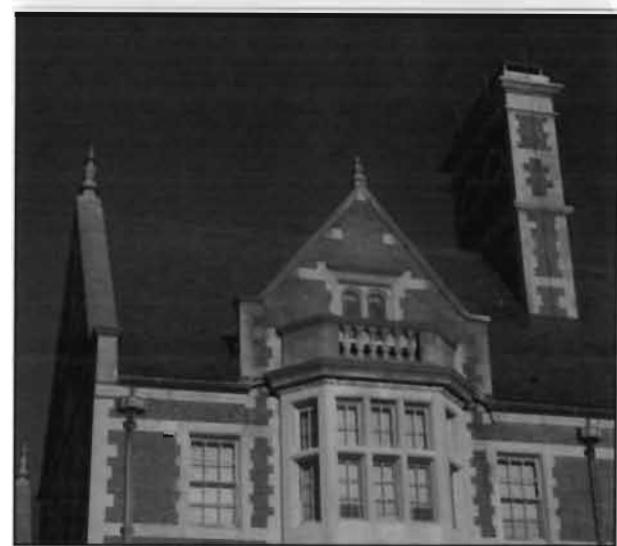
Visible from many parts of the Historic District, the lively roofline of the Searles Building (1904; 41 Pleasant St.) features projecting parapets on the gable ends, gabled dormers, finials, roof balustrades, and striking chimneys, using the same play of shapes, textures, and colors that characterizes the walls below.

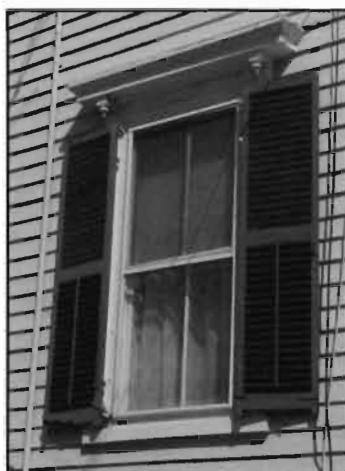
Historic wood shutters on the Elbridge Clark House (ca. 1875; 10 Park St.) provide an important visual accent to the window on the exterior, and allow for control of ventilation and light on the interior.

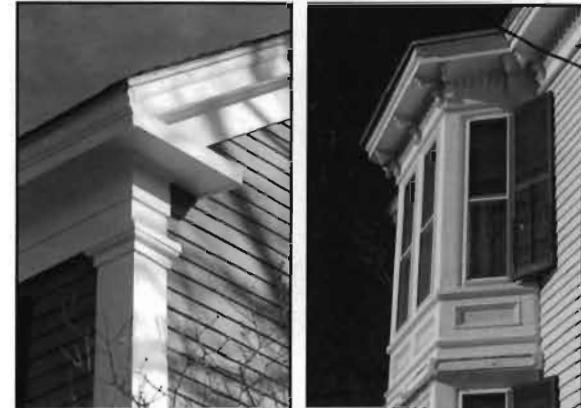
(left) Handsome wood trim articulates the corners and eaves of the Greek Revival style, Henry Preston House (ca. 1840; 17 Park St.).

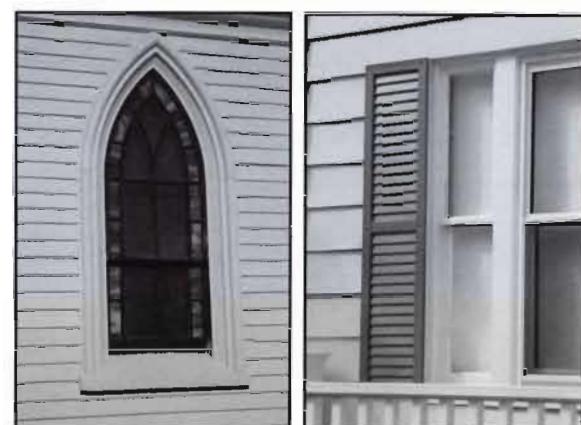
(left) A series of bold round moldings frames this pointed-arch window at the First Baptist Church (1869; 24 Park St.).

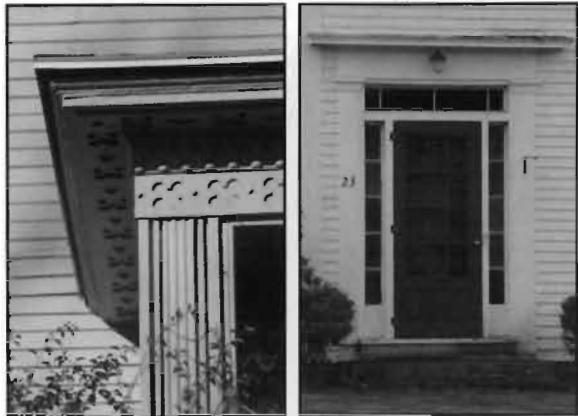
(left) An unusual array of carvings on the entrance vestibule accents the otherwise plain and traditional façade of the Federal style Carleton/Johnson House (1811; 8 Ditson Pl.).

(right) The Greek Revival house at 23 East Street (ca. 1850) displays a typical period doorway, with full height sidelights, a rectangular transom, and flat pilasters carrying a simple entablature with molded cornice.

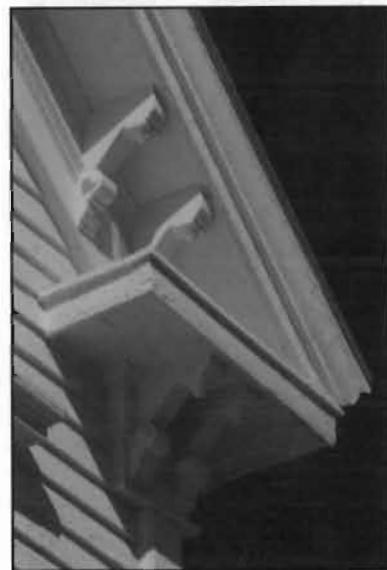
This detail of the Baptist Church Parsonage (1877; 32 Park St.) shows a handsome and well-preserved combination of clapboards, corner boards, entablature, and bracketed eaves in a typical Italianate design.

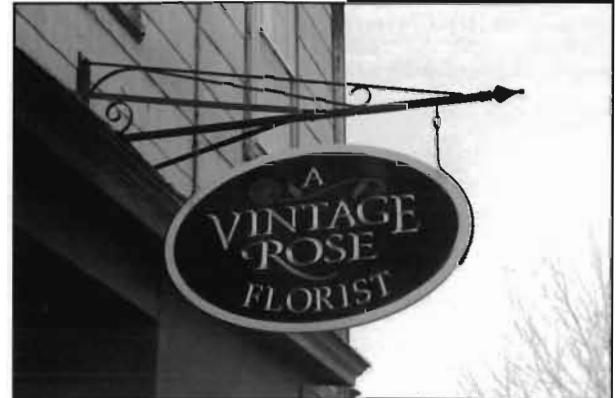
This well-proportioned, modern sign at 46 Hampshire Street (Methuen Company Store; ca. 1860) is simple and attractive, with classical lettering and a decorative metal support. It is appropriately mounted over the storefront windows.

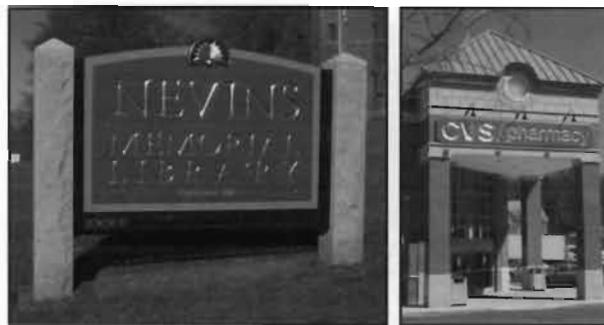
(left) The design and materials of the new, free-standing sign for the Nevins Memorial Library (305 Broadway) harmonize with the setting and design of the historic building.

(right) The sign on the new CVS store on Broadway is appropriately located in the traditional sign band location and constructed of wood, with carved letters, subdued colors, and simple down-lighting.

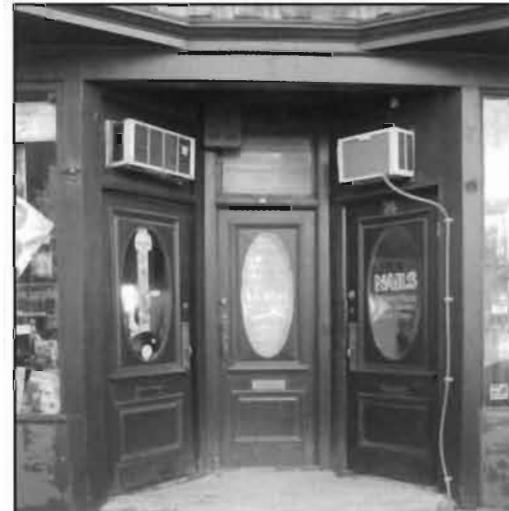
The recessed entrance to 20-24 Hampshire Street (1915) retains its original three-part configuration, wood doors, and transom openings. Any future renovations to the flanking storefronts or upper floor should capitalize on these distinctive features.

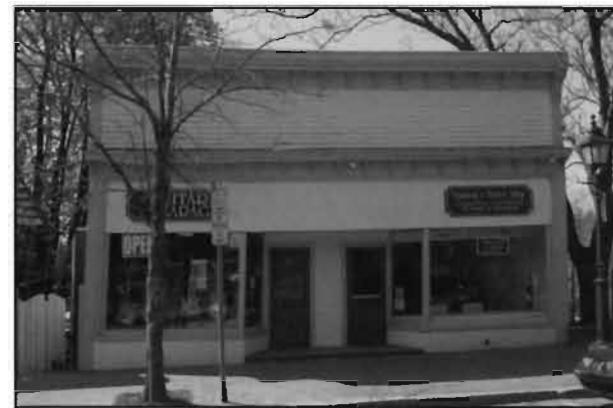
One of the best preserved facades on Hampshire Street, this small storefront at 4-6 Hampshire Street retains historic materials and the traditional composition of a recessed center entrance with flanking display windows.

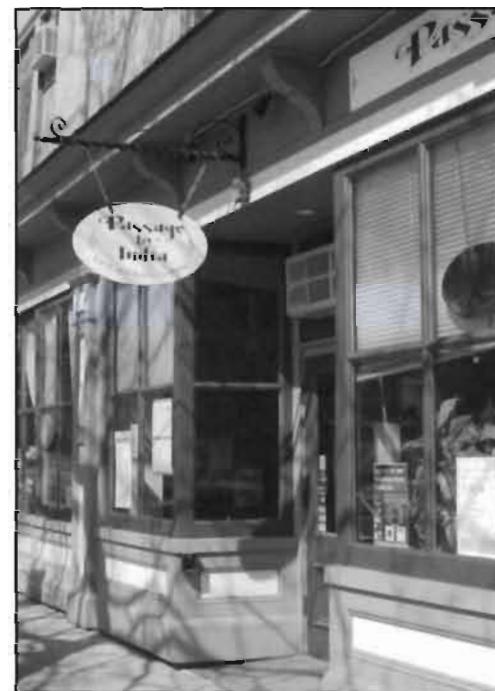
This recent but historically appropriate storefront in Salem, Mass. features wood base panels, large storefront windows, recessed entrances, and a sign band with a bracketed cornice.

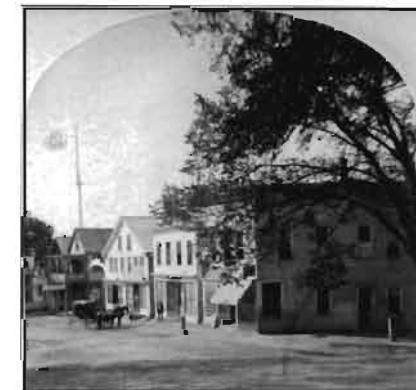
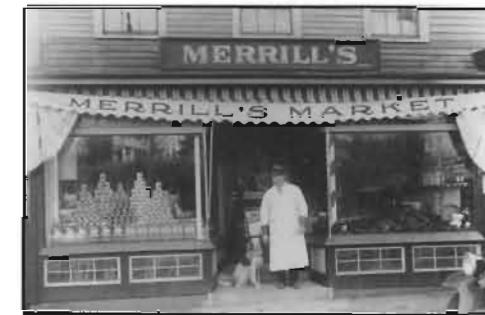
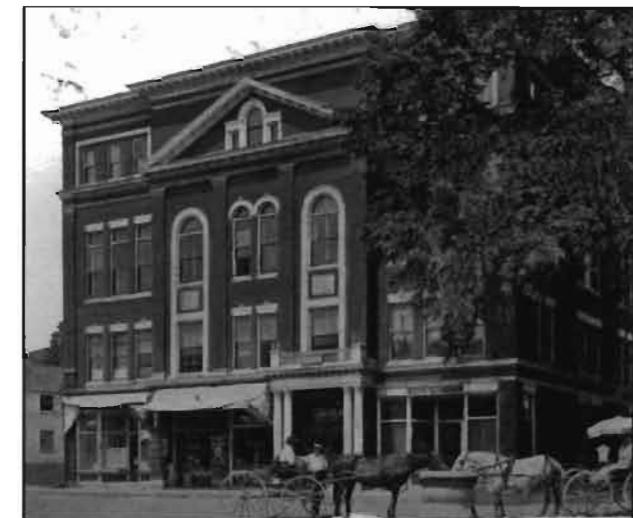
These historic images of Methuen in the 19th and early 20th century illustrate typical storefront designs that provide human scale and texture, encourage pedestrian activity, and are still appropriate today.

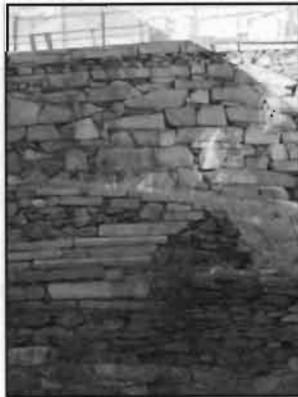
(left) Largely hidden from public view, this dry-laid retaining wall between Hampshire and Osgood streets displays beautiful stonework in an informal variety of patterns.

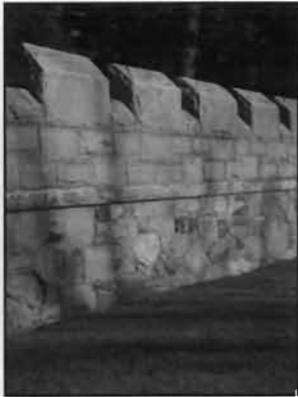
(right) The very formal granite walls around the Searles estate feature variegated bands of masonry and a crenellated top that produce an interesting texture and a rhythmic play of light and shadow.

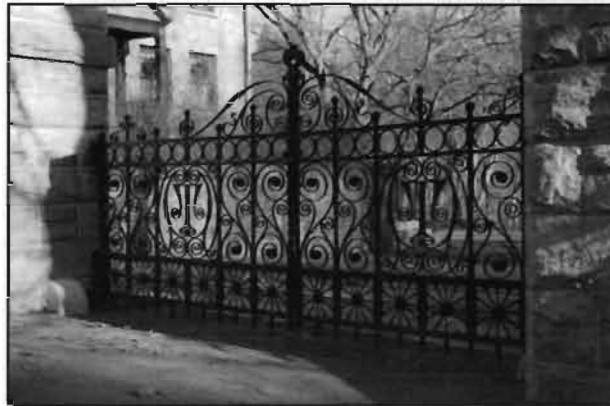
The ornate scrollwork on the fence to the Tenney estate (Greycourt; 1890; 37 Pleasant St.) is a delicate contrast to the flanking granite block walls.

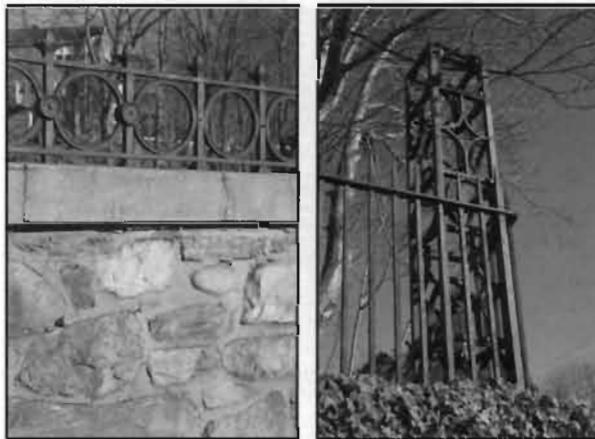
(left) The decorative metal railing that surmounts this stone wall on Osgood Street provides a light, screen-like touch at the top edge.

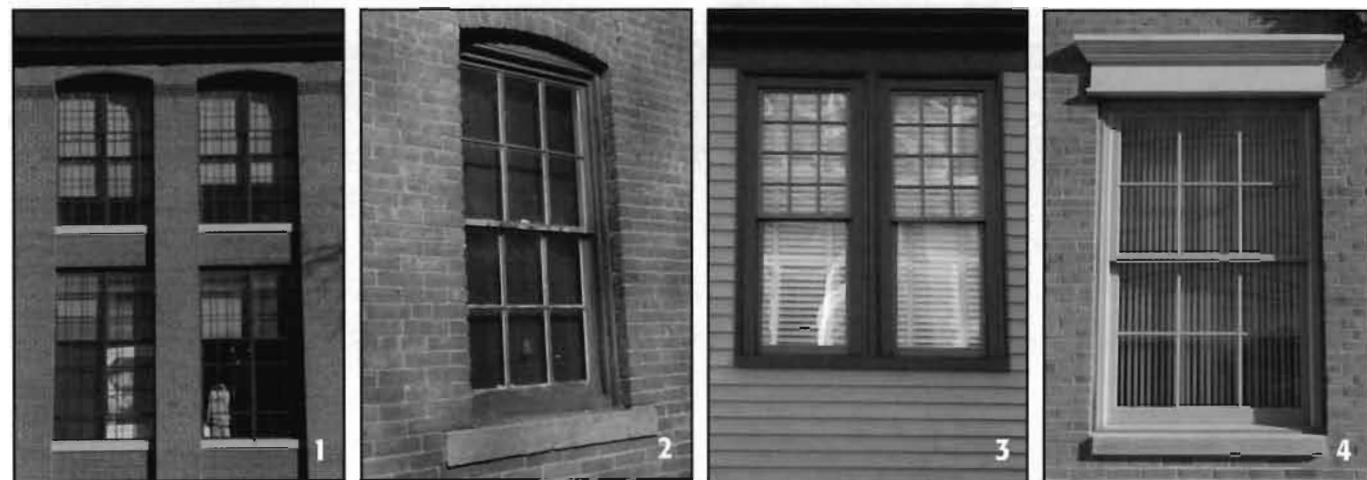
1. The rehabilitation of the Selden Worsted Mills Building (1919; 225 Broadway) involved the reproduction of multi-paned wood window sash that bring warmth, depth, and scale to the façade.

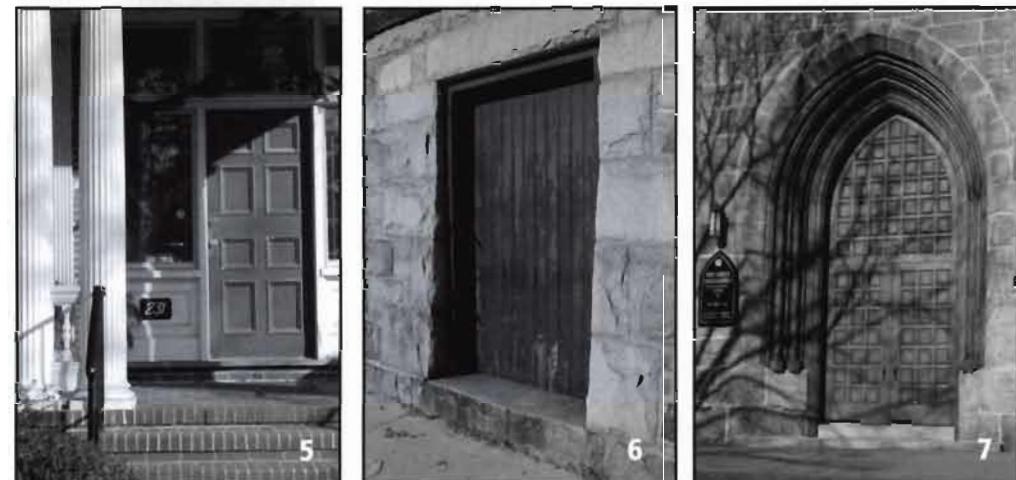
5. The eight-panel wood door on St. Monica's Rectory (1922; 231 Broadway) is an integral part of an elaborate composition featuring leaded-glass sidelights and transom, and a columned porch.
