# INDOOR AIR QUALITY ASSESSMENT

**Timony Grammar School**  
45 Pleasant View Street  
Methuen, MA  
April 2025

Prepared by:  
Massachusetts Department of Public Health  
Bureau of Climate and Environmental Health  
Division of Environmental Health Regulations and Standards

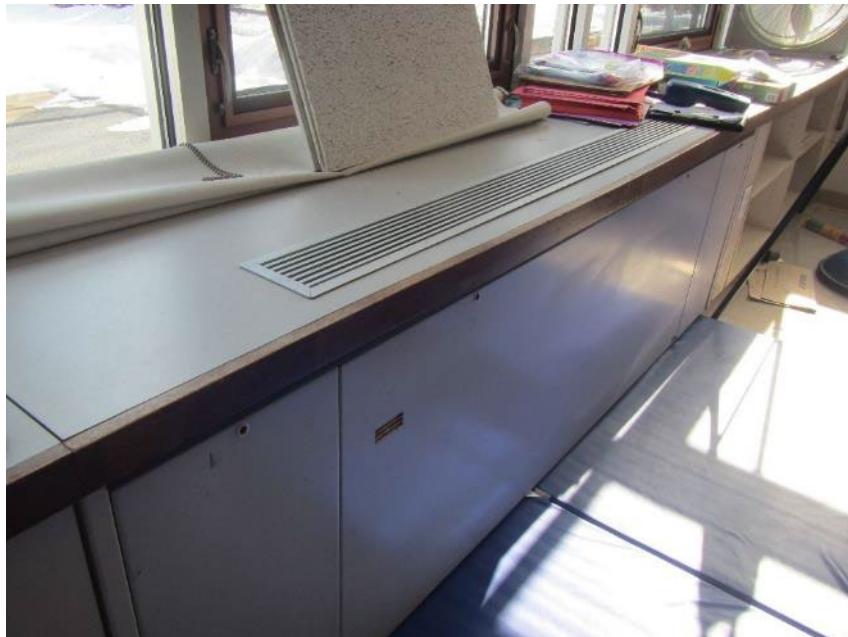
Picture 1

Classroom unit ventilator (univent)

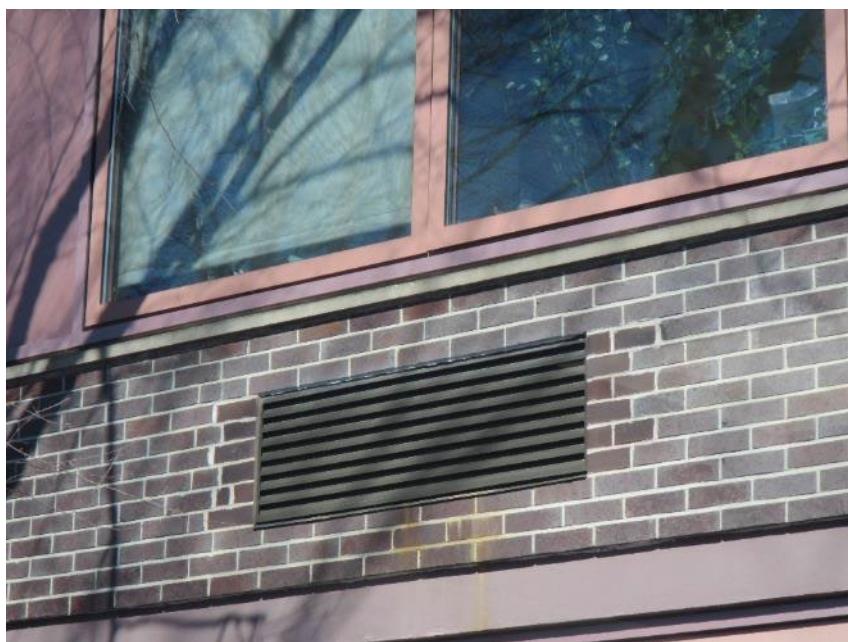
Picture 2

Univent vent on the outside of the building

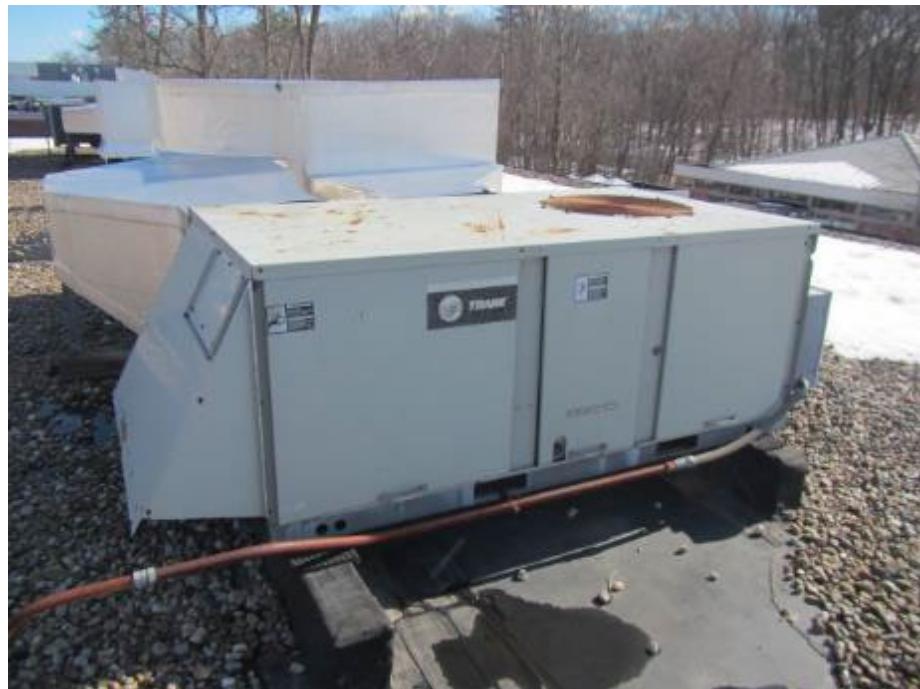
Picture 3

Air handing unit on the roof

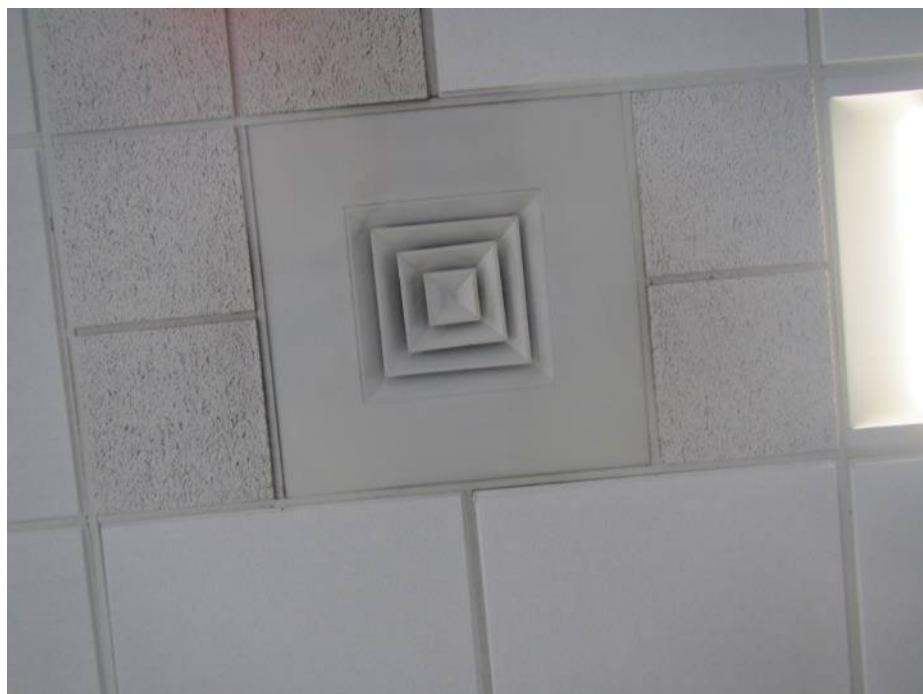
Picture 4

Typical supply vent

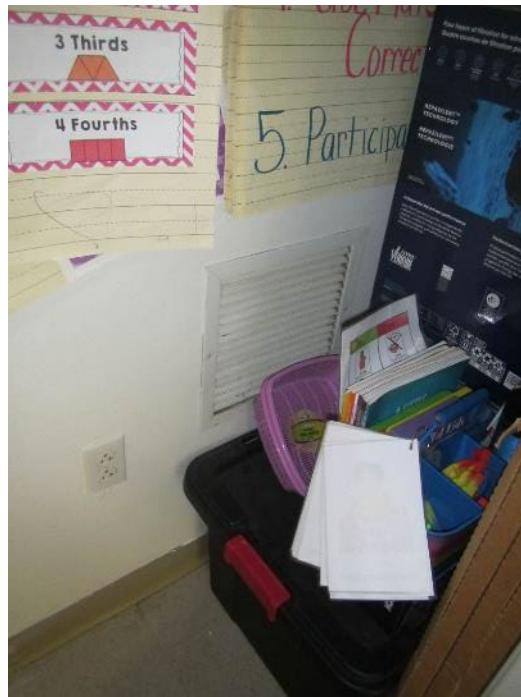
Picture 5

Typical classroom exhaust vent

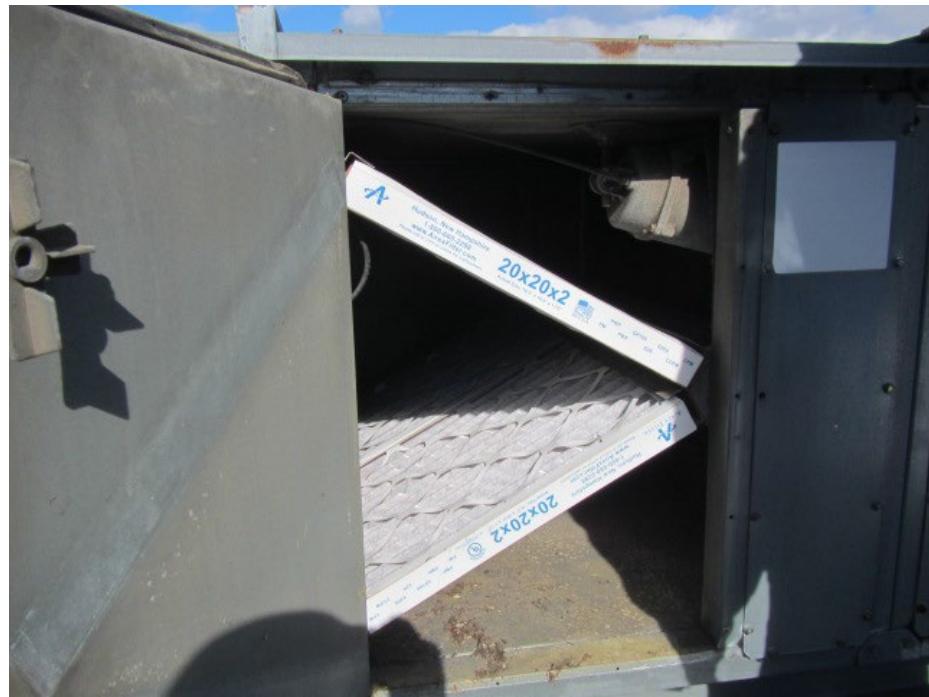
Picture 7

- It was reported that MERV 13 filters (Picture 7) are used in roof-mounted AHUs and replaced quarterly. MDPH recommends that filters be changed two to four times a year or as per the manufacturers' recommendations.

MERV 13 filter in rooftop AHU

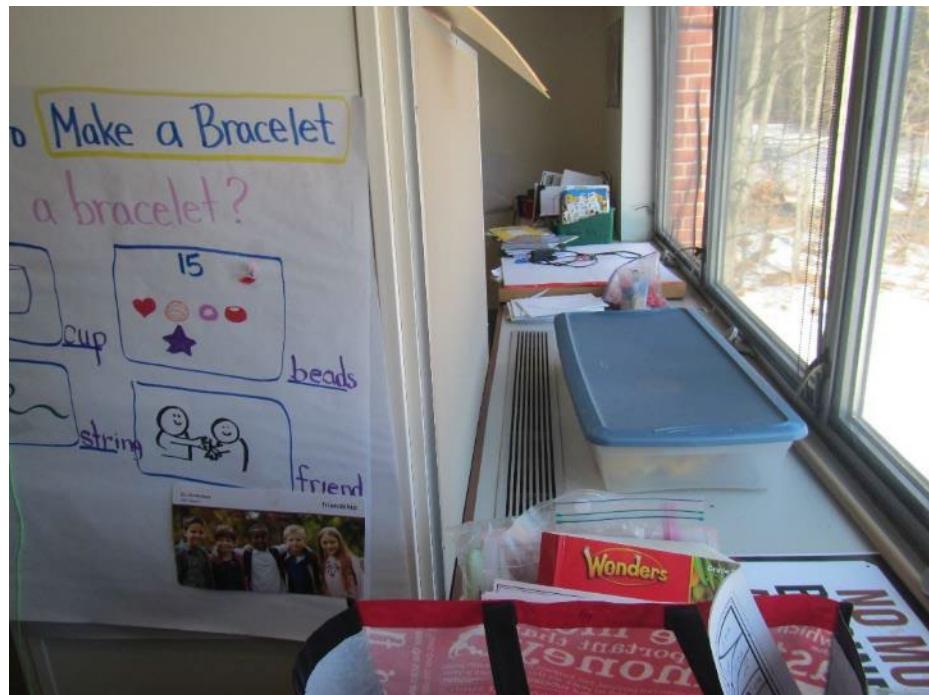
Picture 8

Univent (on the right side of picture) blocked by furniture

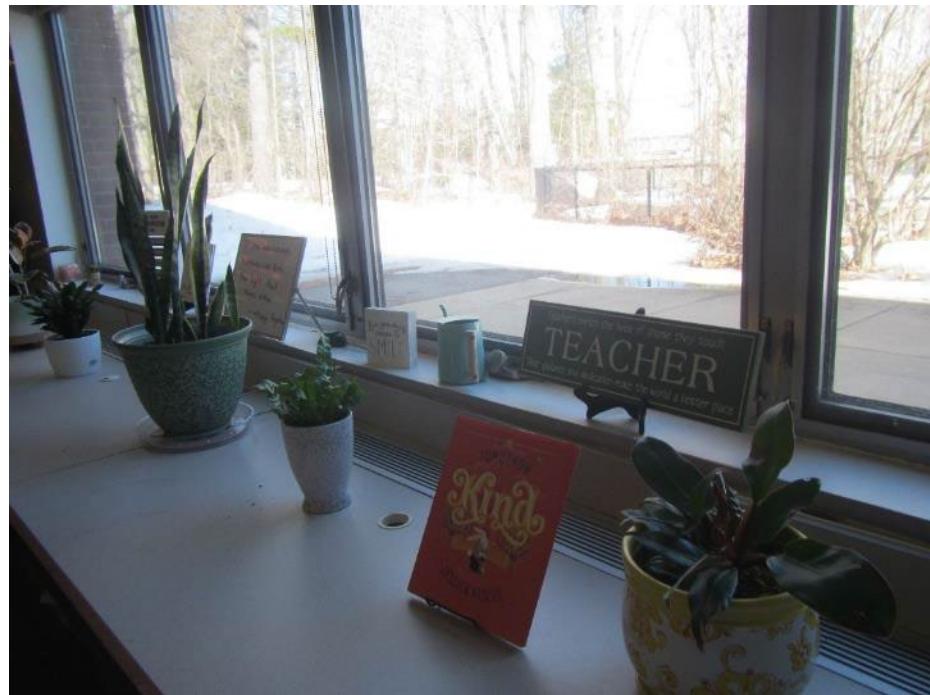
Picture 9

- Some sinks also could not be turned off completely (Table 1) which adds moisture to the environment. Plumbing leaks should be repaired.
- Plants were found in some classrooms and offices (Picture 9; Table 1). Plants should not be placed on ventilation equipment, should be well-maintained, and placed on non-porous drip pans that are cleaned frequently.

Plants on a univent

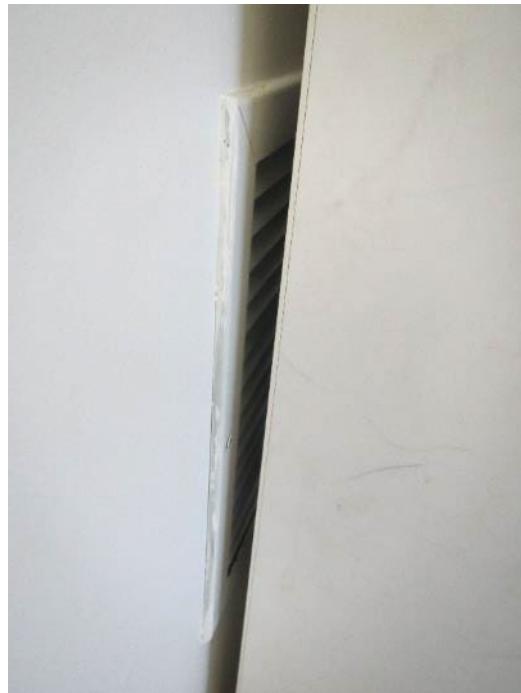
Picture 10

- Many wall-mounted exhaust vents were blocked by furniture or items, often a white storage cabinet found in most classrooms (Picture 10). Blocked exhaust vents do not function well to remove stale air.

Exhaust vent blocked by a cabinet

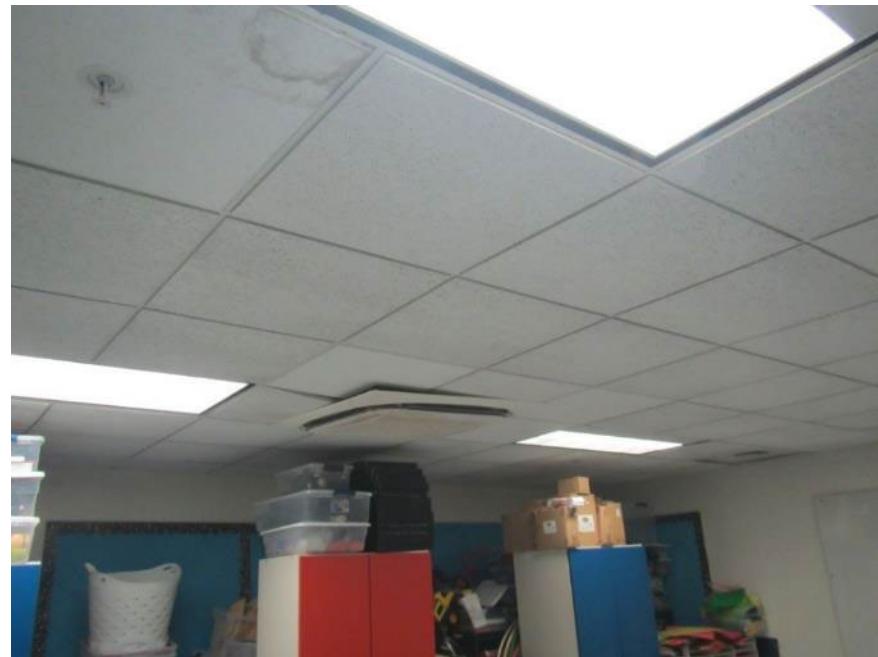
Picture 11

items piled near ceiling and supply vent

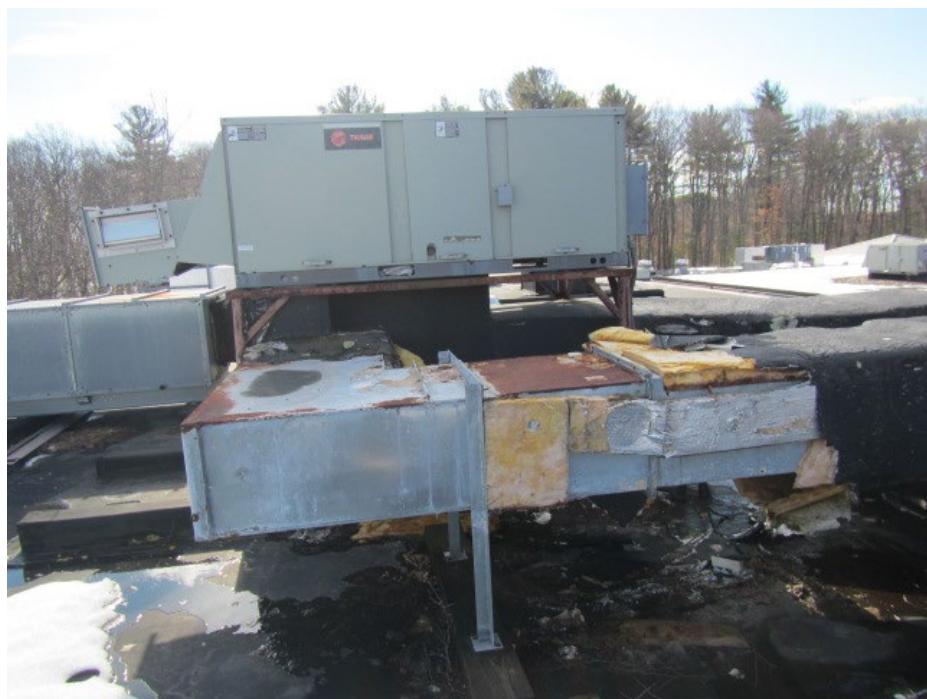
Picture 12

- Conditions were found that would compromise the function of the rooftop AHUs. The equipment was showing signs of age including rust and ductwork falling away from the main units (Picture 12).
- Newer insulation had been added to the units, but it had holes and gaps. This appears to be damage done by animals.

Damaged ductwork for rooftop AHU

7.	During filter changes, clean dust and debris from the inside of univent and HVAC system cabinets.	
8.	Repair damage to rooftop AHU ducts and insulation.

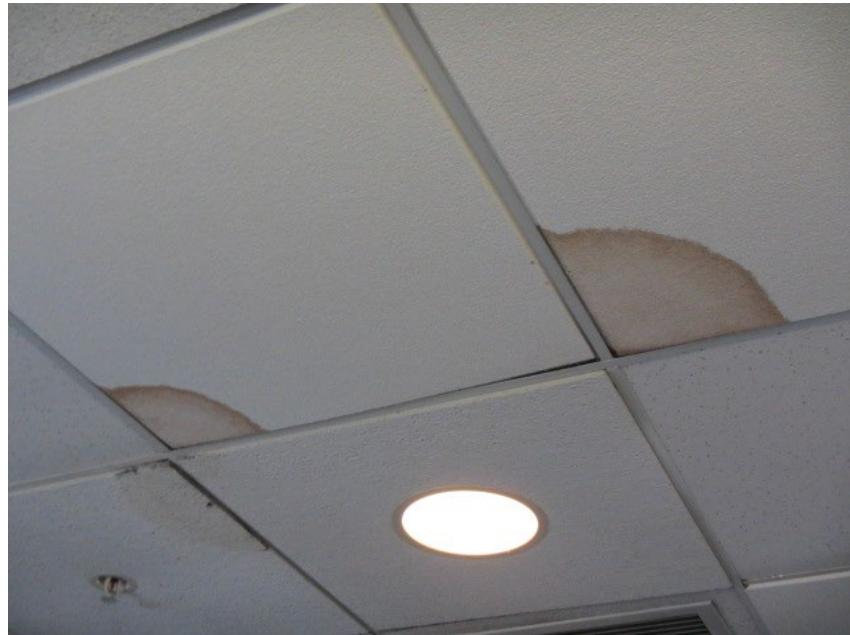
Picture 13

- **Water-damaged ceiling tiles were found in some locations (Pictures 13 and 14; Table 1),** which can indicate current/historic roof/plumbing leaks or other water infiltration. Water-damaged ceiling tiles can provide a source of mold and should be replaced after a water leak is discovered and repaired.

Water-damaged ceiling tiles

13.	Ensure any roof and plumbing leaks are repaired promptly and replace any remaining water-damaged suspended ceiling tiles or other porous building materials.

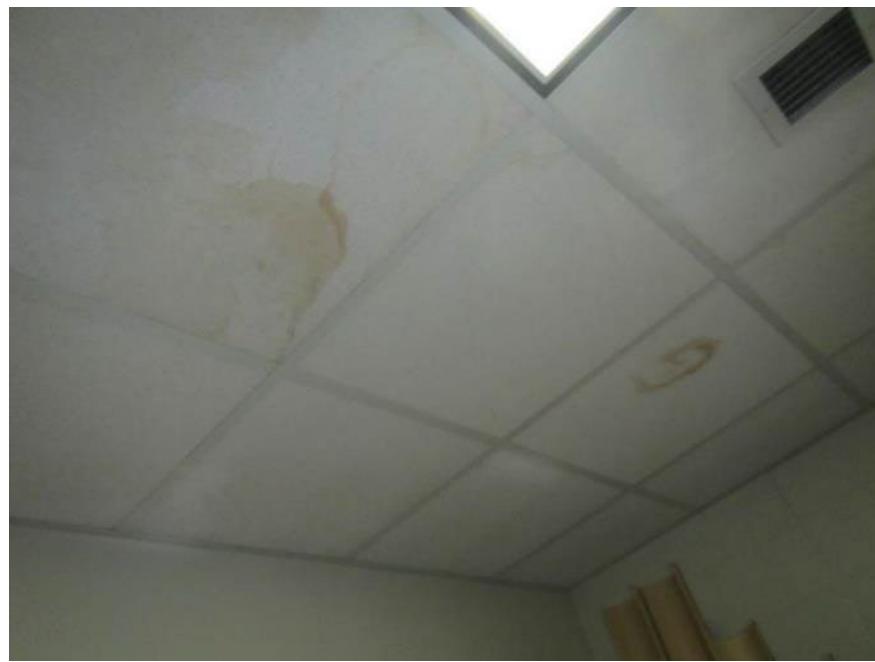
Picture 14

Water-damaged ceiling tiles

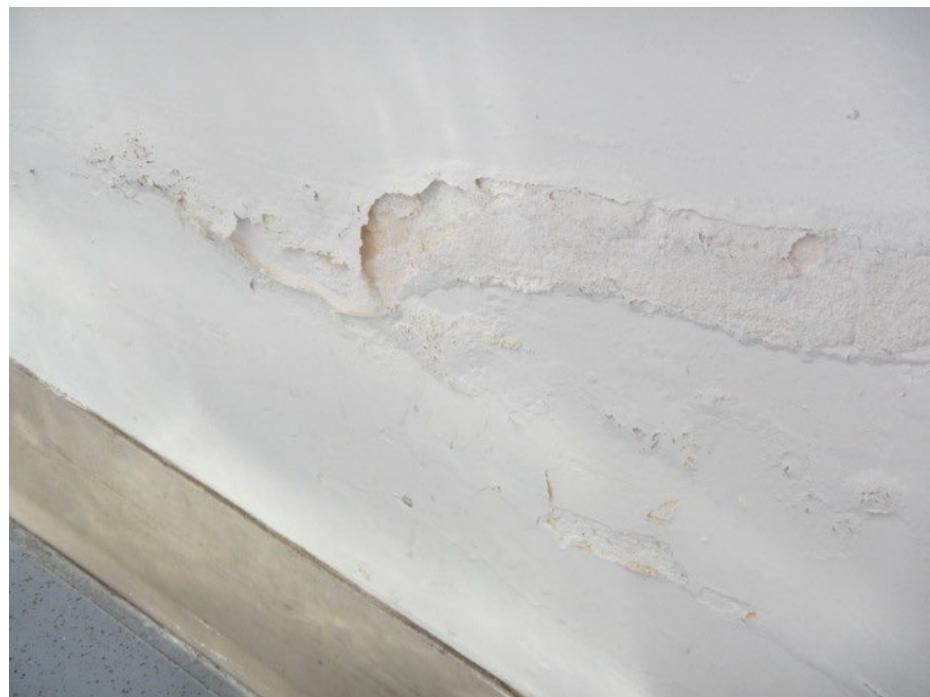
Picture 15

- Water-damaged plaster/efflorescence was noted (Picture 15), and other water stains on building materials (Picture 16).
- Active leaks were noted in a few rooms (Table 1) and buckets were being used to catch water. Active leaks should be repaired as soon as possible to avoid ongoing water damage as well as slipping hazards.

Water-damaged plaster

14.	Clean and patch water-damaged plaster to remove efflorescence.	
15.	Continue to monitor areas of active leaks until repairs to building envelope are complete. Any buckets or hoses used to capture water should be emptied and cleaned at least daily to prevent odors.

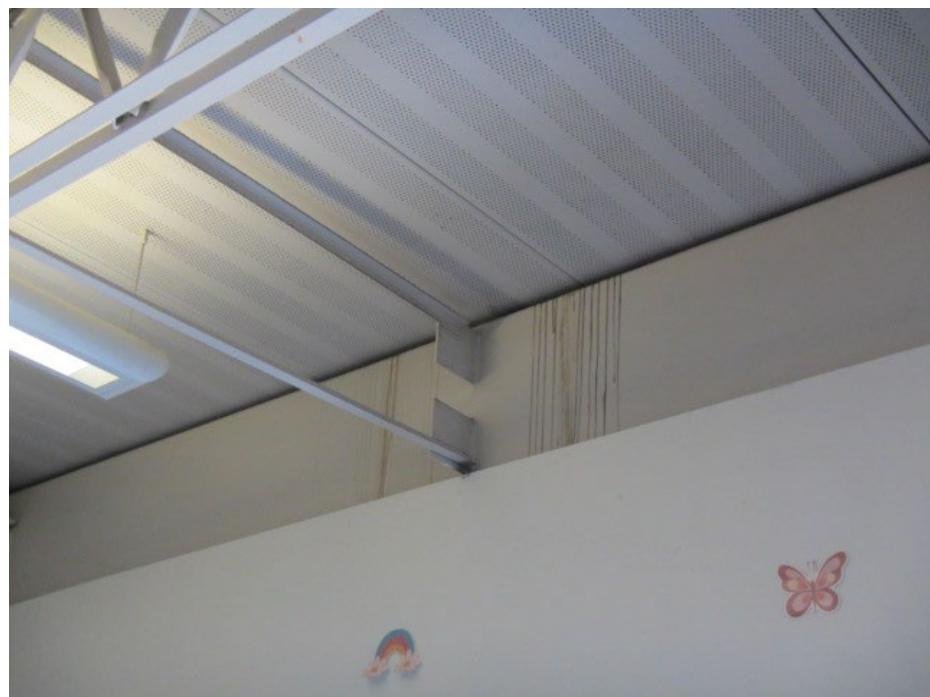
Picture 16

Staining from roof leak on wall in room 203

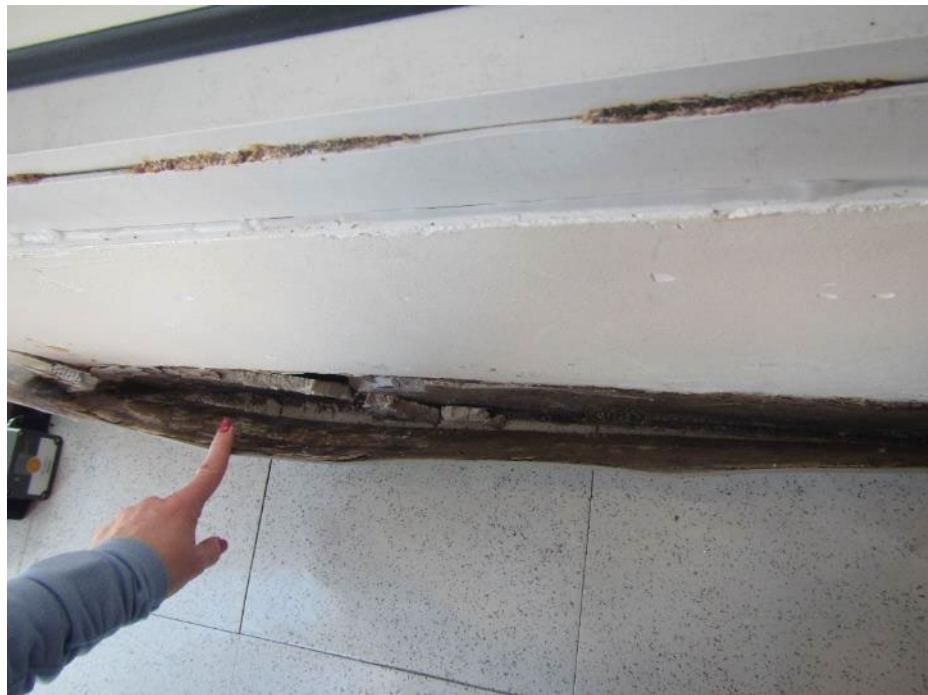
Picture 17

- On the ground floor, evidence of water damage in areas close to classroom exterior doors was noted. Various water-damaged materials were found including walls, coving, cabinets, and ceilings (Pictures 17 and 18). While majority of the materials found around the exterior doors were mostly non-porous and not conducive to mold growth (e.g., concrete and tile), this area should be kept clean of dust and debris (which can grow mold) and should be monitored after heavy rains to ensure prompt clean up and drying, and avoid moisture spreading to other areas with porous building materials, which may be conducive to mold growth.

Water-damaged wall on the lower level

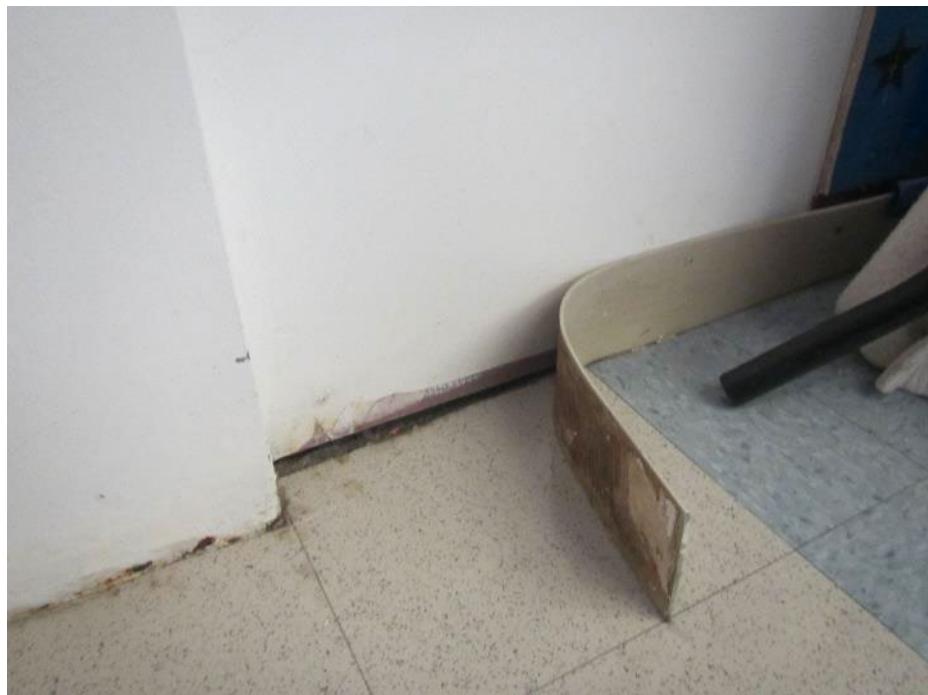
Picture 18

Water-damaged wall and loose coving on the lower level

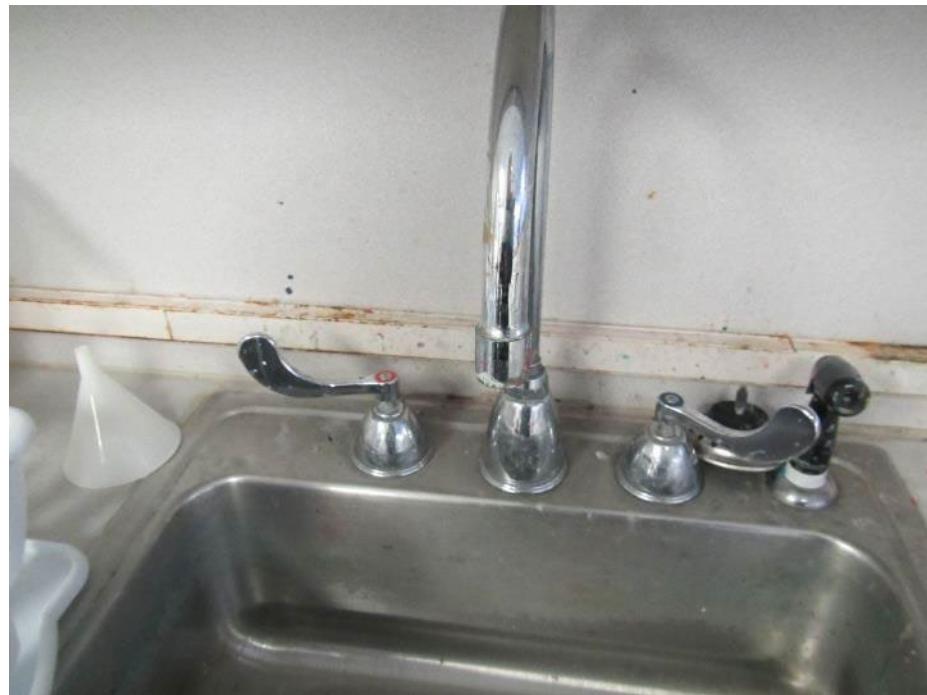
Picture 19

- Many classrooms had sinks. Damaged backsplashes were observed in some sinks (Picture 19). If a backsplash is damaged, it becomes very difficult to keep clean, and can lead to additional damage to the material underneath.

Water-damaged backsplash on a classroom sink

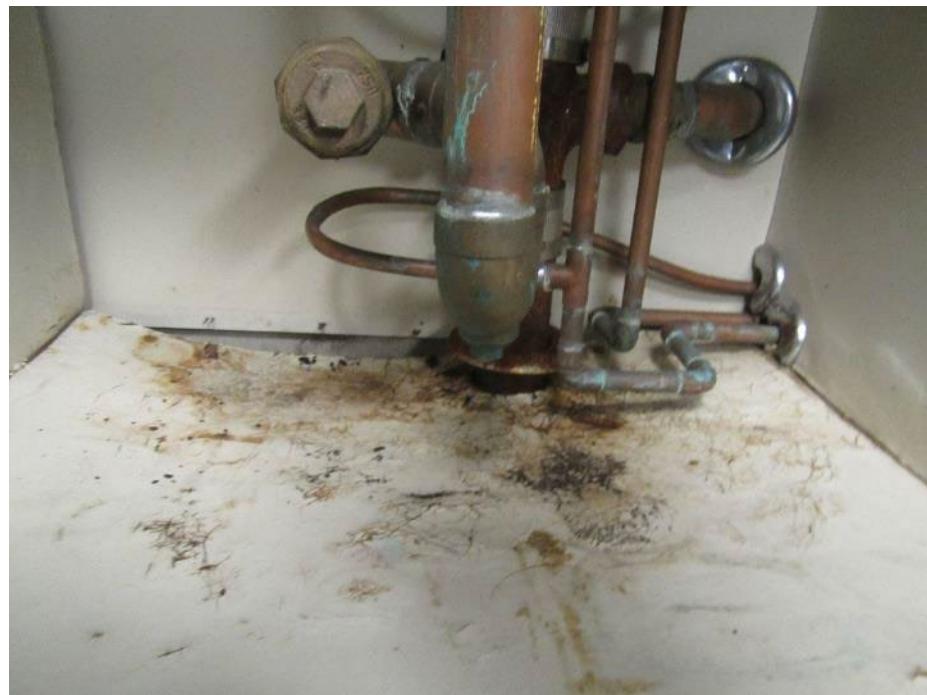
Picture 20

- Cabinets for classroom sinks were often in poor condition. Water damaged building material was found underneath many of them (Picture 20). Many doors on sink cabinets could not be opened and closed properly. Uneven surfaces cannot be adequately cleaned, and any breaches can serve as pathways for pests and rodents into occupied areas.

Water-damaged, rusted, and bent material underneath a classroom sink

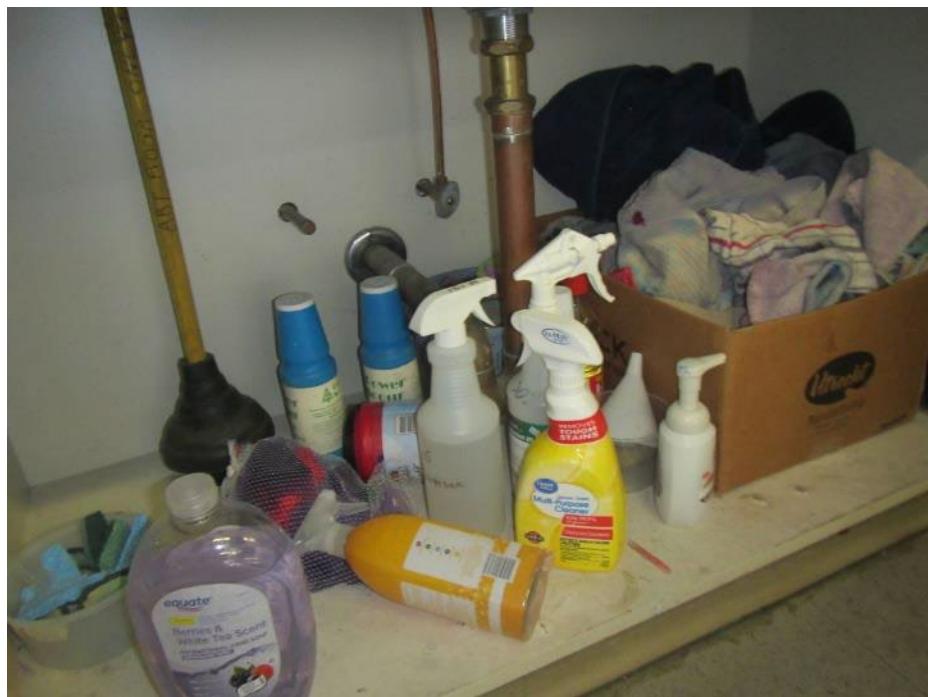
Picture 21

- In addition to water-damaged building materials, porous items were found under many sinks (Picture 21). Storing items in a moist environment can create conditions conducive to mold growth. An excess of items can also prevent leak detection and allow rodents a place to hide.

- **Cleaning products, including unlabeled bottles or bottles where the labels had worn off were found in many classrooms, frequently under the sink (Picture 21).** Cleaning products should be kept out of the reach of children. All products used in the school should have Safety Data Sheets (SDS) available in case of spills or misuse. All bottles should be properly labeled as to contents.

Items, including porous items, cleaning products, and unlabeled bottles under a classroom sink

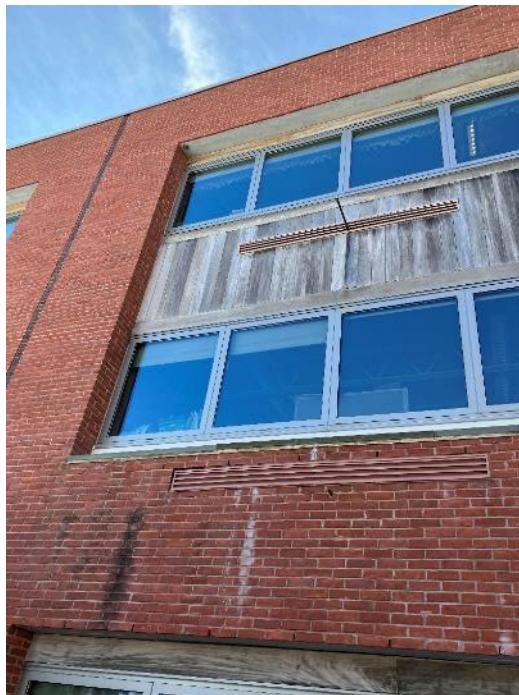
Picture 23

- While most of the brickwork was in good condition, some was water-stained or damaged (Picture 23).
- As a part of the rodent exclusion efforts for Methuen schools, **heavy-duty metal door sweeps were added to exterior doors in this building**. No light was visible beneath them. Good door-sweeps/weatherstripping can not only exclude pests but can keep unconditioned outside air and moisture from entering the building.

Water damage and stains on brickwork

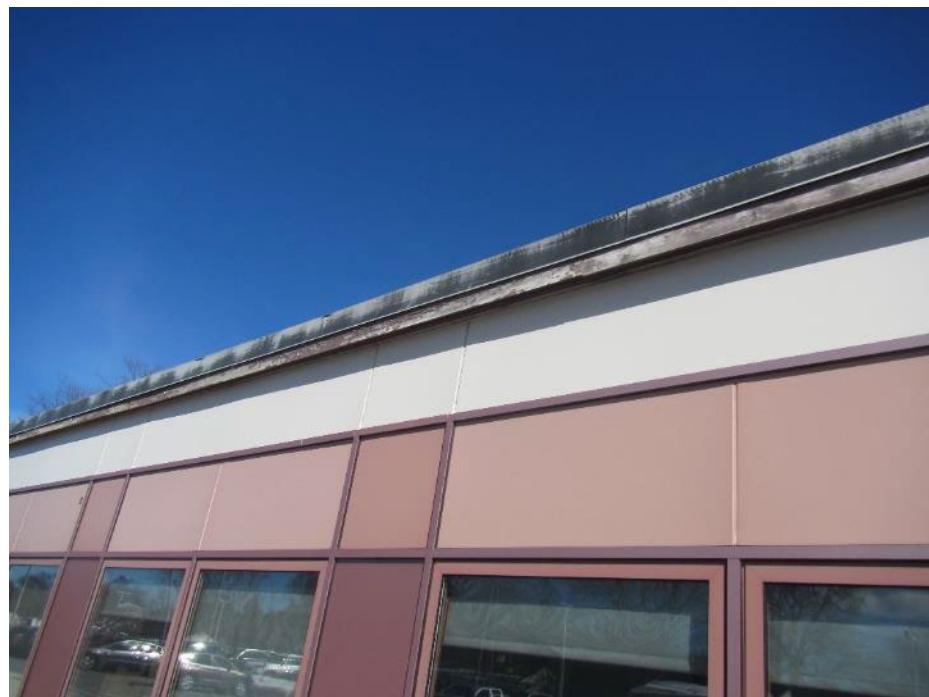
Picture 24

- **Damaged wood and delaminating paint/stain were found along the roof eaves and trim around windows (Picture 24)**, which can accelerate water damage and rot allowing a pathway for drafts, moisture, and pest entry into the building.

Damaged wooden trim and eaves at the top of the building edge

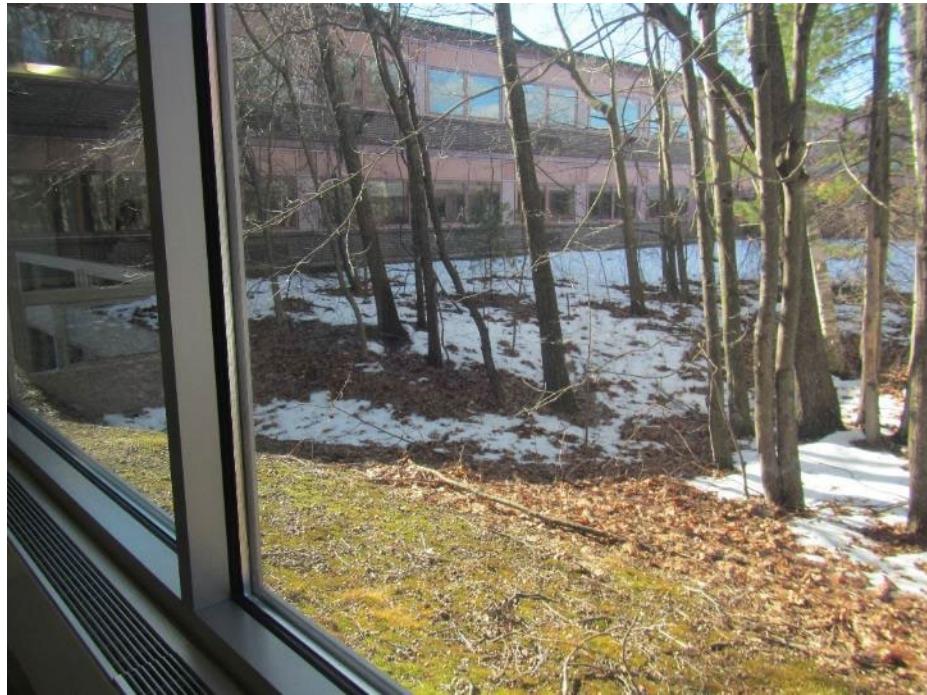
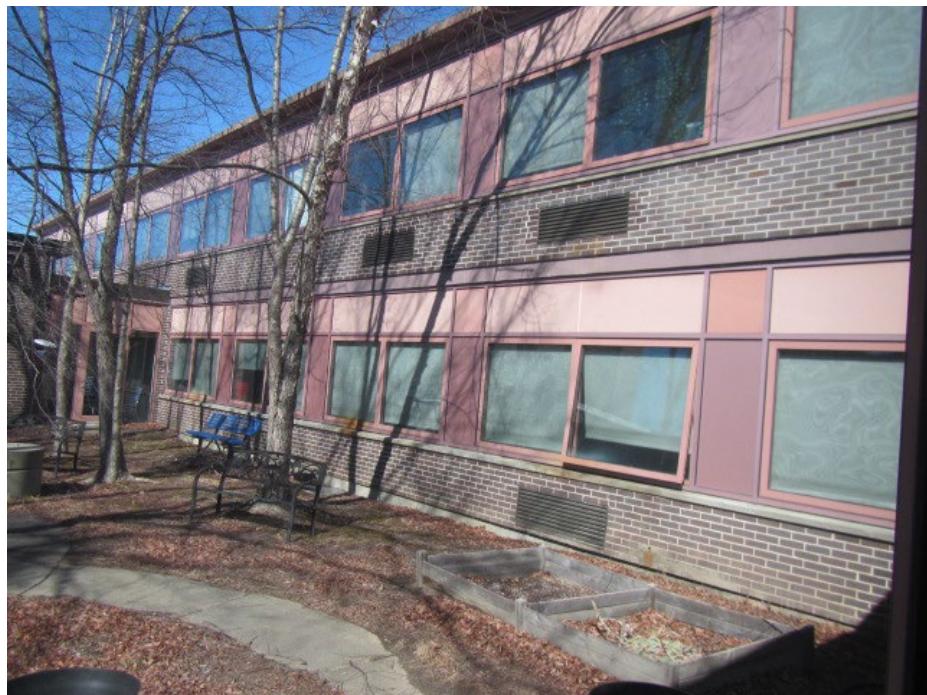
Picture 25

- **Large trees were noted in the courtyard of the building and near the exterior (Picture 25 and 26)**. **Ivy was noted growing on the building in one area**. Plants near or on the building can cause water damage to brickwork and mortar. In addition, plants shading exterior walls can slow drying. Water can eventually penetrate the brick, subsequently freezing and thawing during the winter. This freezing/thawing action can weaken and damage bricks and mortar.

Large trees in the courtyard

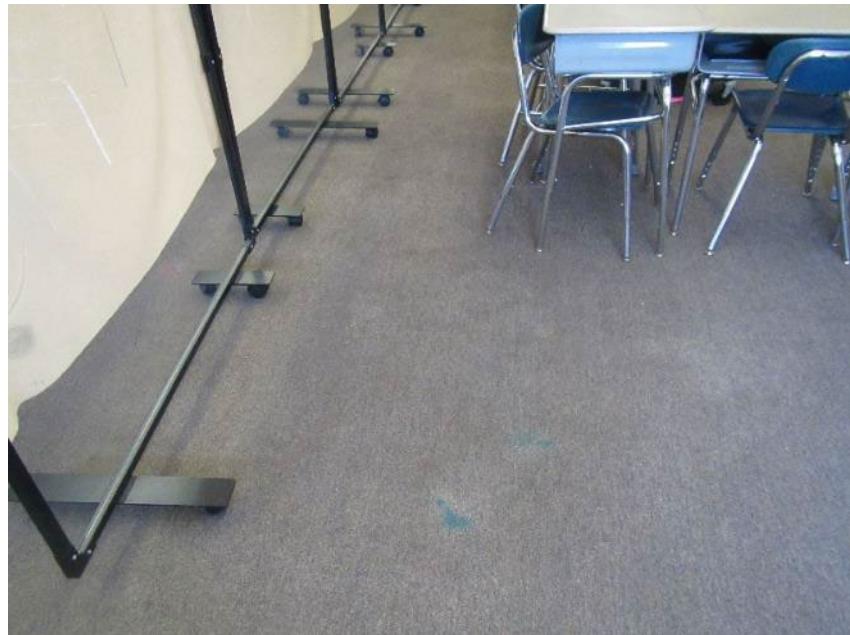
Picture 27

- Reporting pest sightings or new gaps in the building envelope to facility management.
- **Some areas are covered with wall-to-wall carpet that is soiled/stained and past its service life (Picture 27).** Carpeting has a service life of approximately 10-11 years (IICRC, 2002). Carpeting that is beyond its service life becomes increasingly difficult to clean and may release fibers which can be irritating if airborne. Carpets should be vacuumed regularly with a high efficiency particulate arrestance (HEPA) filter equipped vacuum cleaner and cleaned annually (or semi-annually in soiled/high traffic areas) in accordance with Institute of Inspection, Cleaning and Restoration Certification (IICRC) recommendations (IICRC, 2012).

Threadbare, worn carpet

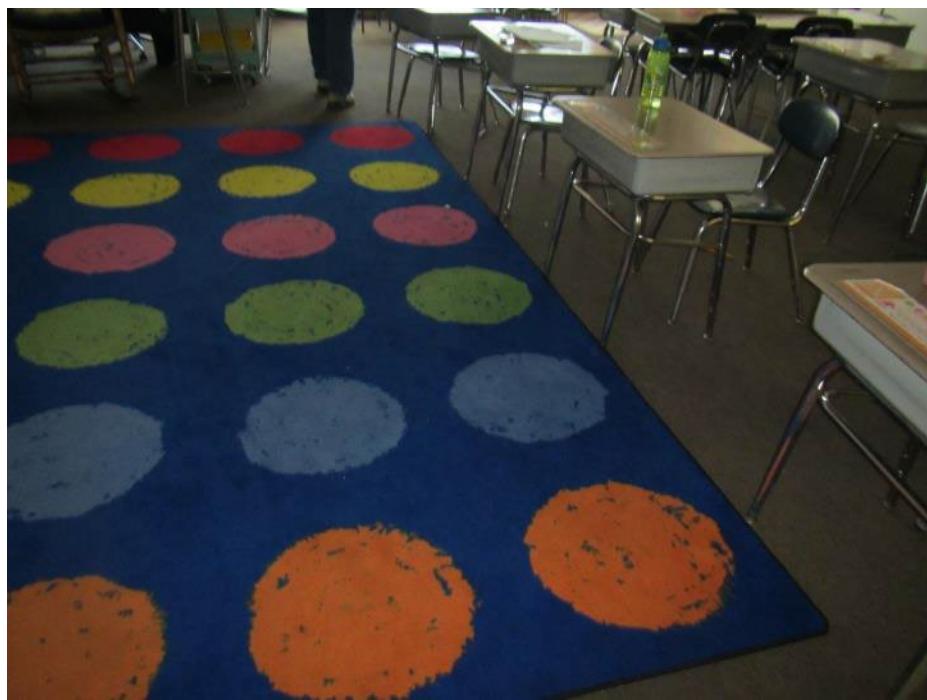
Picture 28

- **Area rugs and plush items were also noted in some classrooms (Picture 28; Table 8).** These need to be cleaned regularly to remove dust and debris. Area rugs should be stored rolled up off the floor in a dry area during the summer. Used area rugs and plush items should not be brought into schools to prevent transferring allergens such as pet hair.

Area rug in a classroom

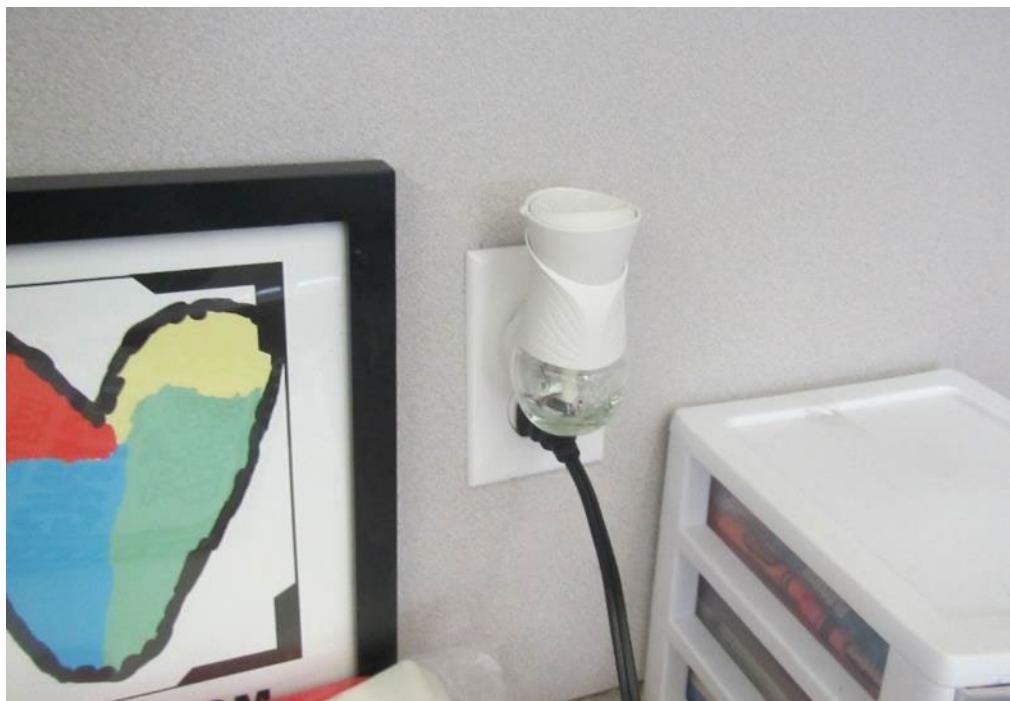
Picture 29

- **Plug-ins and other air fresheners were noted in classrooms (Picture 29; Table 1).** **Exposure to low levels of total volatile organic compounds (TVOCs)** may produce eye, nose, throat, and/or respiratory irritation in some sensitive individuals. MDPH staff examined rooms for products containing VOCs and noted hand sanitizers, air fresheners, cleaners, and dry erase materials in use within the building (Picture 32). These products have the potential to be irritants to the eyes, nose, throat, and

Plug-in air freshener

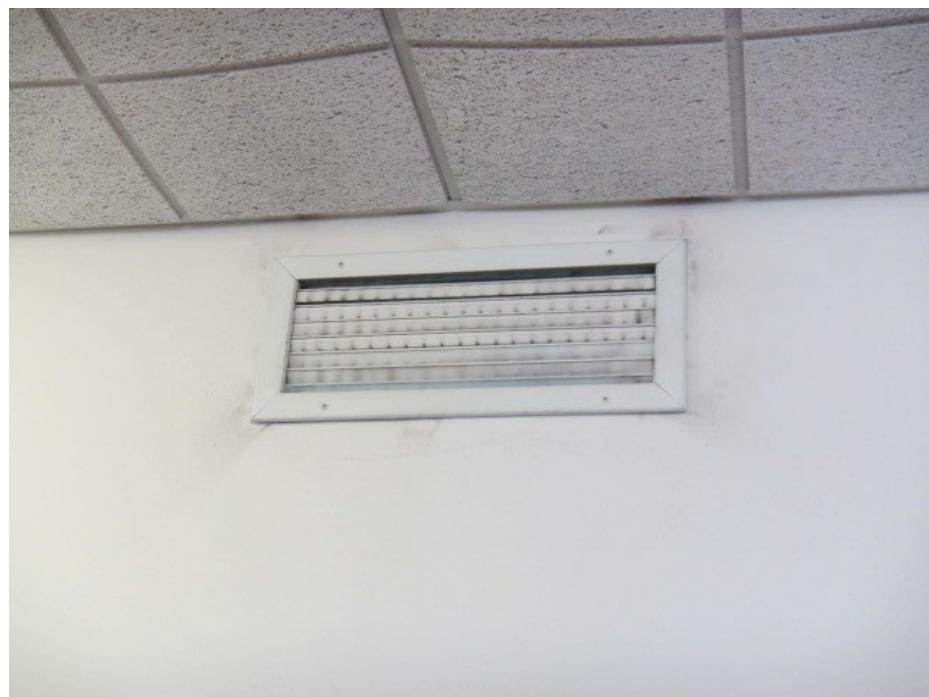
Picture 30

- **Supply, exhaust, return vents and surrounding ceiling tiles had accumulations of dust and debris (Pictures 30 and 31; Table 1).** This dust/debris can be aerosolized under certain conditions, and should be cleaned periodically (e.g., during regular filter changes). It is important to note that the location of these tiles *directly in the airstream* of mechanical ventilation makes them more susceptible to collecting dust due to constant airflow over the surface of the tile. If these tiles cannot be adequately cleaned, they should be replaced.

Dusty exhaust vent

11.	Clean dust and debris from vents and surrounding ceiling tiles periodically. If ceiling tiles cannot be adequately cleaned, replace.

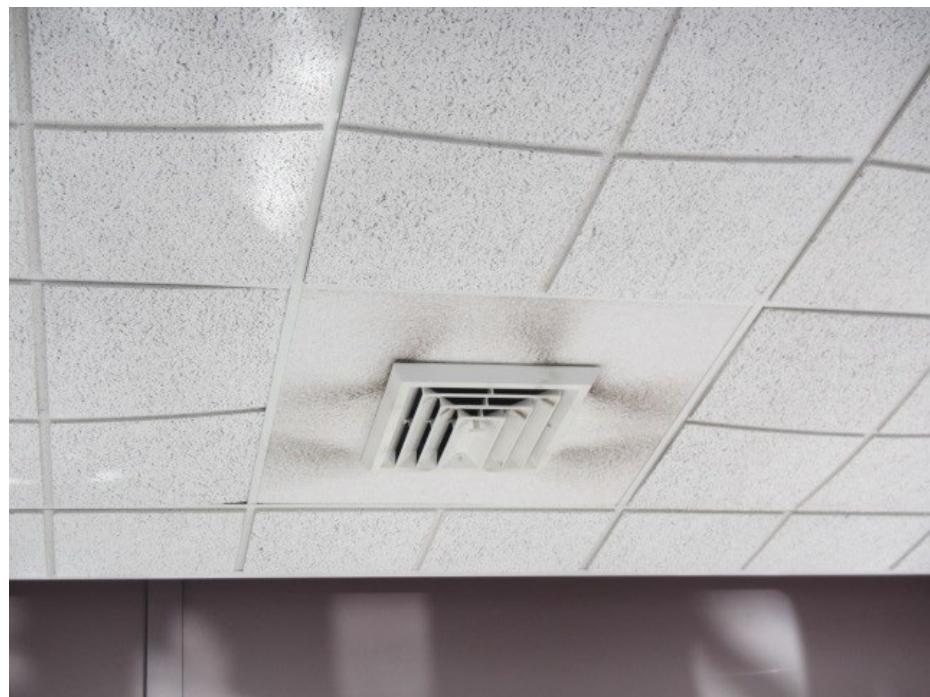
Picture 31

Dusty vent with dusty tiles
