December 5, 2024

Re: Forest Lake, Methuen, MA – 2024 Year End Report – DEP #219-1145

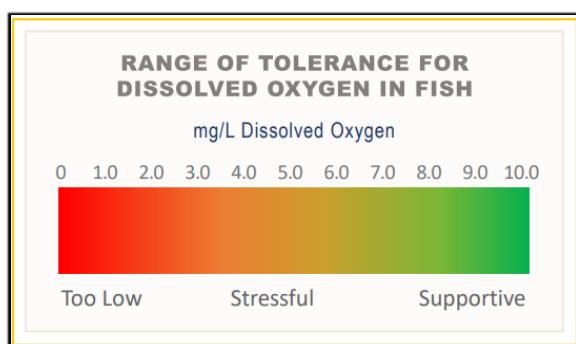
Figure 2: Dissolved oxygen table

general range of fish tolerance (Source: epa.gov). Dissolved oxygen can be affected by many outside factors, such as: temperature, time of day, and pollution. Dissolved oxygen levels are typically lowest early in the morning. Healthy water should generally have concentrations of about 6.5-8+ mg/L (table in Figure 2). Water clarity was also assessed using a Secchi disk. A Secchi disk is a disk with alternating black and white quadrants. It is lowered into the water of a pond or lake until it can no longer be seen by the observer. This depth of disappearance, called the Secchi depth, is a measurement of the transparency of the water. All readings are included in the tables throughout this report.

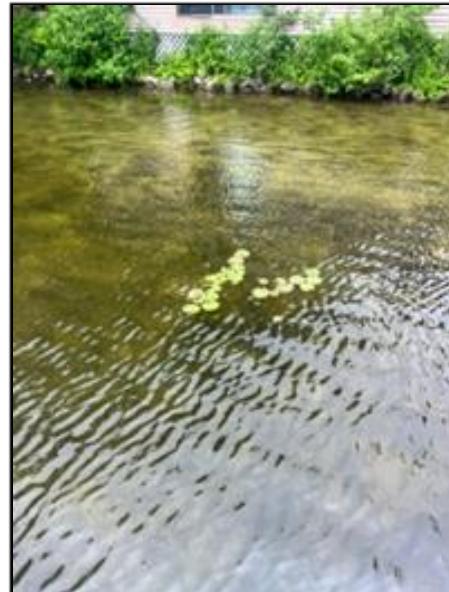
Figure 3: Native waterlilies observed during initial survey

Native species observed include waterlilies (pictured in Figure 3), thin-leaf pondweed (*Potamogeton pusillus*), ribbon-leaf pondweed (*Potamogeton epihydrus*), and cattails (*Typha sp.*). These species were all found in sparse, beneficial densities. Benthic filamentous algae was also observed scattered throughout the lake. Pollen was noted on the surface of the water and within the water column, this should not be confused with microscopic algae.

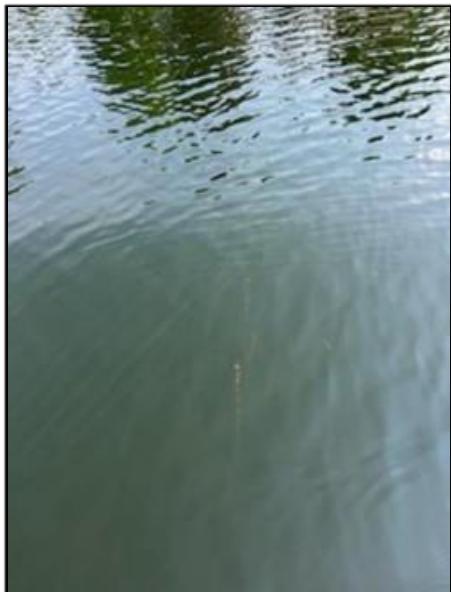
Figure 4: Clasping-leaf pondweed growing in the water column

Observed throughout the lake were varying densities of clasping-leaf pondweed, which is a native species that has the ability to reach nuisance

densities. Clasping-leaf pondweed varied from sparse to dense densities. The moderate to dense densities were noted around the island and through the center of the lake. Many of the patches of clasping-leaf pondweed were at the surface or just below the surface of the water. The water clarity was excellent, making visibility high. Additional areas of moderate-dense clasping-leaf pondweed were documented in the cove areas and by the boat launch. Also found near the boat launch was trace densities of curly-leaf pondweed, which was the only invasive species documented during the survey. This species is a colder-water invasive which dies off naturally as water temperatures increase. The curly-leaf pondweed was only found through rake tosses and appeared unhealthy.

applied to handle nuisance native plants (Figure 4) in addition to brittle naiad. The herbicide was applied using a treatment boat equipped with a calibrated sub-surface injection system. This application methodology allows for even coverage within the treatment areas. Prior to the treatment, the shoreline was posted with neon signage noting the treatment, affiliated water use restrictions, and Water & Wetland contact information. The signs fulfill permit obligations for shoreline posting.

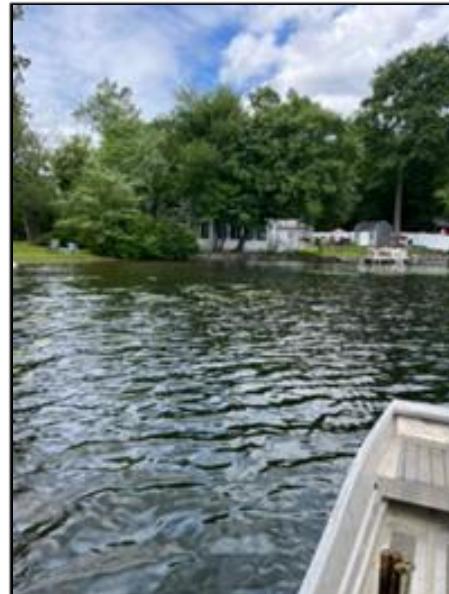
Figure 5: Survey conditions on Forest Lake during August 8th visit

A survey of Forest Lake (Water and Wetland conducting a survey in Figure 5) was conducted to assess the efficacy of the previous treatment, guide future management needs, and map dominant and invasive species. It was quickly apparent that the previous treatment worked extremely well, with all target species (pondweeds and brittle naiad) controlled. Additionally, areas outside of the treatment locations had great control, as well. Waterlilies were scattered around the perimeter of the lake in sparse to moderate densities, but otherwise, minimal vegetation was documented. The water clarity was great, and the lake appeared to be in good condition.

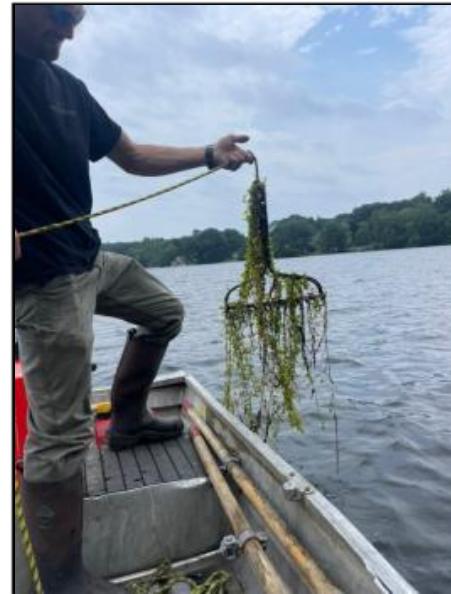
Figure 6: Clasping-Leaf Pondweed documented during the July survey

Similar to previous years, in 2024, the aquatic management program at Forest Lake consisted of a series of surveys, followed by a treatment on an “as necessary” basis. It is important to note that all management is based and driven by survey data only. The 2024 management program featured only two surveys compared to three which usually occurred in the past, a result of shifting the timelines of the survey dates. This is due to the lack of vegetation that was typically present during the early-season survey in previous years. The 2024 aquatic management program featured an herbicide treatment targeted nuisance densities of clasping-leaf pondweed (Figure 6) and invasive brittle naiad (spiny naiad). The waterlily population still appeared to be under control as a result of the 2022 waterlily treatment. It is important and beneficial to have native species, such as waterlilies, within the waterbody as these species provide habitat, improve water quality by filtering nutrients, stabilize shorelines, help promote oxygen levels, etc. – which all lead to a healthy, balanced ecosystem.

We recommend continued monitoring of the lake with the series of two surveys. The monitoring would include documenting species presence/densities of clasping-leaf pondweed, waterlilies, spiny naiad, and curly-leaf pondweed, in addition to the overall water quality. If densities do reach nuisance levels, then management will be recommended. Consideration should be given to continuing control of curly-leaf pondweed and brittle naiad, the two invasive species in Forest Lake. Clasping-leaf pondweed, although native, has also reached nuisance densities historically. The clasping-leaf pondweed populations did meet nuisance densities this year and warranted an application. Both Sonar and diquat have been used at Forest Lake in the past. Generally, based on the target species in Forest Lake, Sonar will not provide much carry-over control. It is also tremendously more expensive than diquat. Given all of the above, diquat is the recommended approach if densities warrant treatment in 2025. All treatments should be based on the monitoring visits.

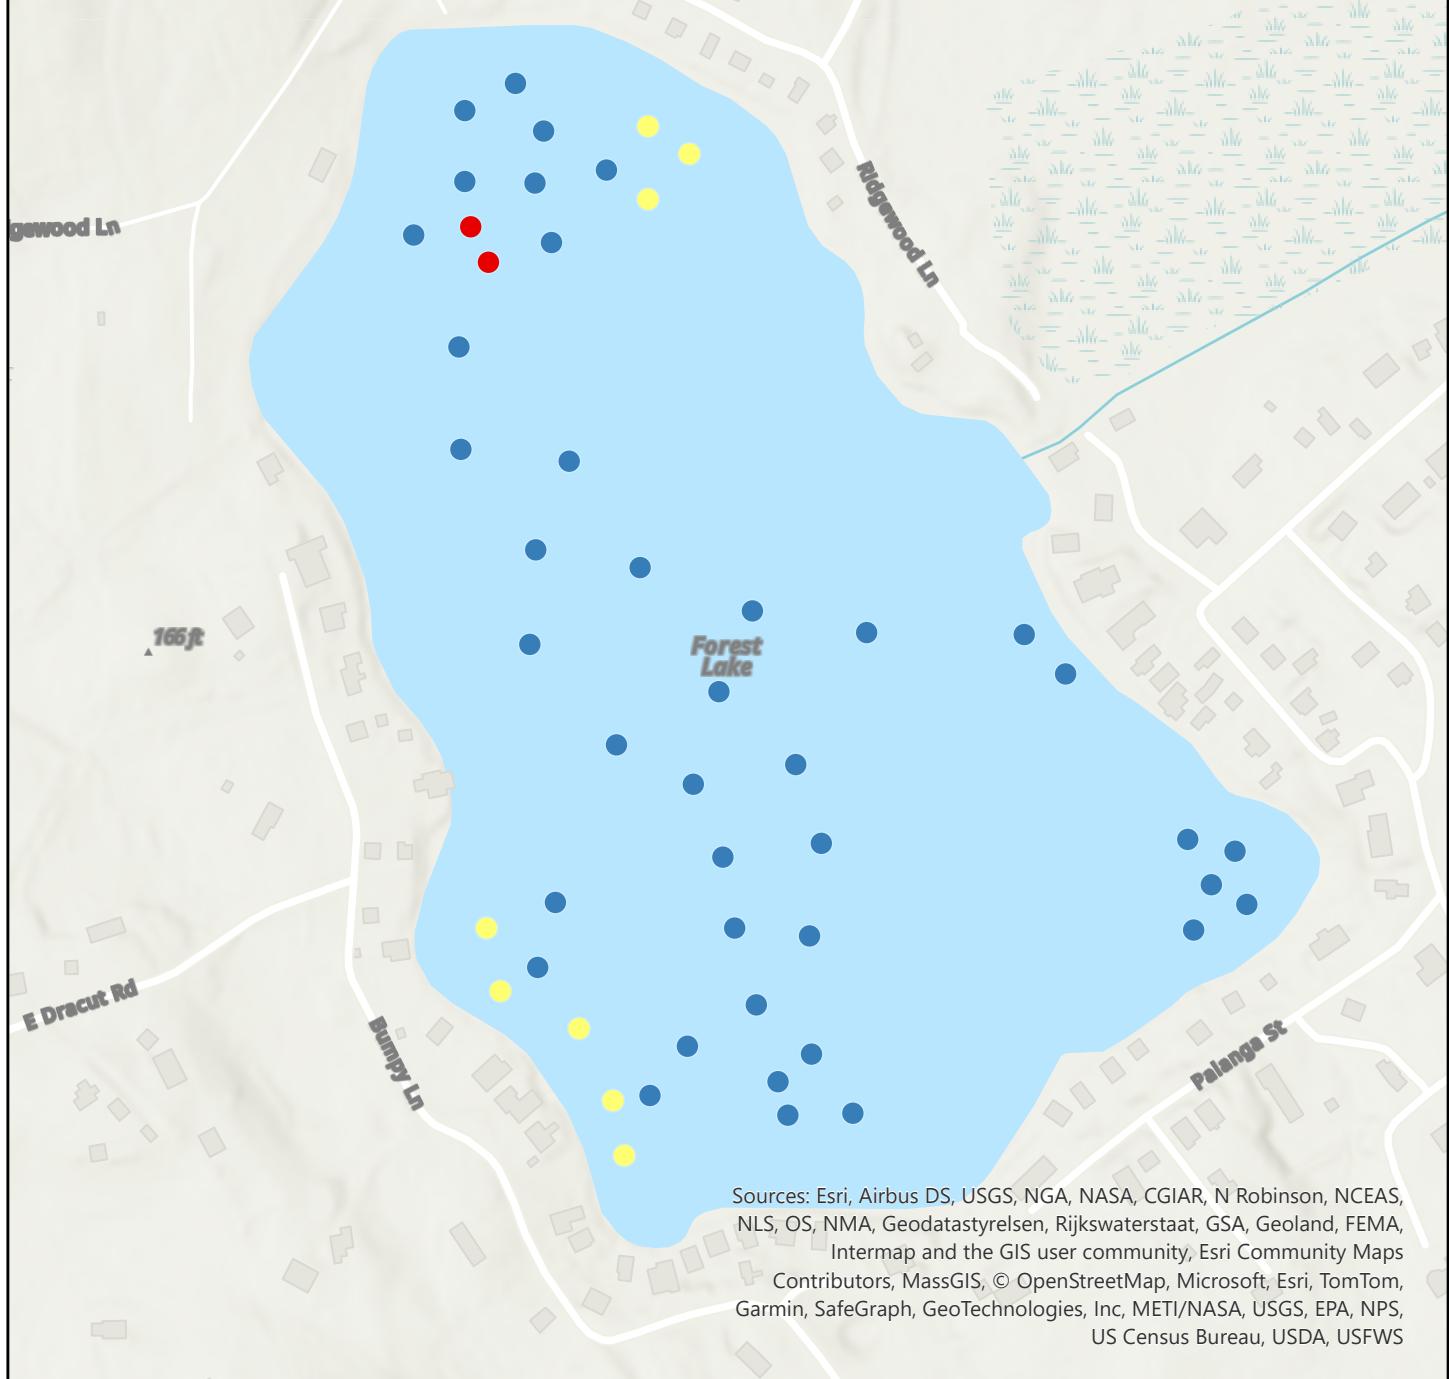
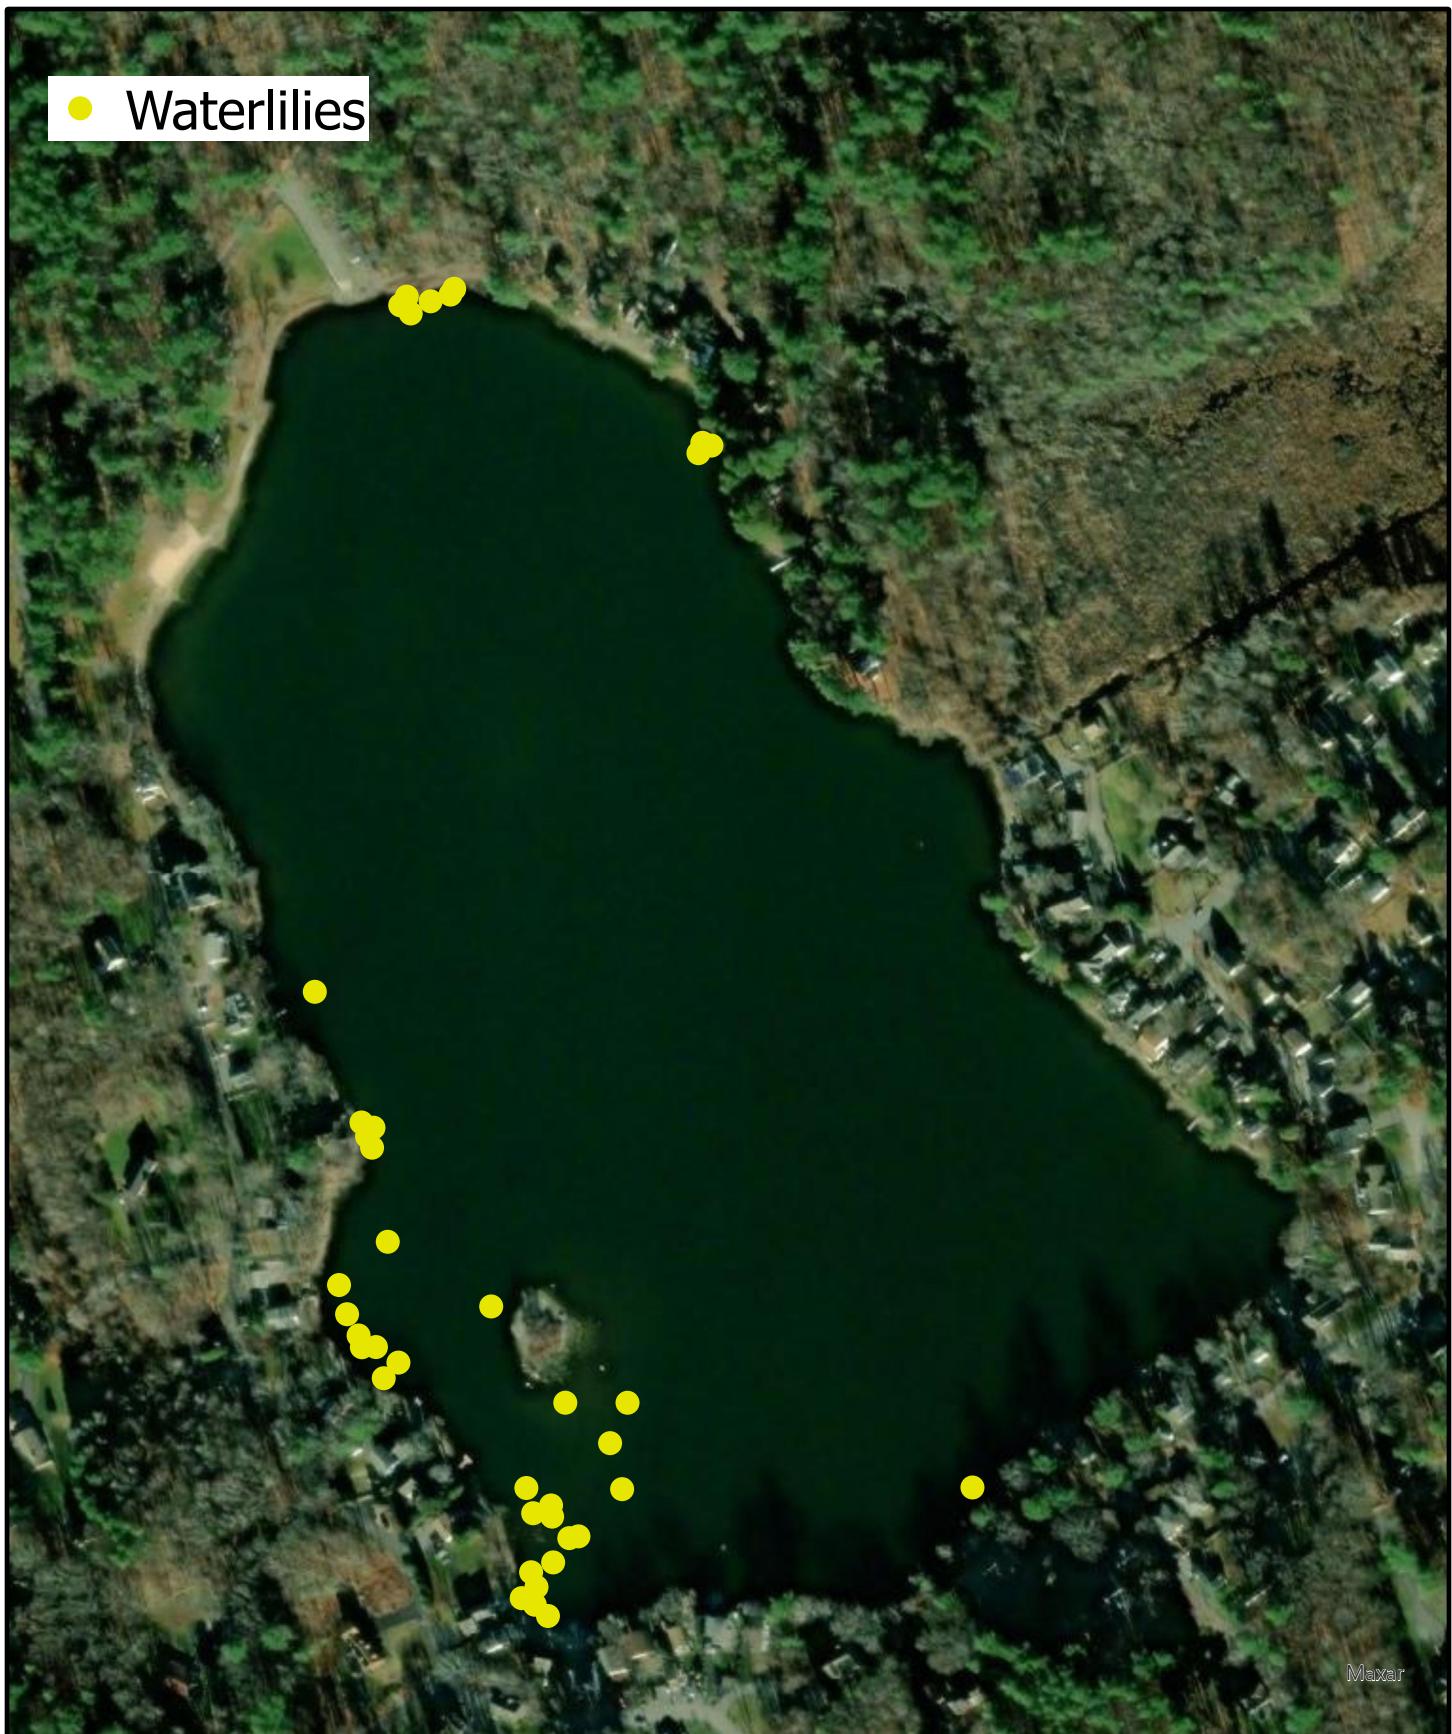
Attachments Include: 2024 Survey Maps

- Waterlilies (Yellow)
- Curly-Leaf (Red)
- Clasping Leaf (Blue)
