Comprehensive Grammar School

City of Methuen ADA Transition Plan

October 2024

Institute for Human Centered Design

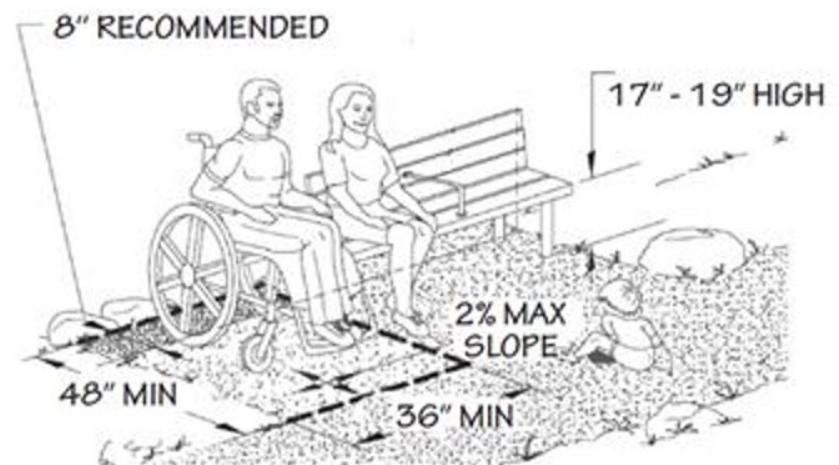
The following illustration demonstrates how to incorporate a 36" min. by 48" min. stable, firm and slip-resistant surface adjacent to at least one bench in each area where benches are provided positioned to allow a person in a wheeled mobility device and a person sitting on the bench to have their shoulders aligned.

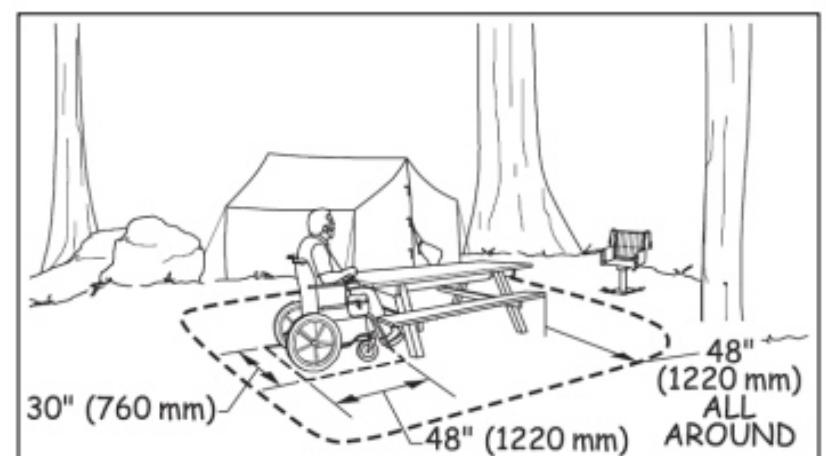
The following illustration demonstrates how to provide a stable, firm and slip-resistant surface that is 48" clear on all sides of the picnic table.
