# Marsh Grammar School

## City of Methuen ADA Transition Plan

October 2024

Institute for Human Centered Design

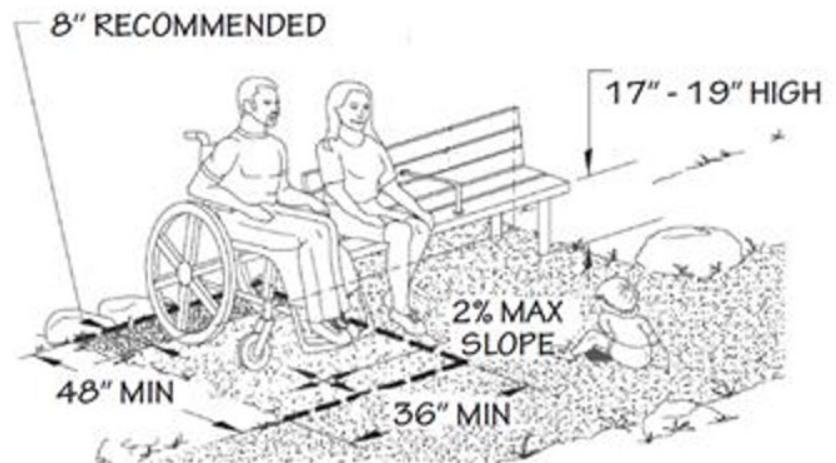
The following illustration demonstrates how to incorporate a 36" min. by 48" min. stable, firm and slip-resistant surface adjacent to at least one bench in each area where benches are provided positioned to allow a person in a wheeled mobility device and a person sitting on the bench to have their shoulders aligned.
